Zia Luxury Property Observer Est.

Villa N41 sustainable city

Villa N41

Property Inspection Summary

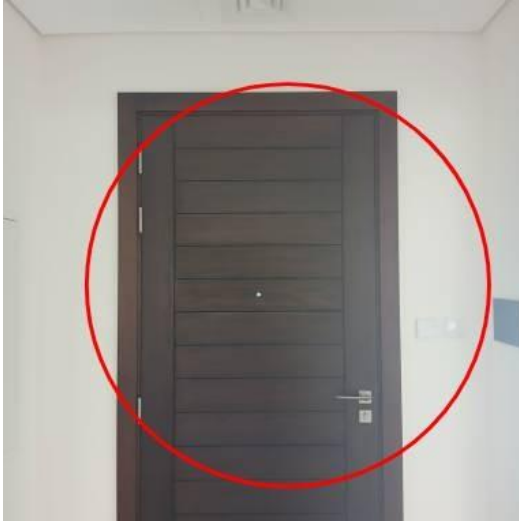
1454.jpg

Door wobbling

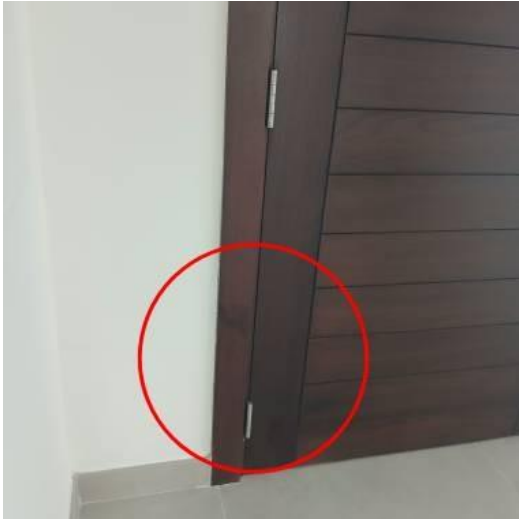
1455.jpg

Damage frame to be rectified

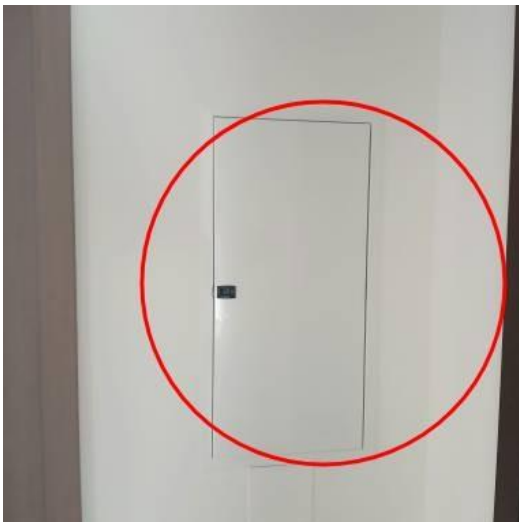
1456.jpg

Dp door not closed properly

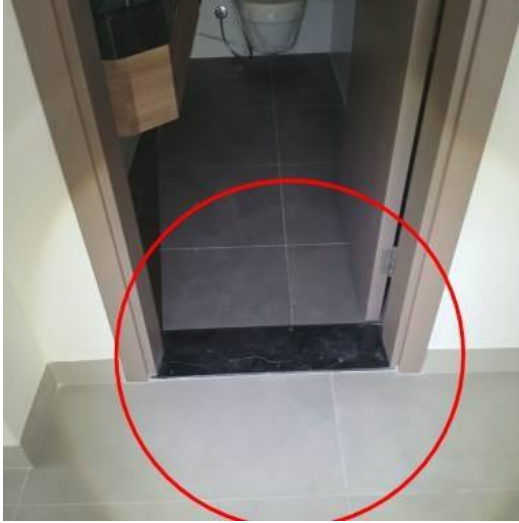
1457.jpg

Silicone needs to be done

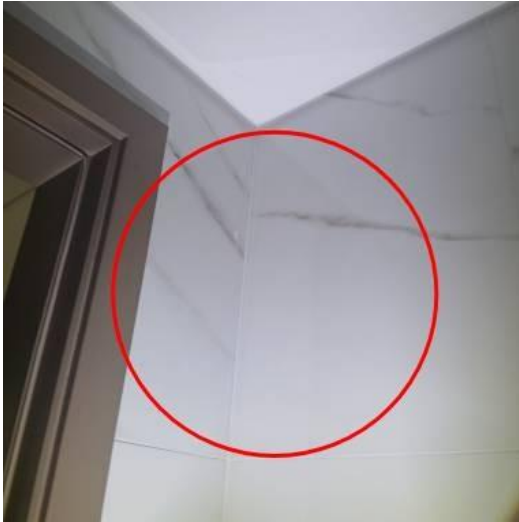
1458.jpg

Paintmark, needs cleaning

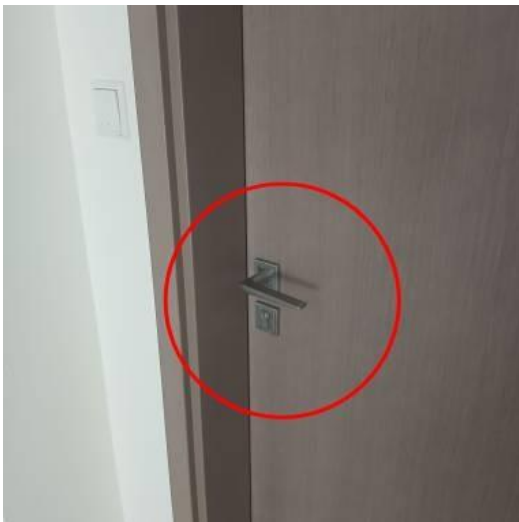
1459.jpg

Door lock not working smoothly

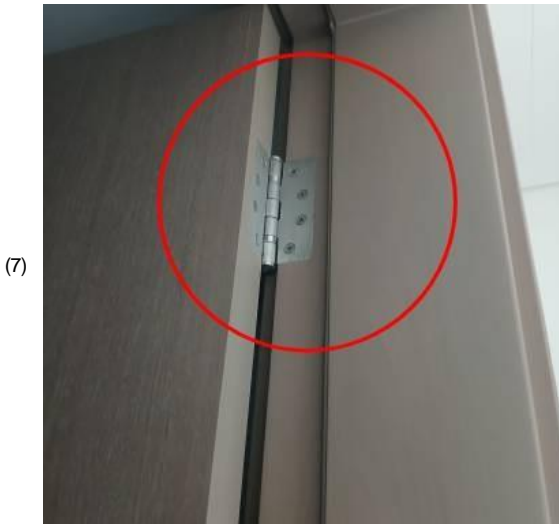
1460.jpg

All damage Screw needs replaced

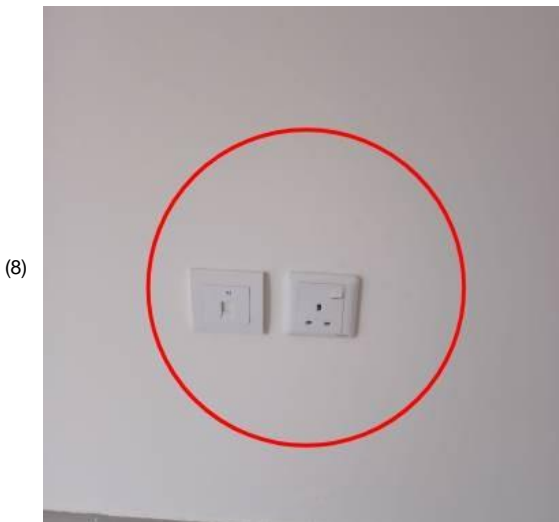
1461.jpg

Gap between fitting and wall

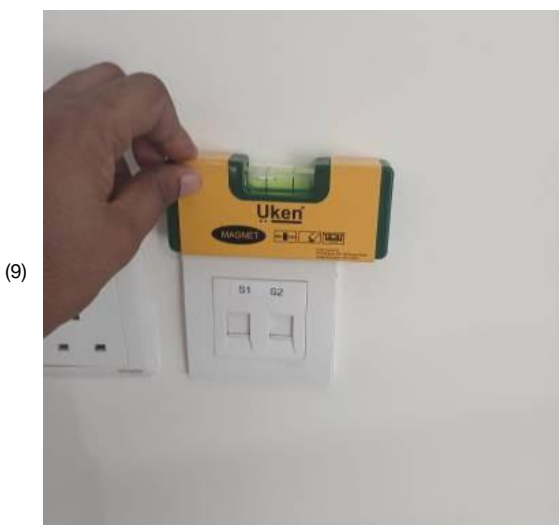
1462.jpg

Socket not aligned straight

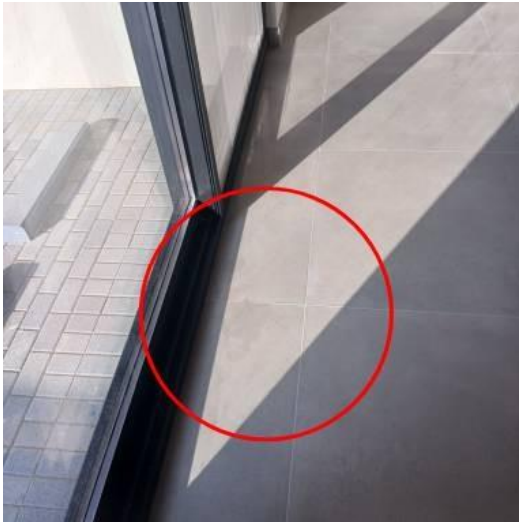
1463.jpg

Stains to be cleaned

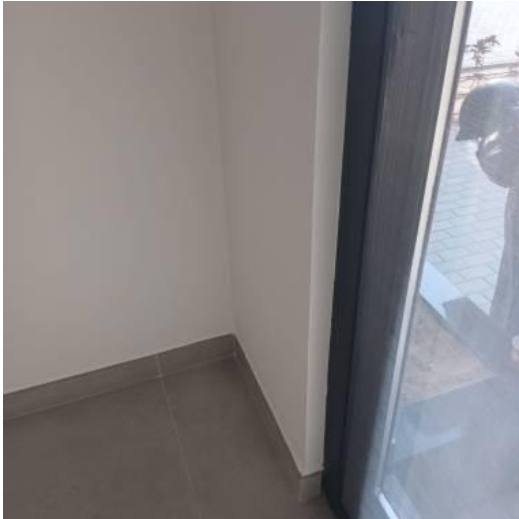
1464.jpg

Fly screen damage

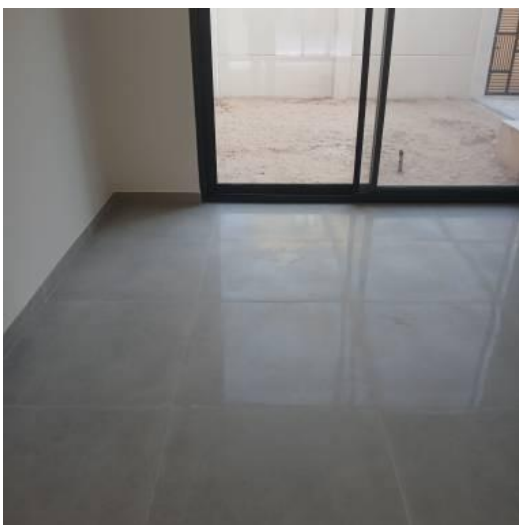
1465.jpg

Staimark on the tile needs to be cleaned

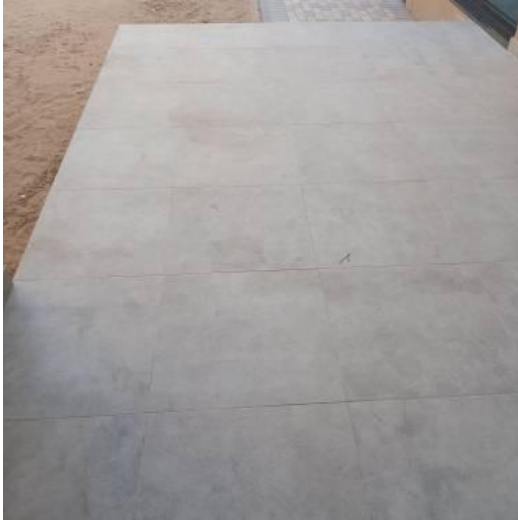
1466.jpg

Stains on the needs to be cleaned

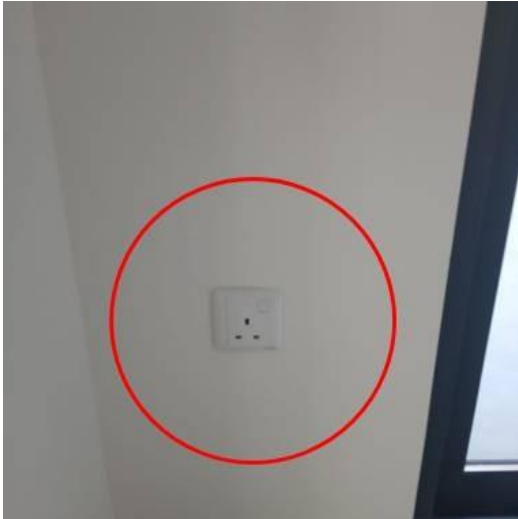
1467.jpg

Gap between fitting and wall

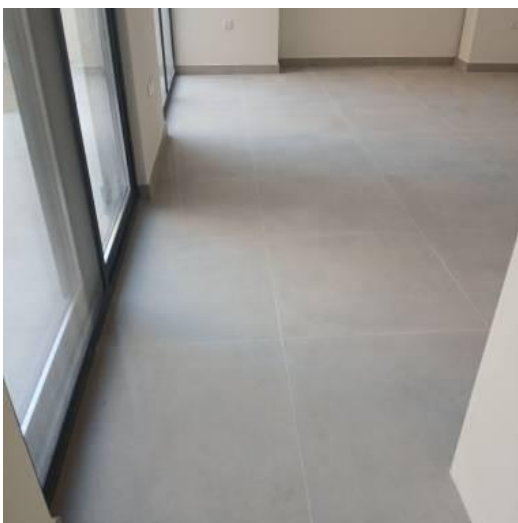
1468.jpg

Stainmark, needs cleaning

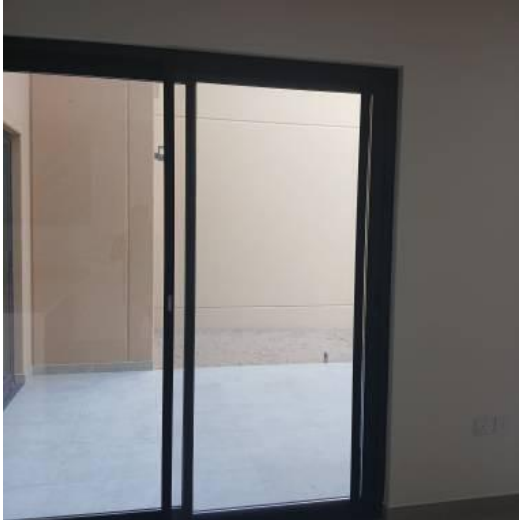
1469.jpg

Fly screen very hard to move,needs to be rectified

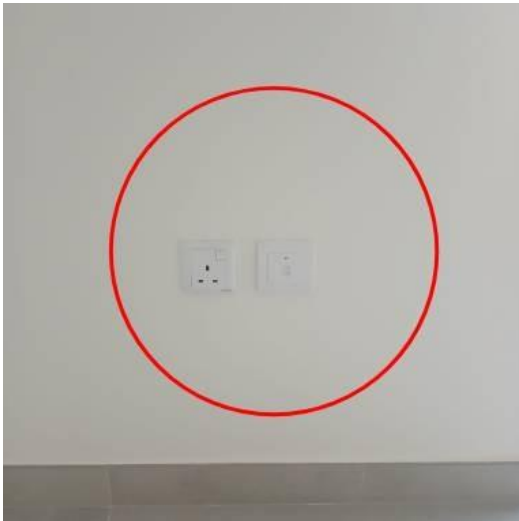
1470.jpg

Gap between fitting and wall

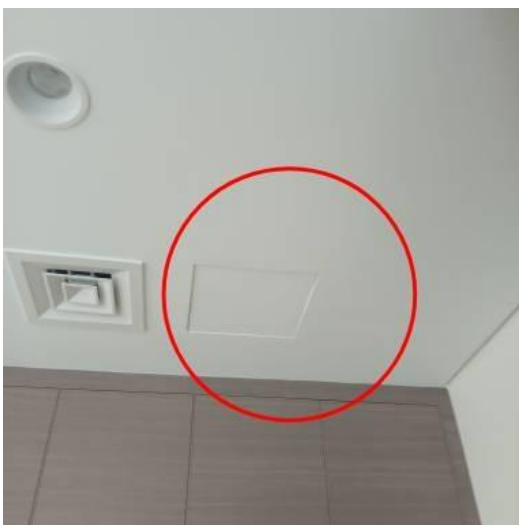
1471.jpg

Uneven ceiling acces panel

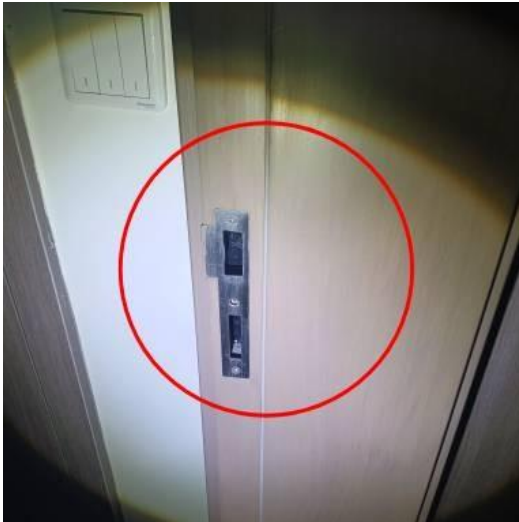
1472.jpg

Screw missing

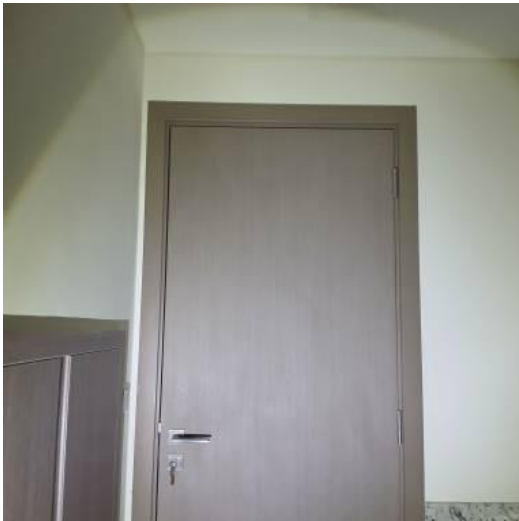
1473.jpg

Door wobbling

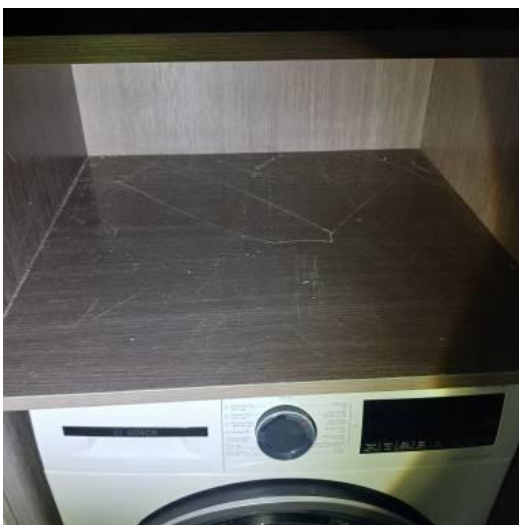
1474.jpg

Scratches found

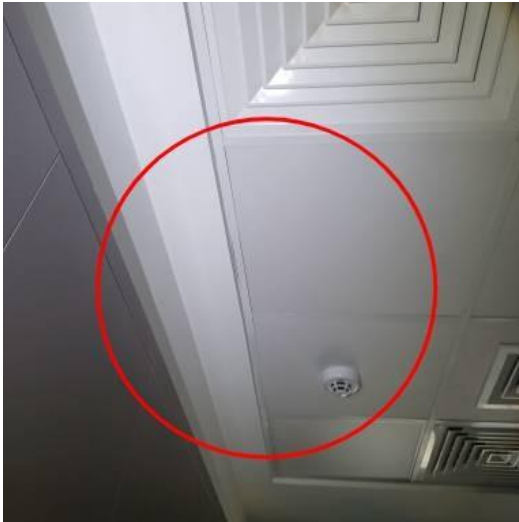
1475.jpg

Ceiling channel should be free from the paint

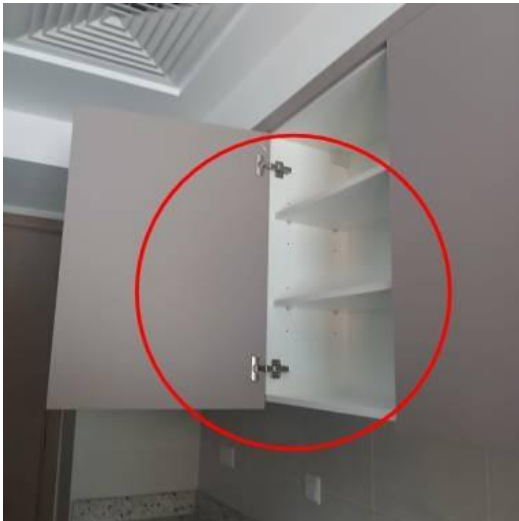
1476.jpg

Hinges needs to be adjustment, misaligned door touch with frame

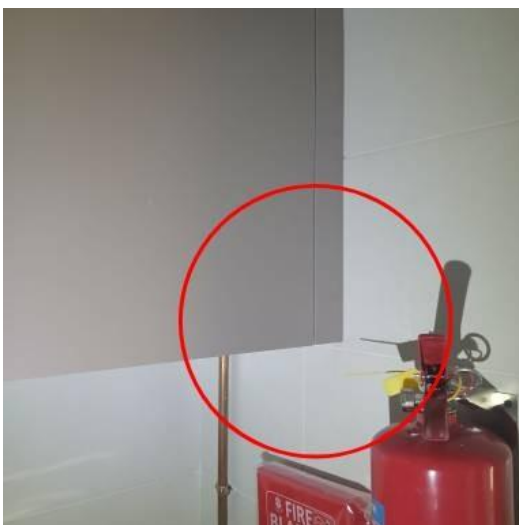
1477.jpg

Mark found to be cleaned

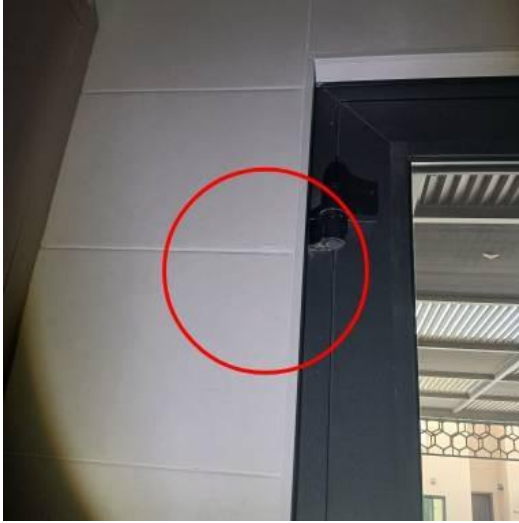
1478.jpg

Grout needs cleaning

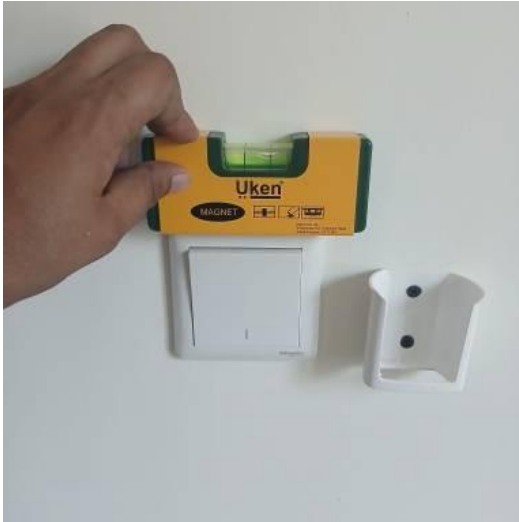
1479.jpg

Not aligned straight

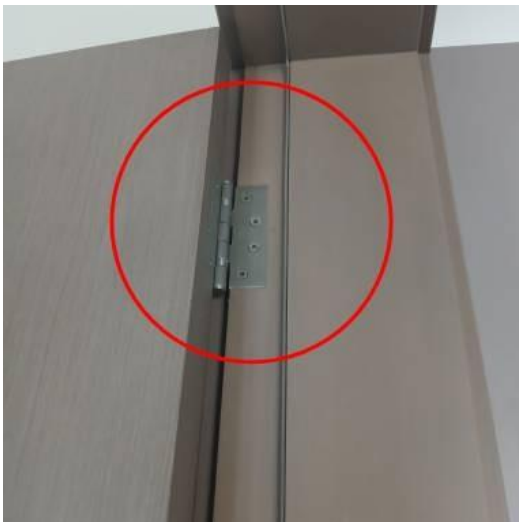
1480.jpg

Damage Screw needs replaced

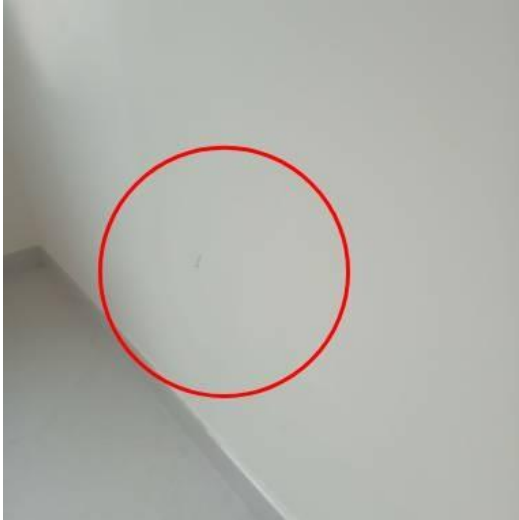
1481.jpg

Damage wall to be rectified

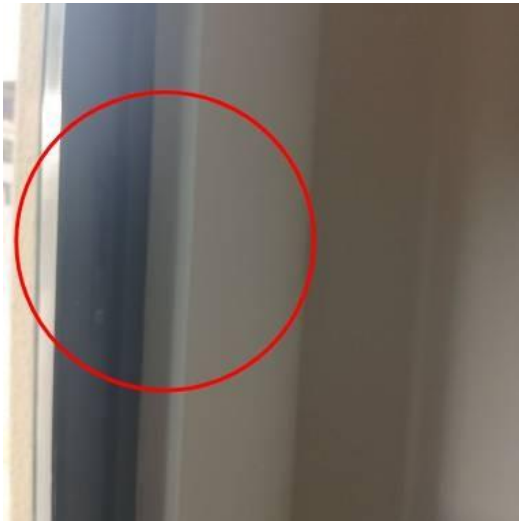
1482.jpg

Lock defective not working

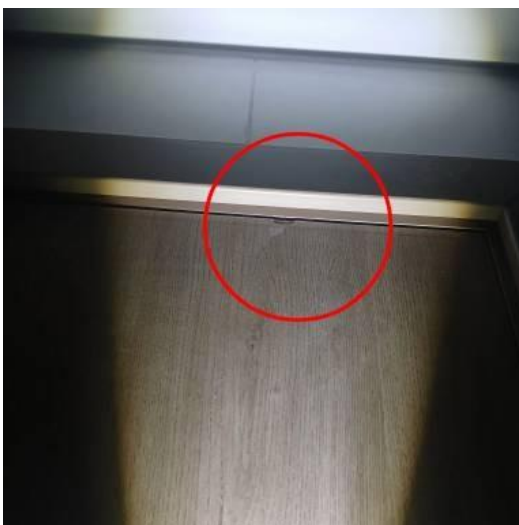
1483.jpg

Chipped found

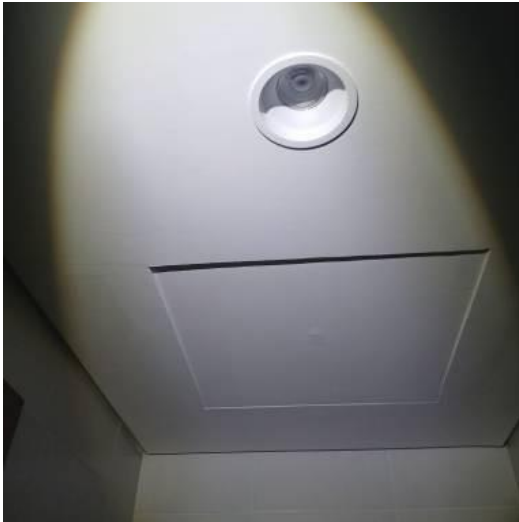
1484.jpg

Ceiling access door uneven

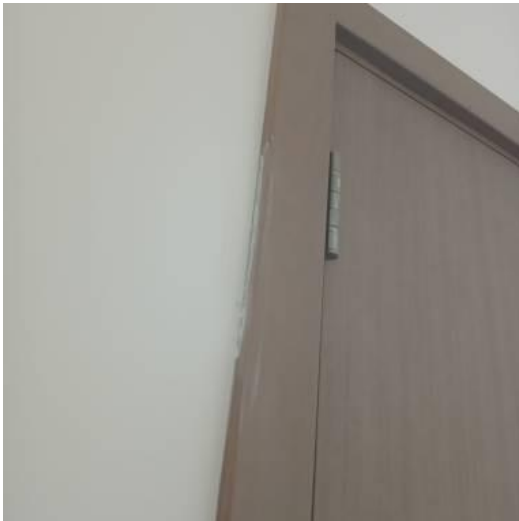
1485.jpg

Door frame free from the paint

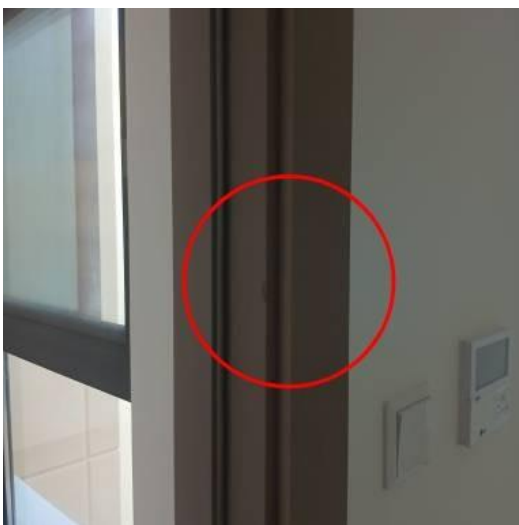
1486.jpg

Chipped found to be rectified

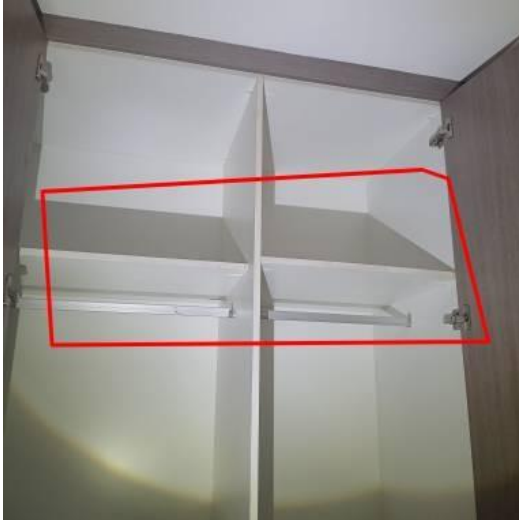
1487.jpg

Poor finishing to be improved

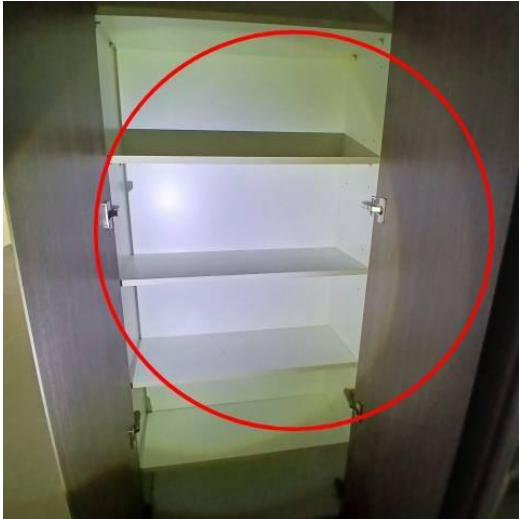
1488.jpg

Poor finishing, Stainmark

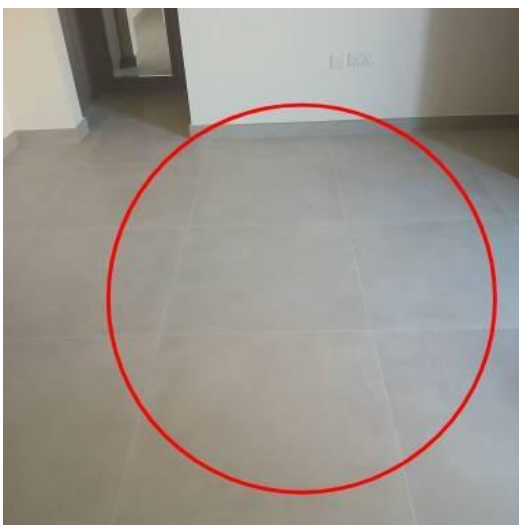
1489.jpg

Stainmark, needs cleaning

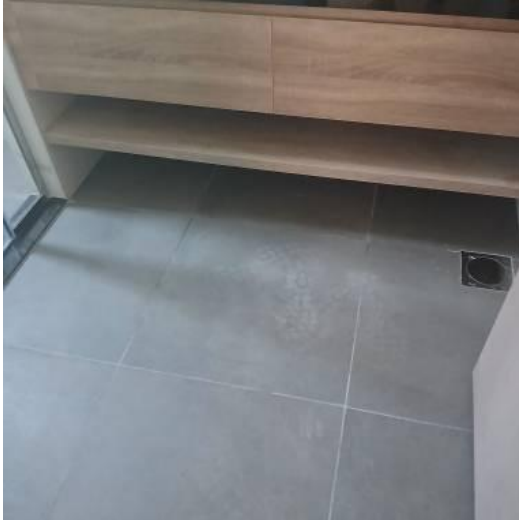
1490.jpg

Grout colour variation, grout needs replaced

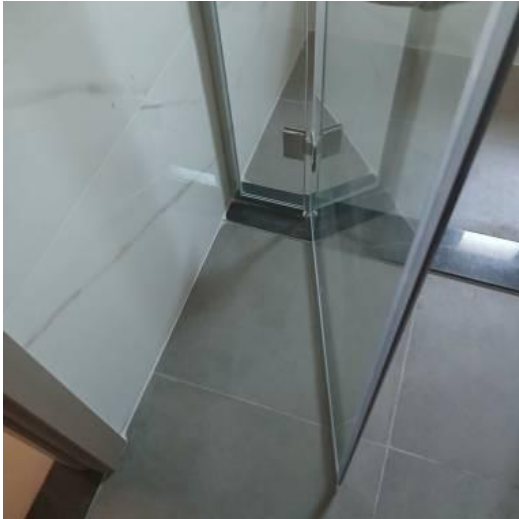
1491.jpg

Glass door stopper missing

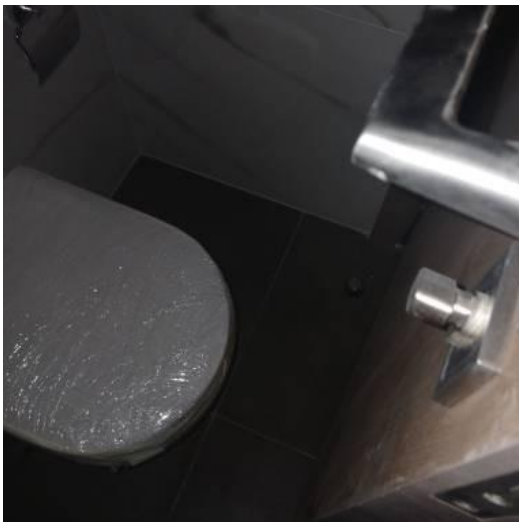
1492.jpg

Door stopper not installed correctly door touching with Bidet

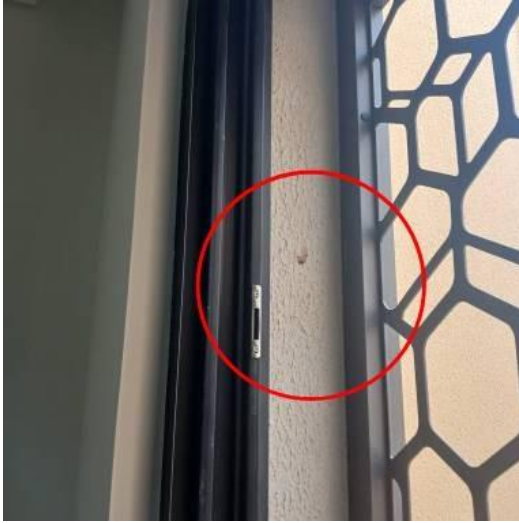
1493.jpg

Paint touch up needs to be done

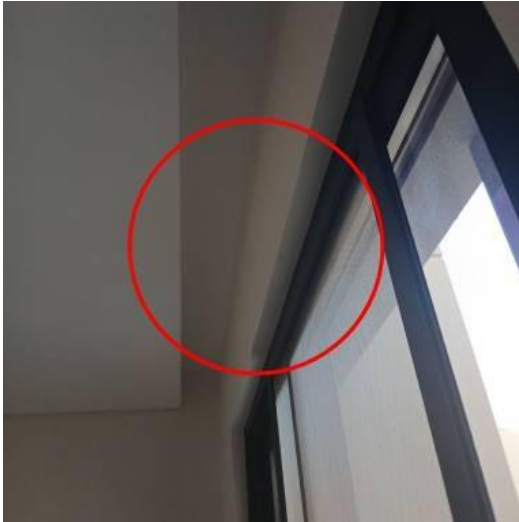
1494.jpg

Paint needs to be done

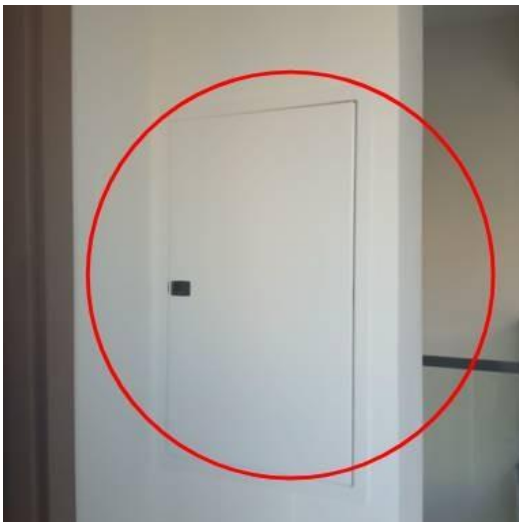
1495.jpg

Dp door doesn't close properly

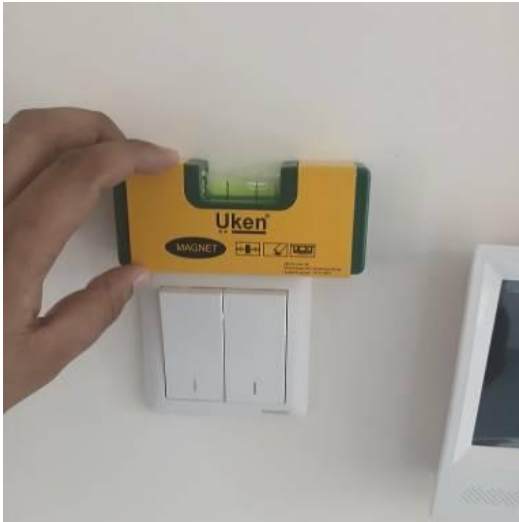
1497.jpg

Not aligned straight

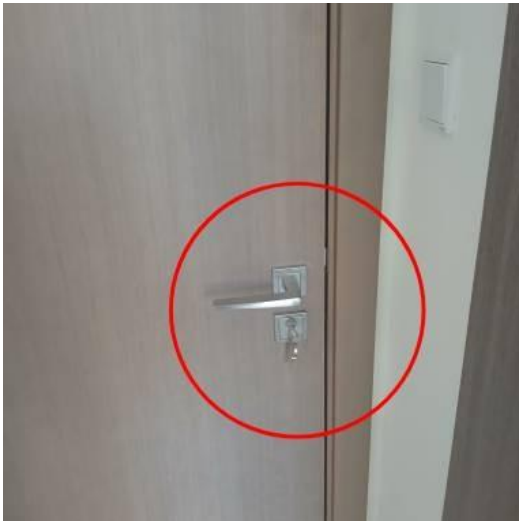
1498.jpg

Lock not working

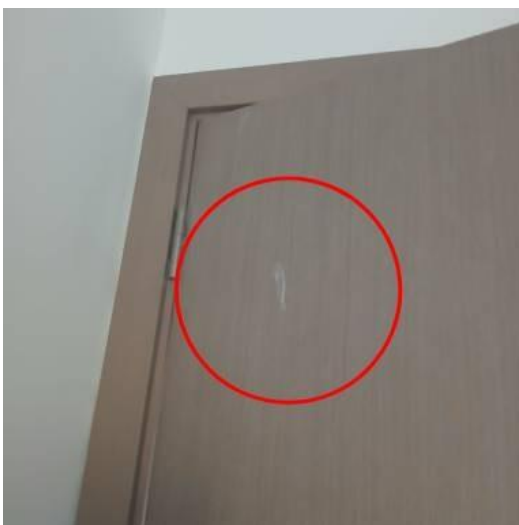
1499.jpg

Paint stain

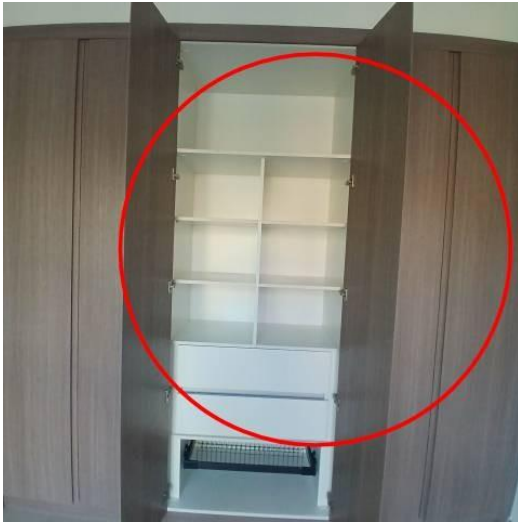
1500.jpg

Stains to be cleaned

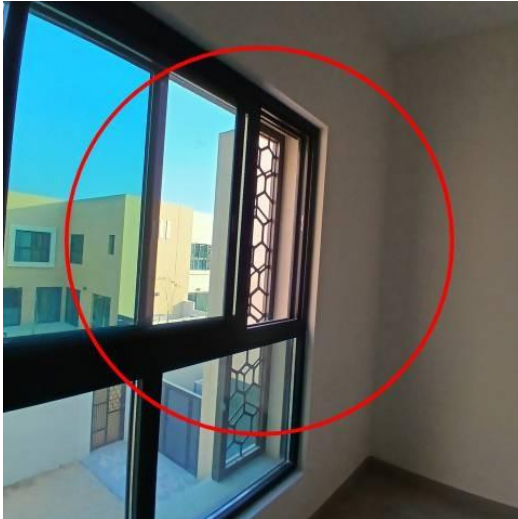
1501.jpg

Paintmark

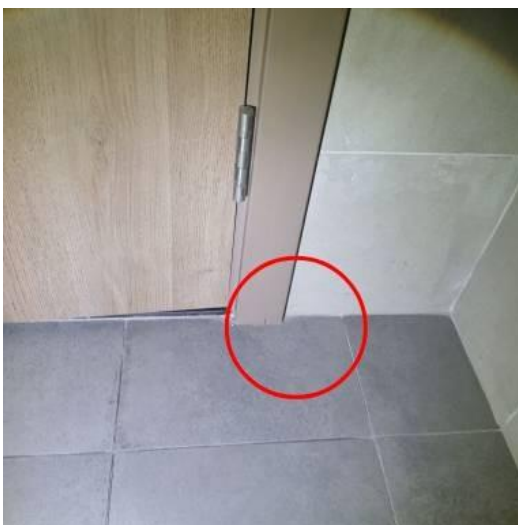
1502.jpg

Crack found

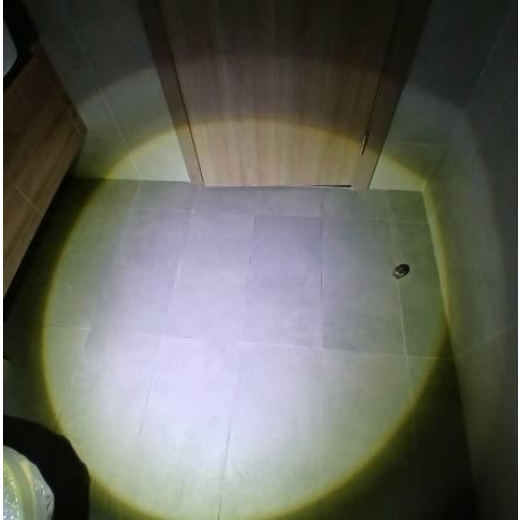
1503.jpg

Grout colour variation, grout needs replaced

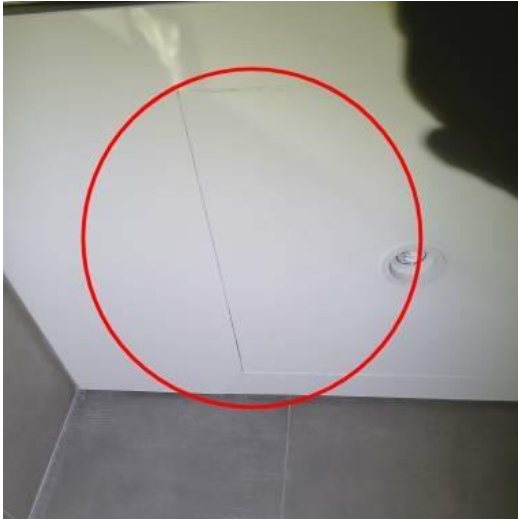
1504.jpg

Crack to be rectified

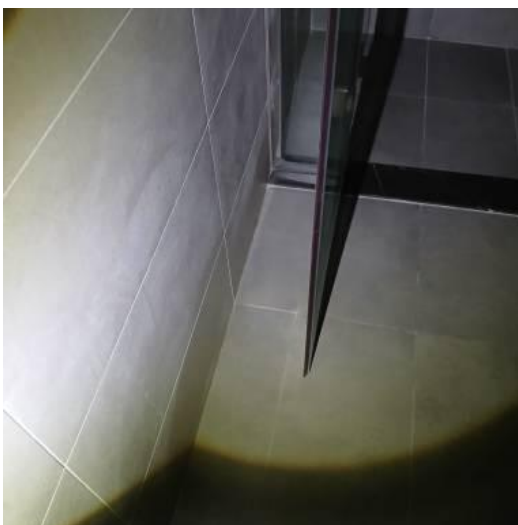
1505.jpg

Shower glass door stopper missing

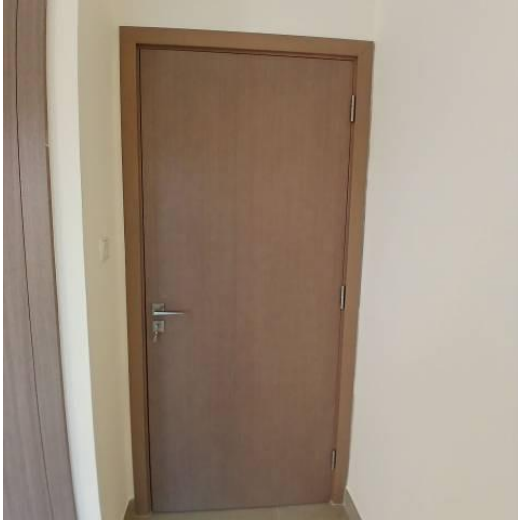
1506.jpg

Door wobbling

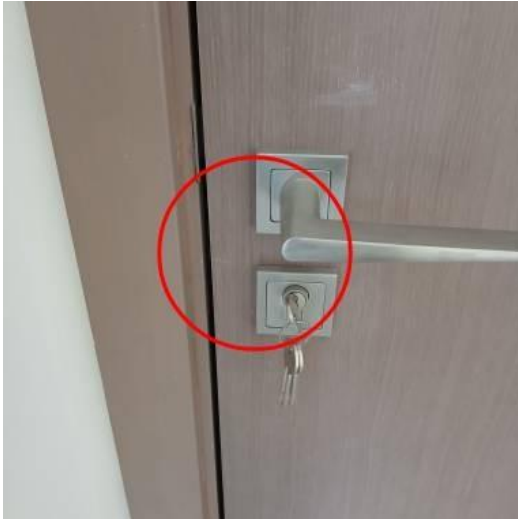
1507.jpg

Scratches found

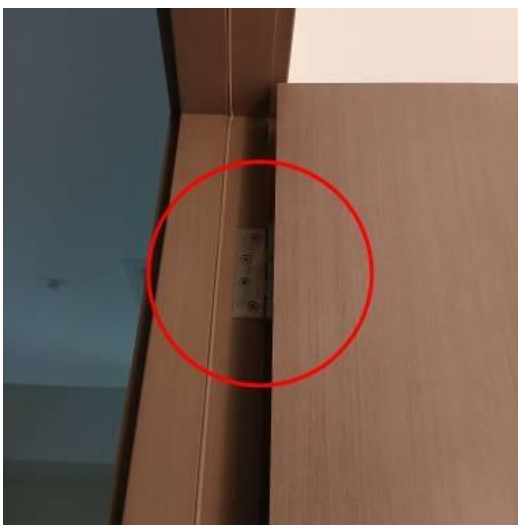
1508.jpg

Damage Screw needs replaced

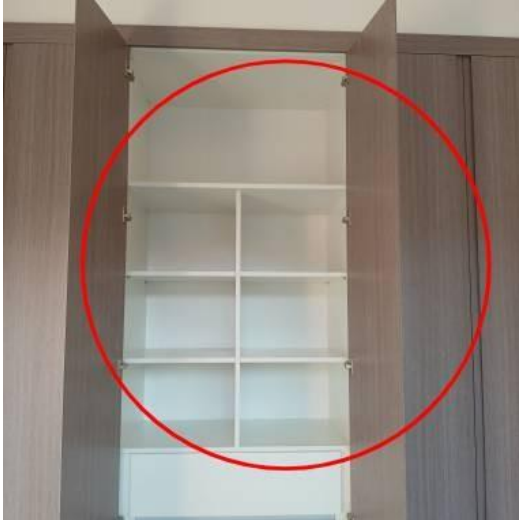
1509.jpg

Stains needs cleaning

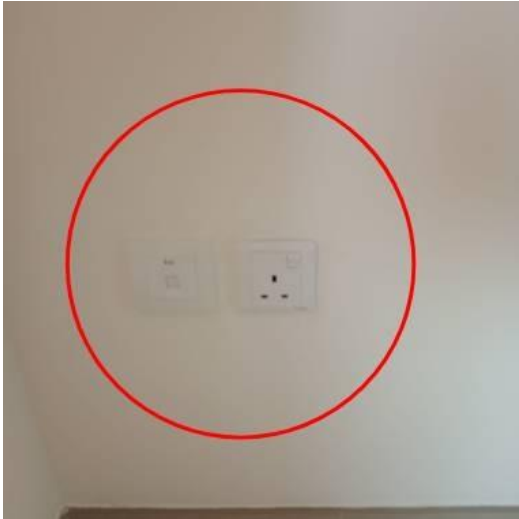
1510.jpg

Gap between fitting and wall

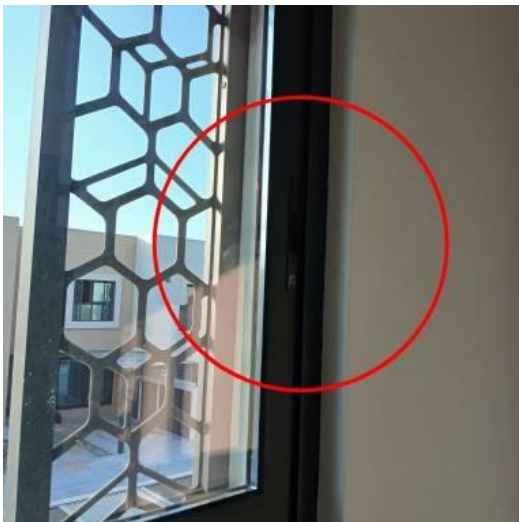
1511.jpg

Lock very hard to open,needs to be rectified

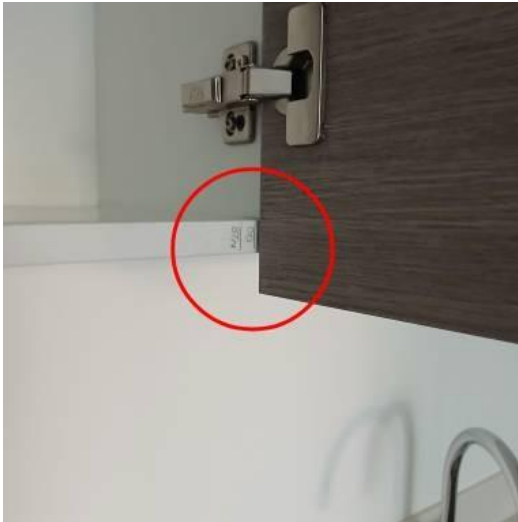
1512.jpg

Mark found , needs cleaning

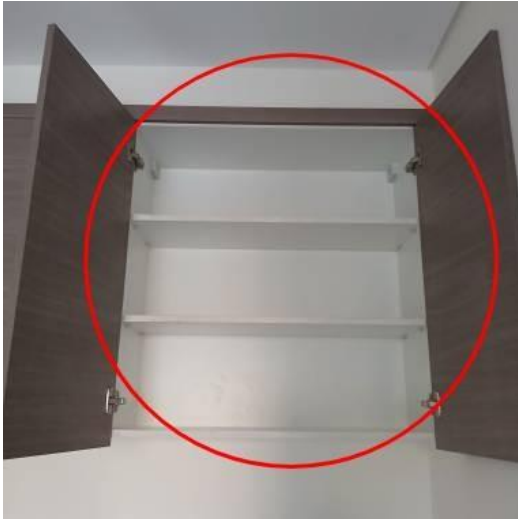
1513.jpg

Stains to be cleaned

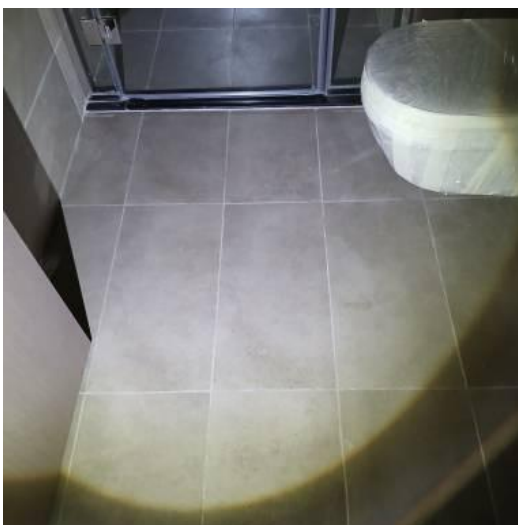
1514.jpg

Grout needs cleaning

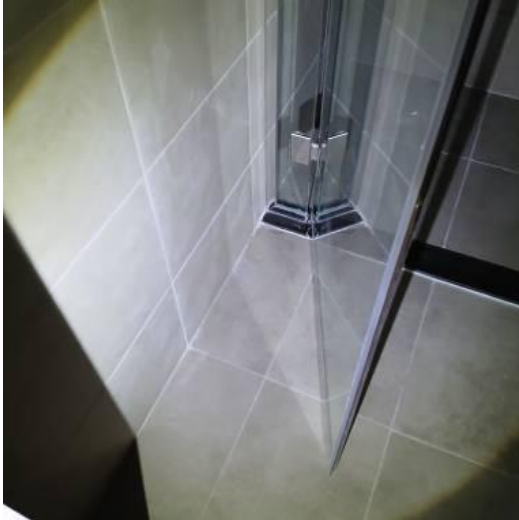
1515.jpg

Shower glass door stopper missing

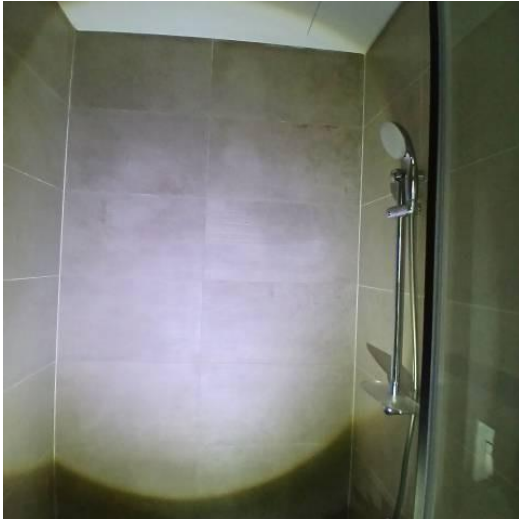
1516.jpg

Stainmark found on tile

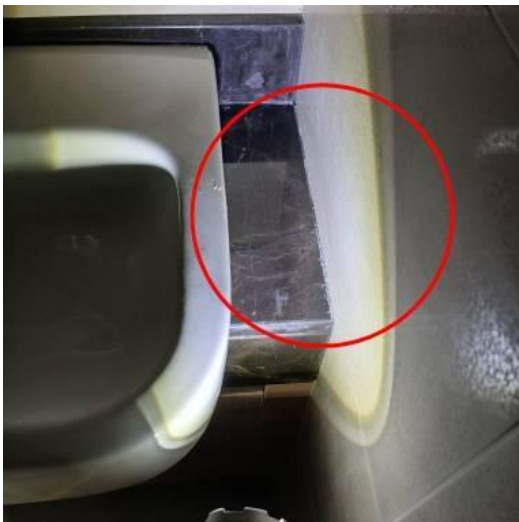
1517.jpg

Silicone missing

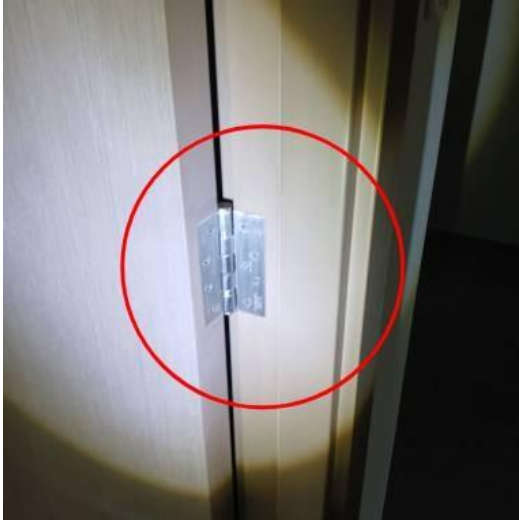
1518.jpg

Damage Screw

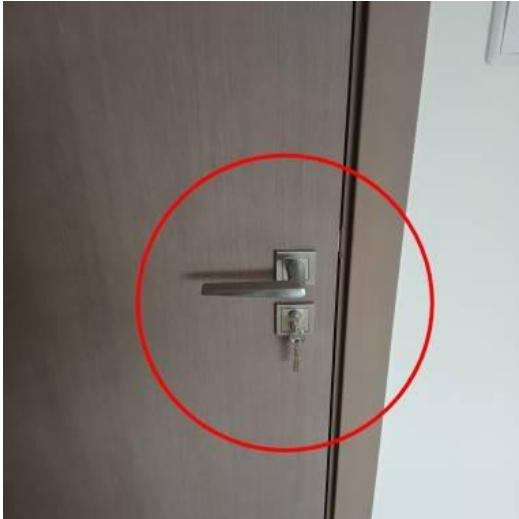
1519.jpg

Lock not working smoothly

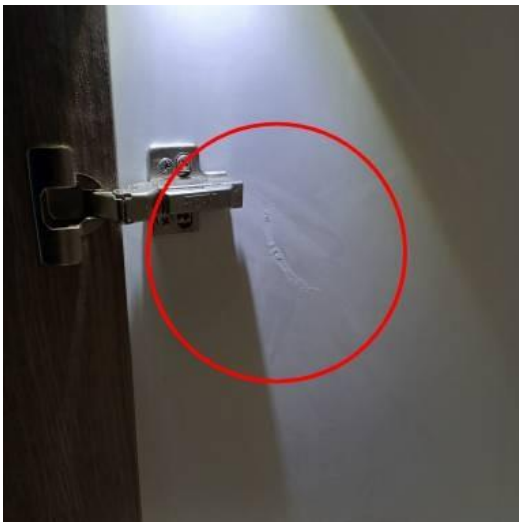
1520.jpg

Damage found

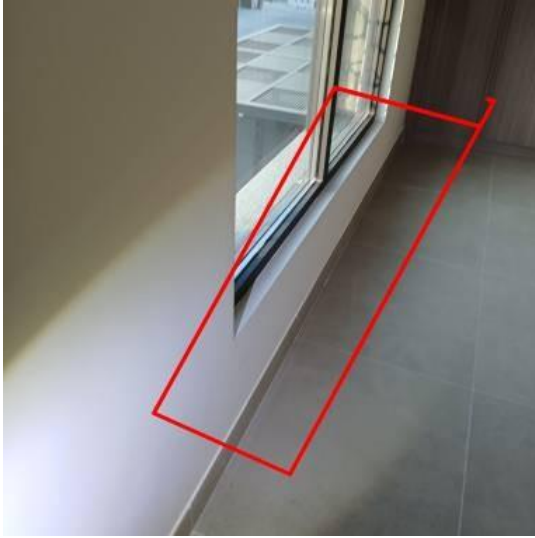
1521.jpg

Paint needs to be done

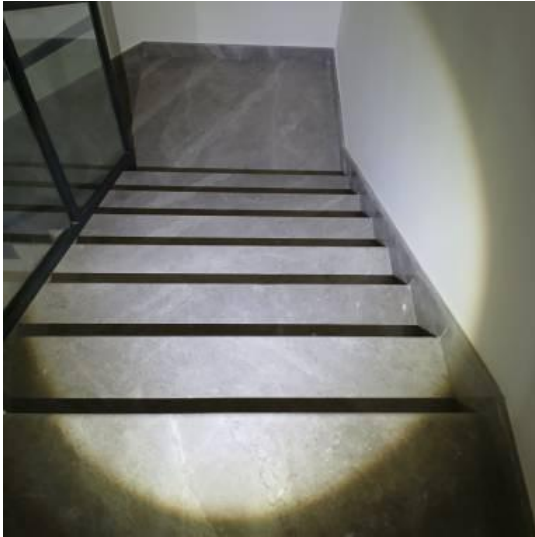
1522.jpg

Paintmark
