PROPERTY INSPECTION REPORT

VILLA # N74 CANAL COVE FROND PALM JUMAIRA

Client Name: Hemalataa Vinayak Shrivastav

Inspection Date: November 22, 2025

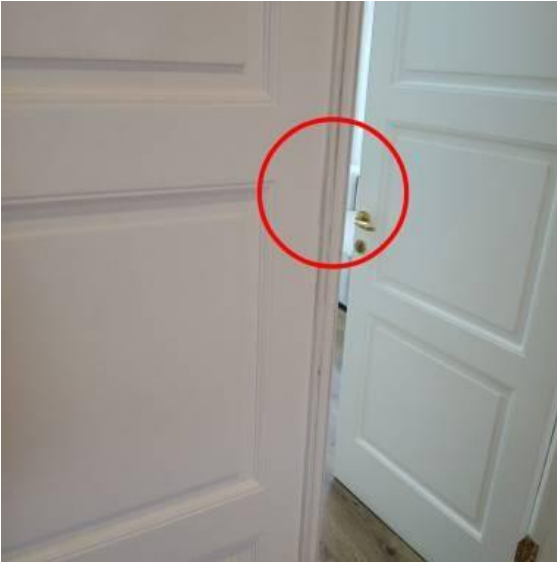
Found Broken door frame

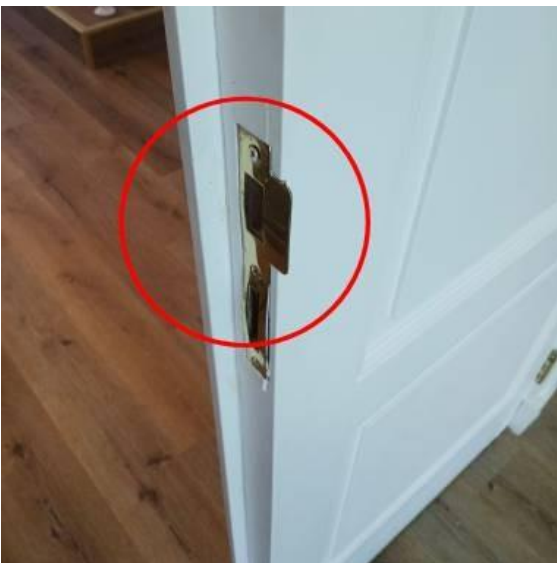
Door strike were damaged

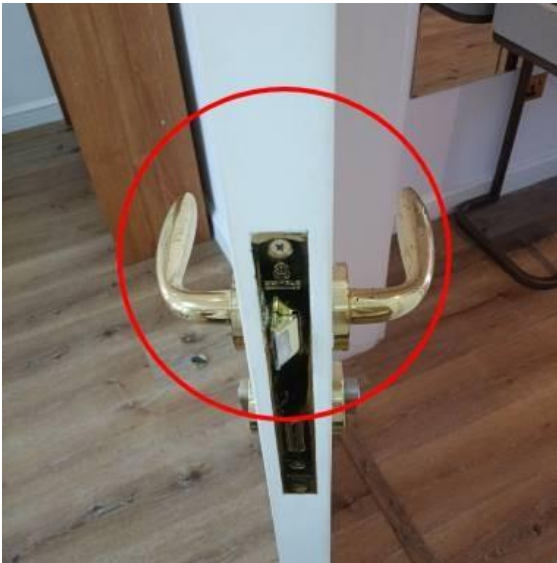
Rust on door lock

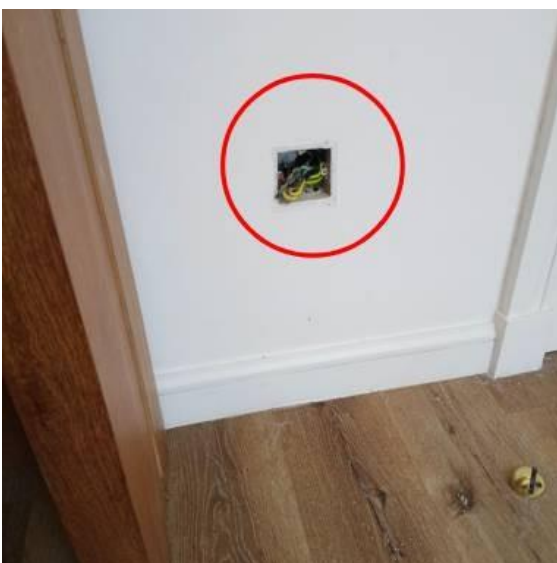
Socket not installed and found exposed wires

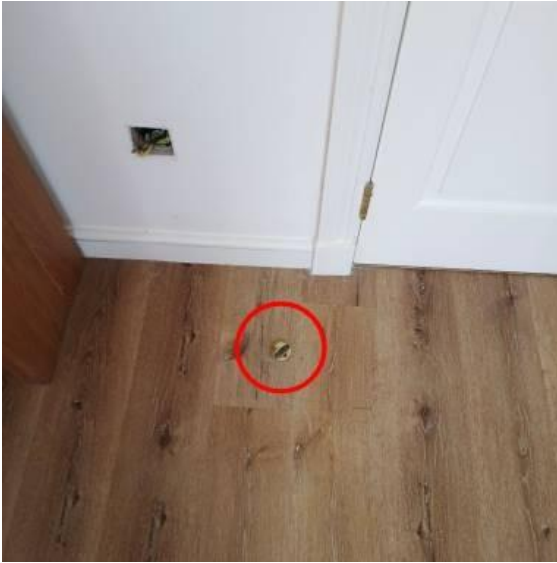
Found Loose door stopper

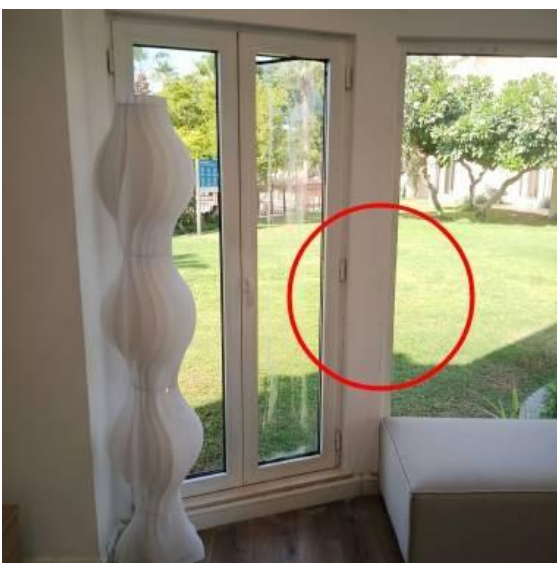
Cracks on wall were noted

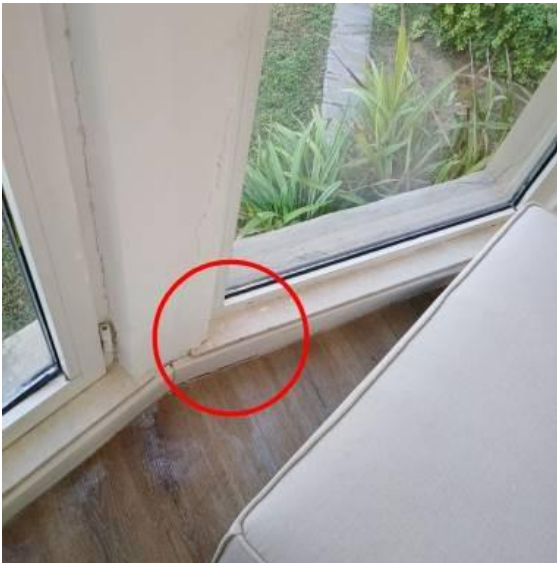
Skirting is detached from the wall

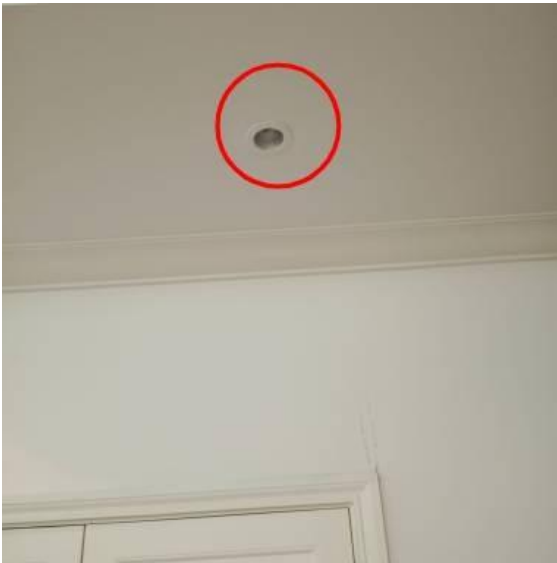
Bulb Light missing

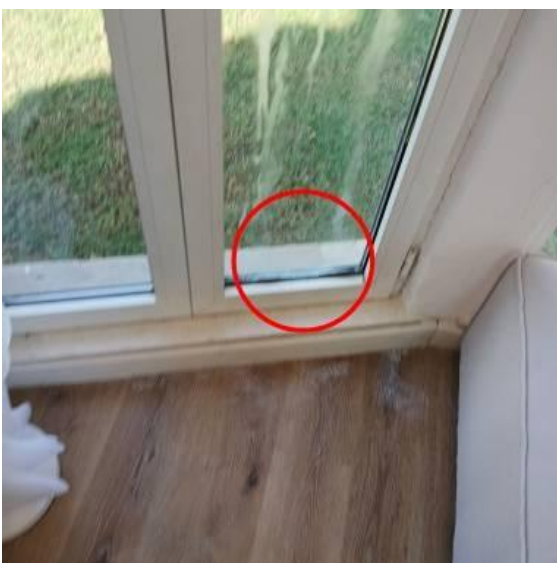
Window seal were damaged

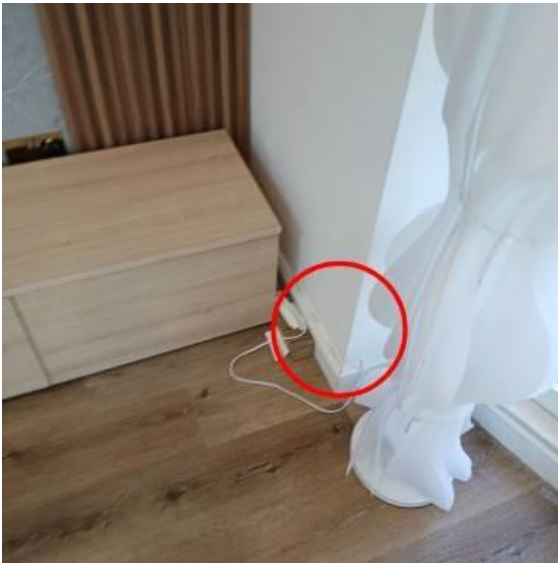
Skirting tiles detached from wall

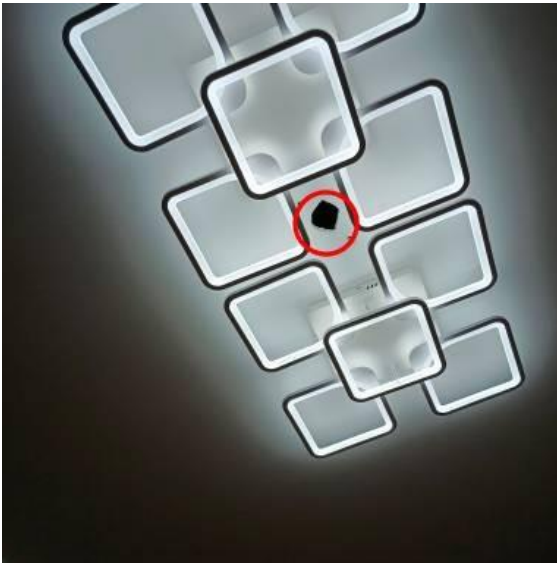
Opening found at ceiling

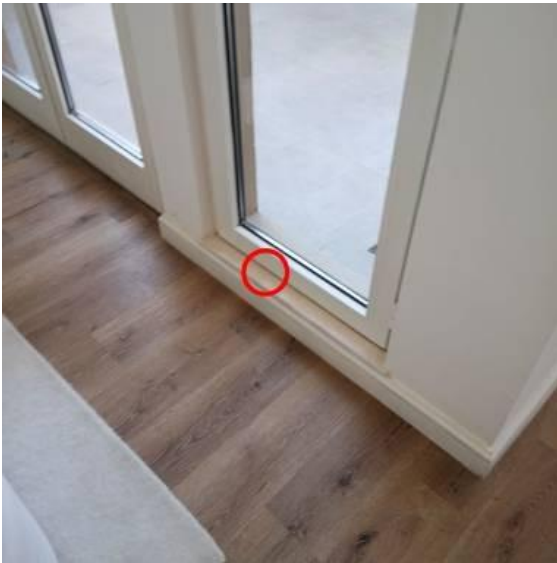
Cracked found on marble window sill

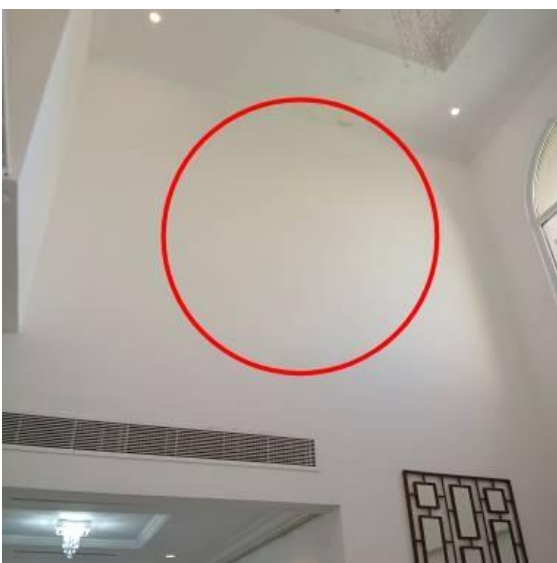
Found major Cracks on walls

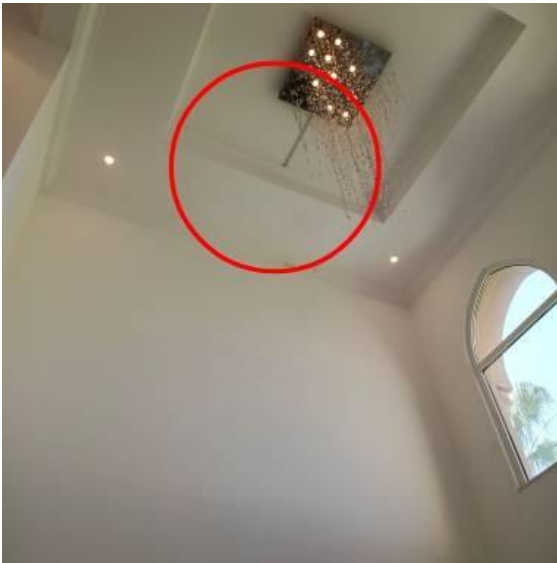
Cracks on ceiling and paint damaged were noted

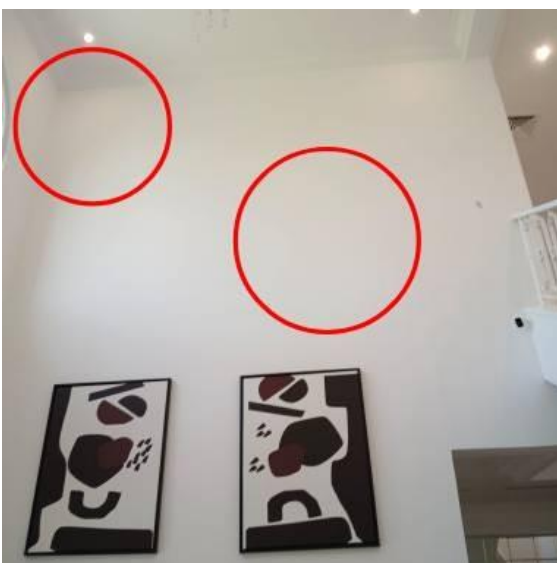
Cracks on wall were found

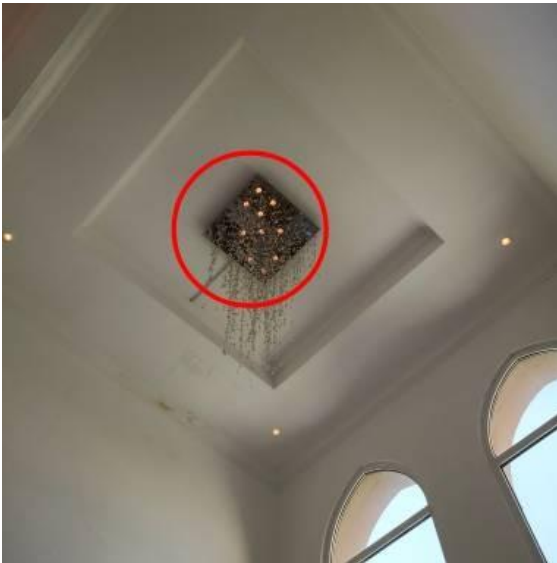
Multiple bulb lights were not working on ceiling chandelier (panose)

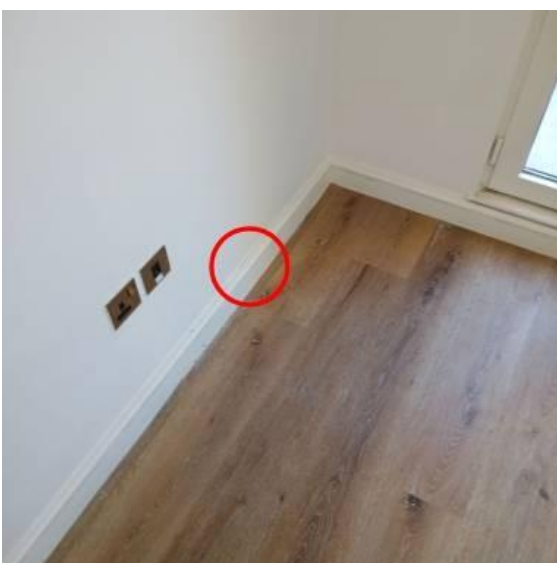
Skirting is detached from the wall

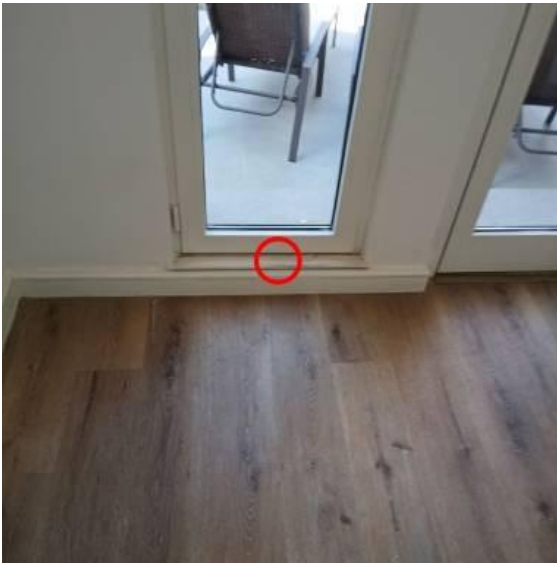
Broken marble on window sill were found

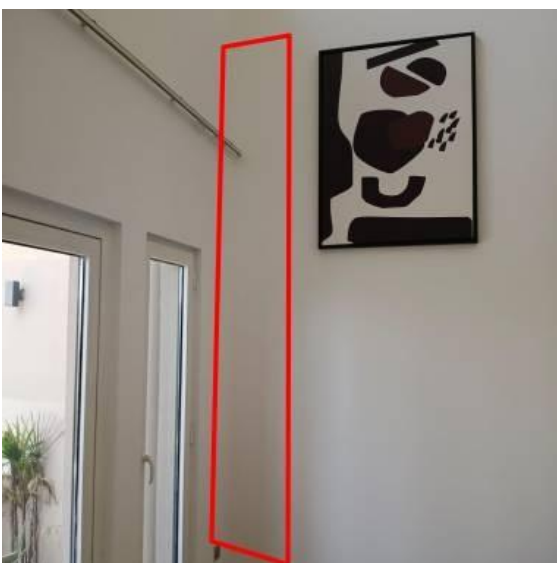
Cracks on entire wall were found

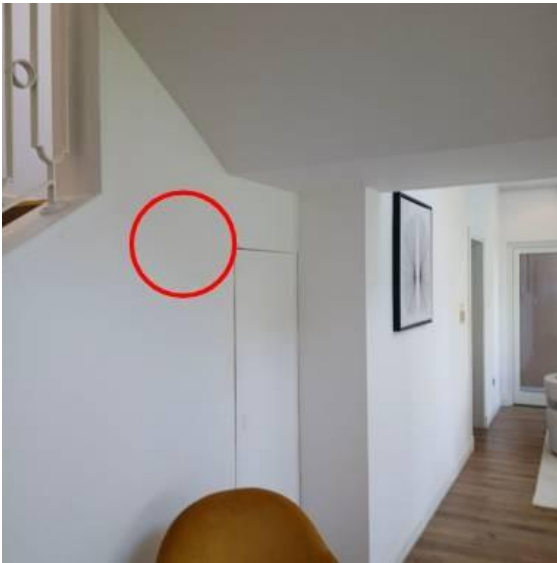
Found Cracks on wall

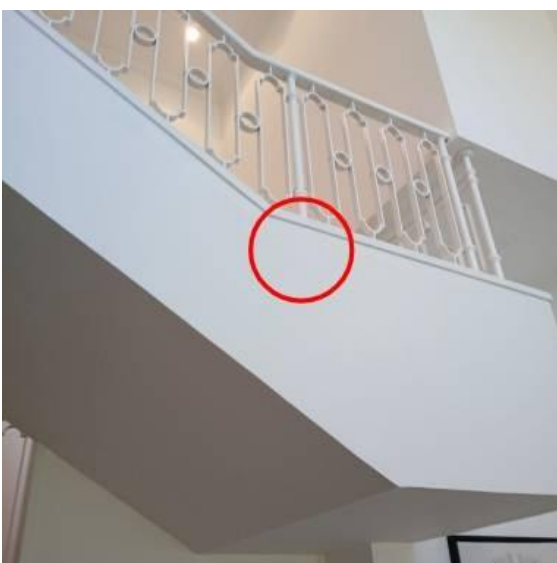
Found cracks on wall

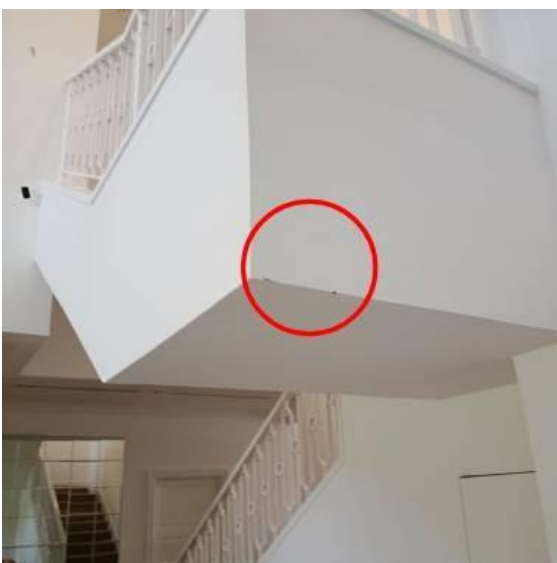
Broken wall edges were noted

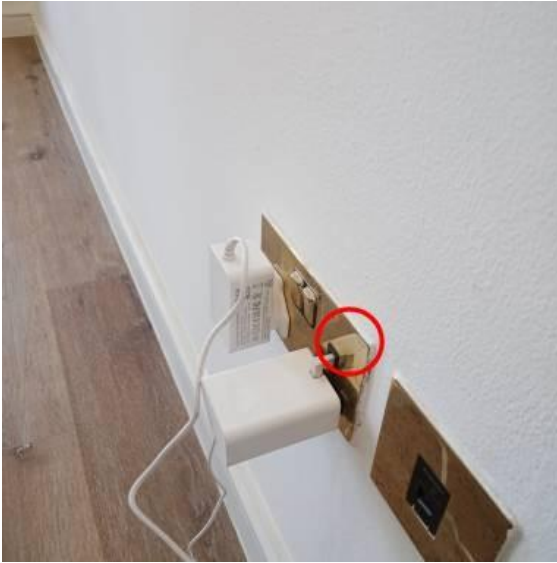
Plug is not going inside the socket checked with multiple plugs and socket tester

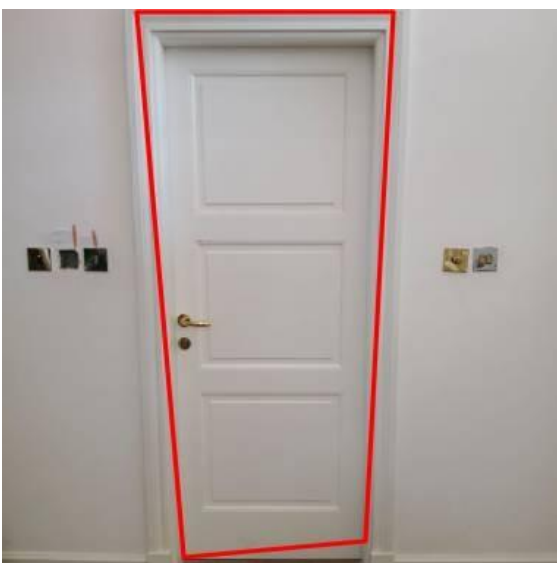
Multiple Chipped and scratches on entire doo

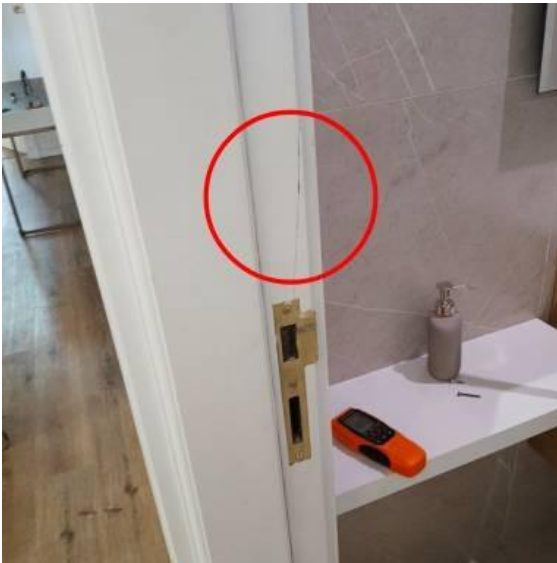
Found Broken door frame

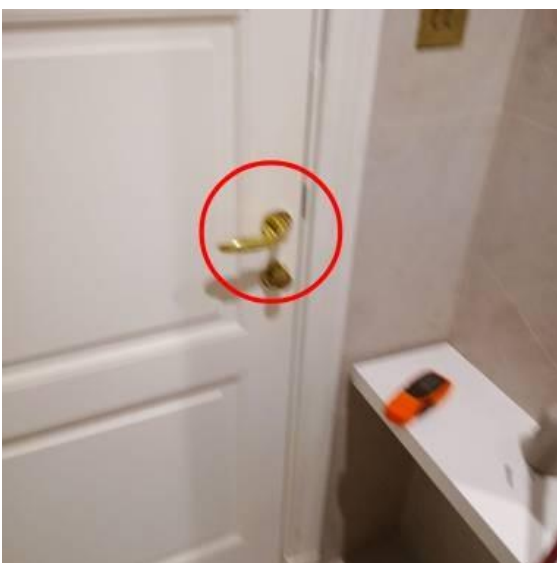
Door Lock hard to operate

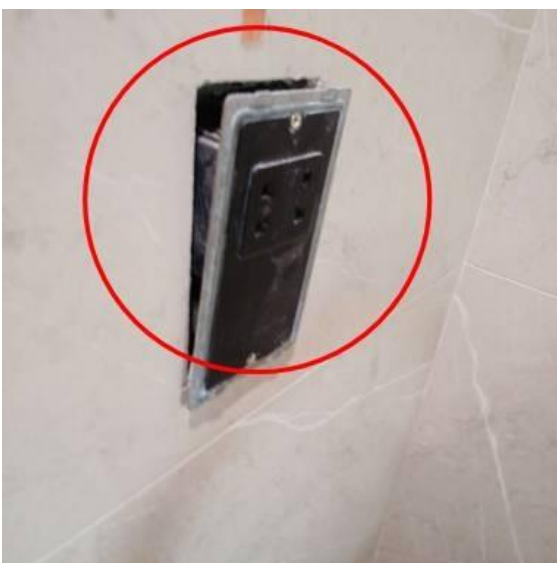
Shaver socket not fixed properly

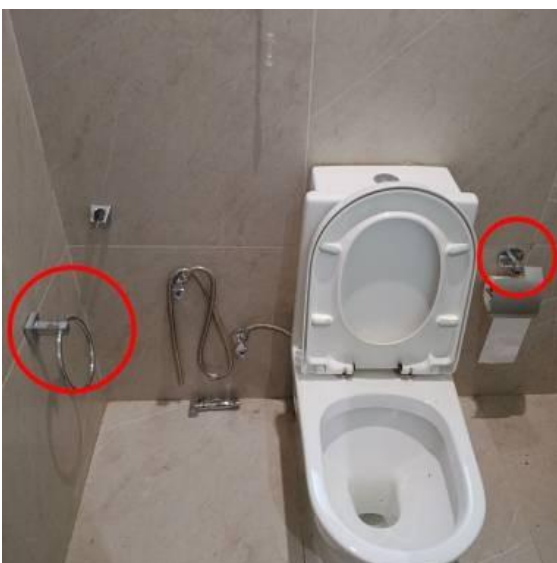
Loose towel and tissue holder

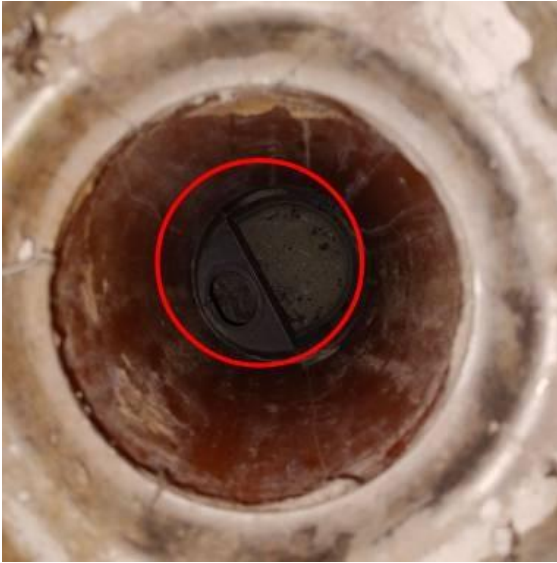
Found debris inside drain

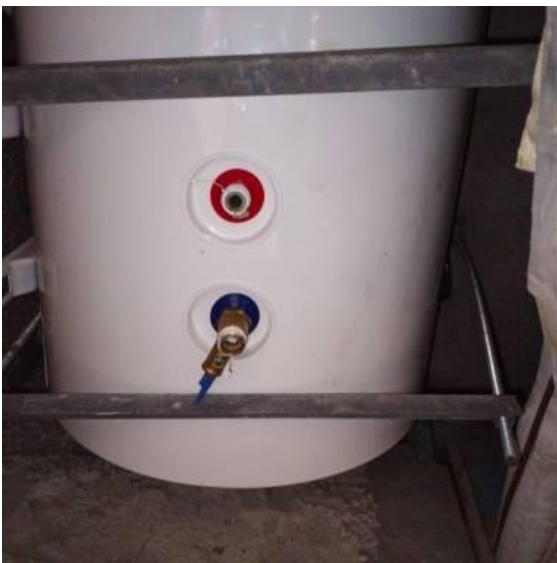
No power connection and pipe fittings for water heater inside access panel

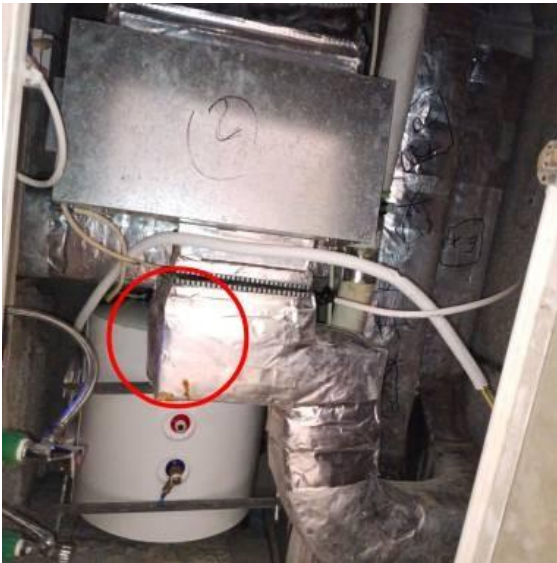
Rust marks on insulation

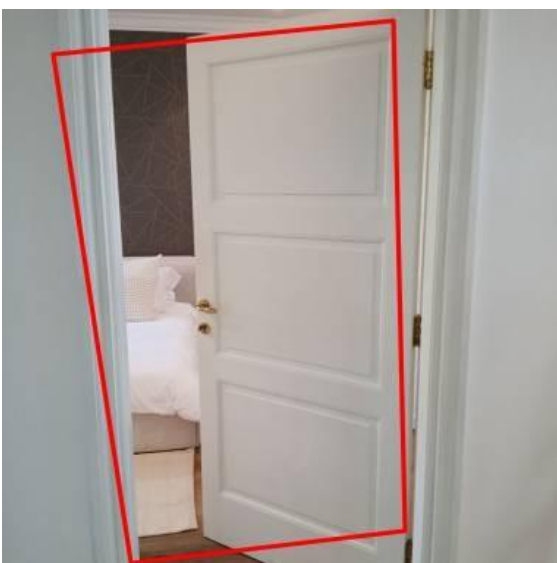
Multiple scratches on door were noted

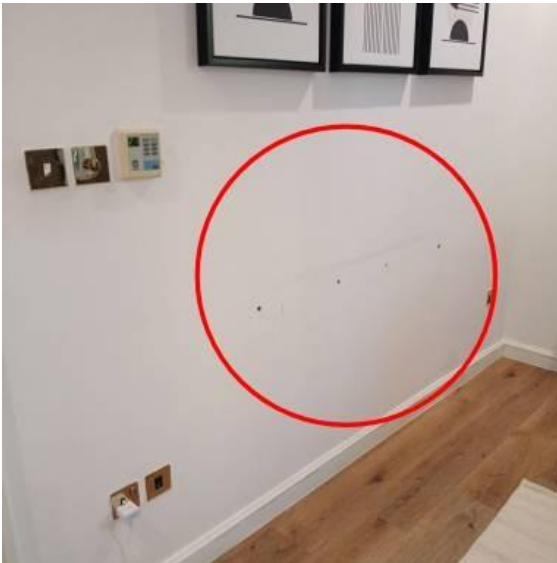
Multiple screw holes on wall

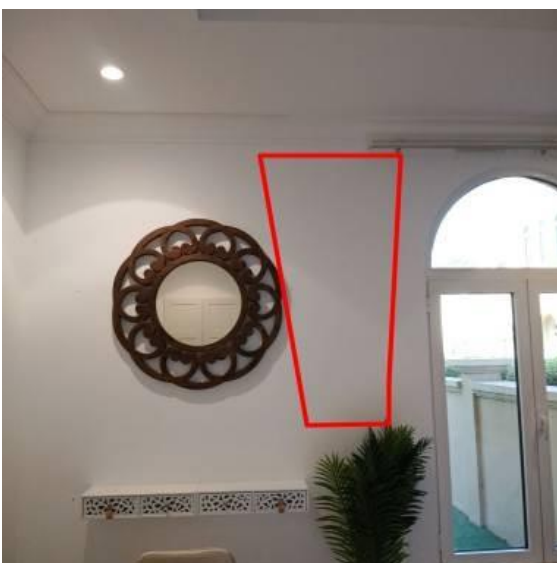
Cracks on wall were noted

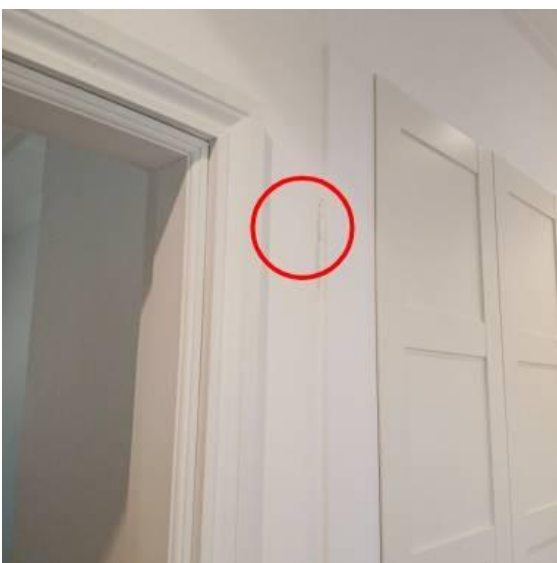
Damaged on wall were noted

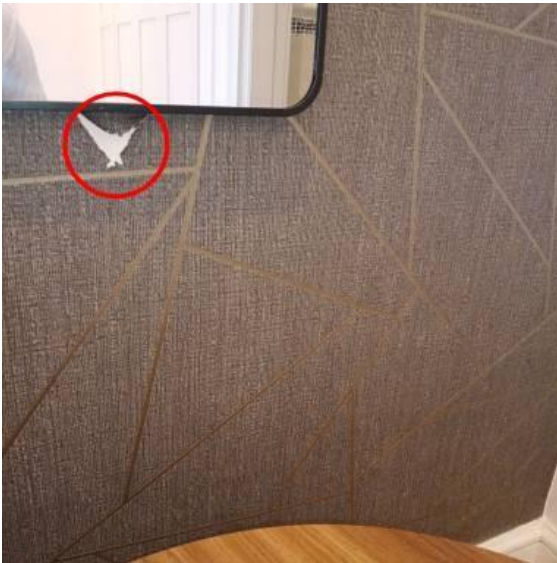
Damaged textile wallpaper were noted

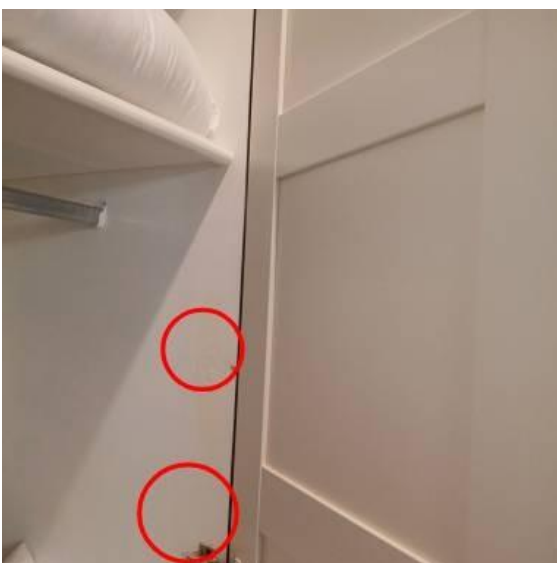
Damaged found on wardrobe cabinets

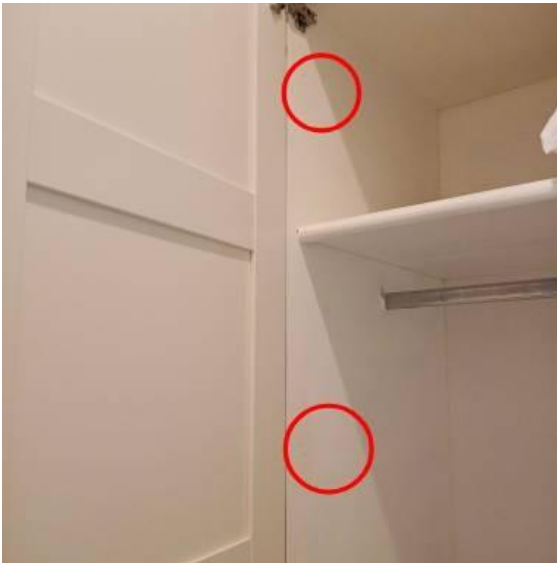
Damaged found on wardrobe cabinets

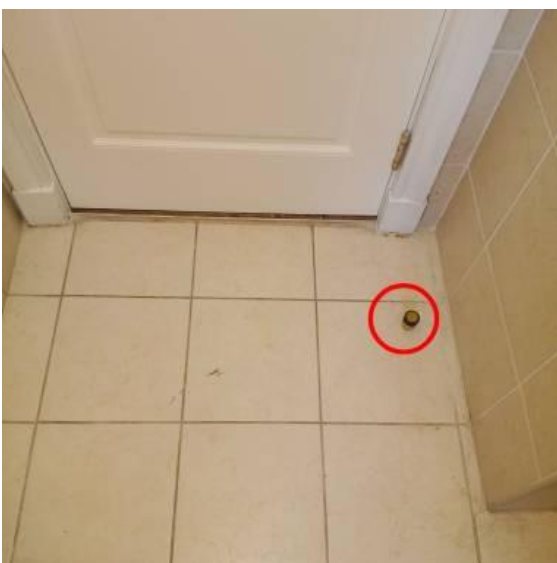
Found Loose door stopper

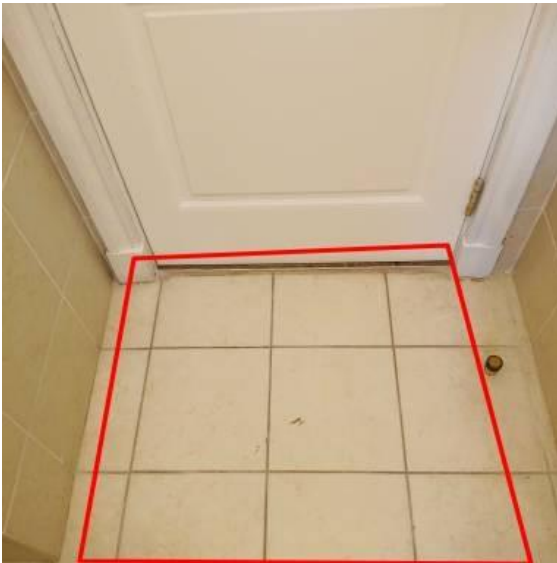
Grout damaged and poor finishing works for entire floor

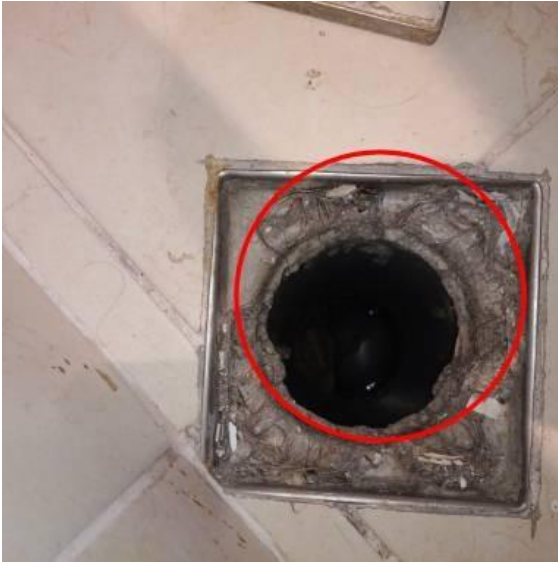
Debris inside drain and drain guard Cover is missing

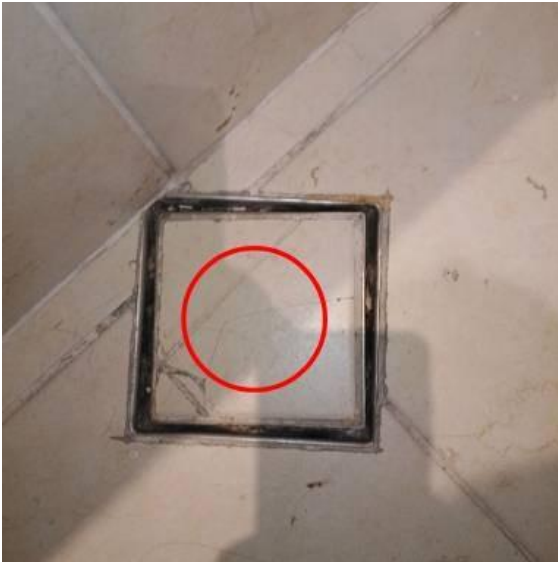
Tile drain cover were cracked

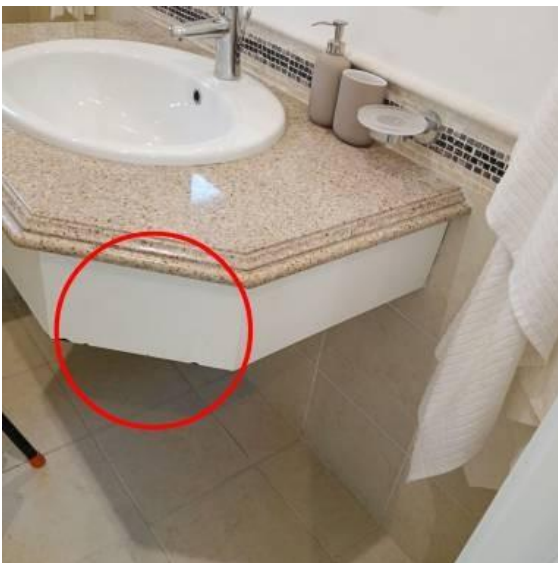
Damaged found on vanity

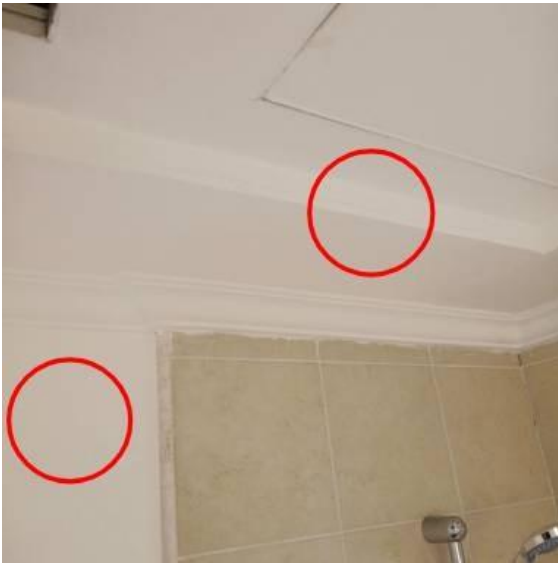
Multiple cracks on wall and ceiling were noted

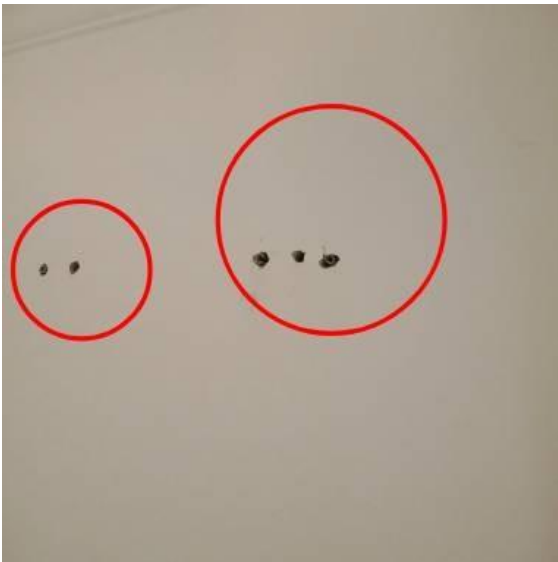
Multiple screw holes on the wall

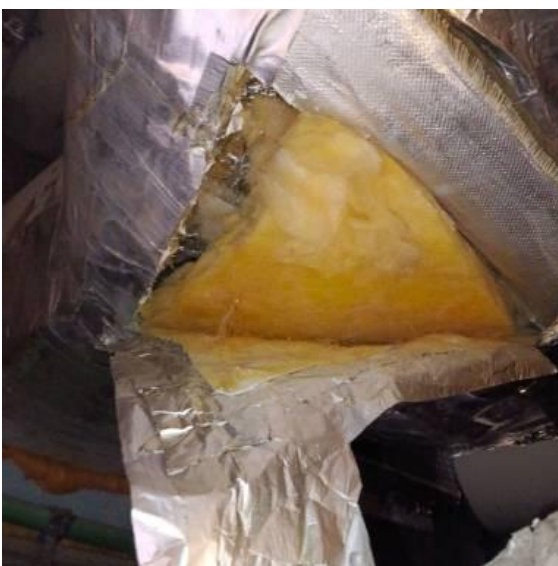
Insulation damaged at access panel

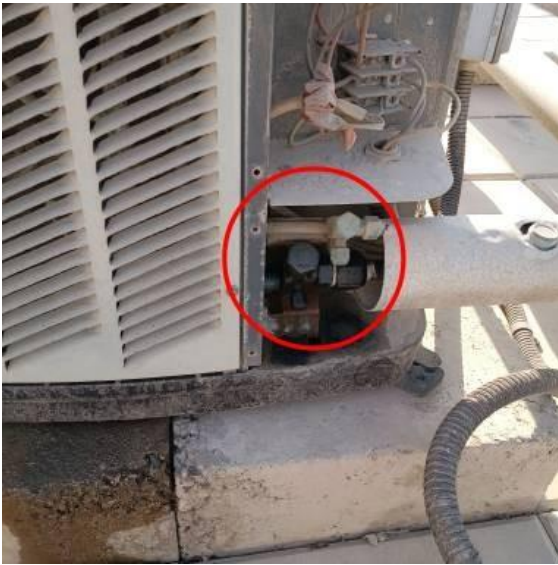
Water leakage from outdoor AC unit

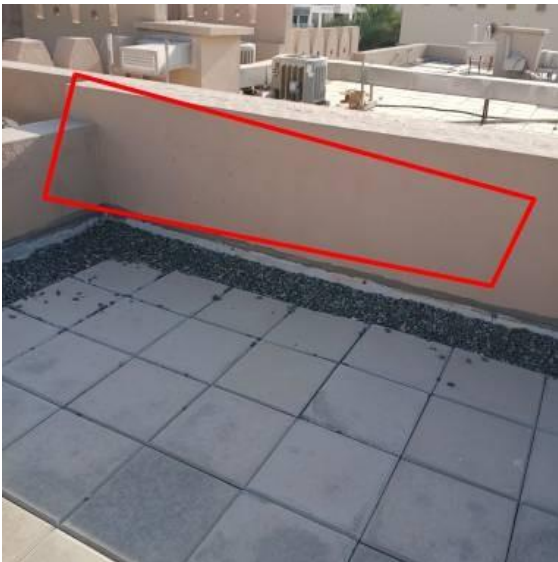
Multiple Cracks were found all around parapet wall

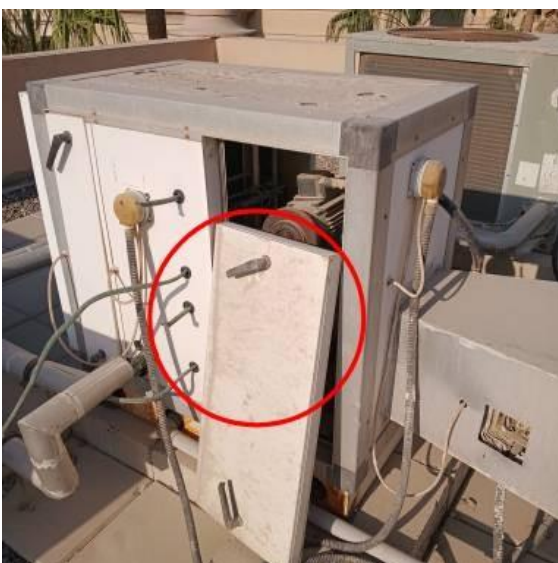
Damaged door for outdoor unit were found

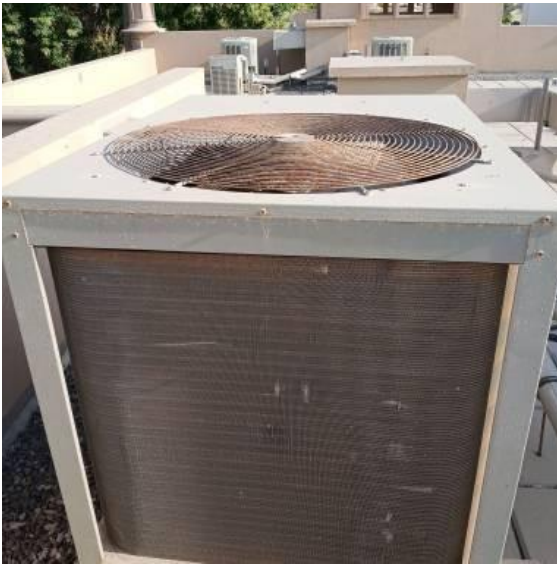
Rusted and dusty outdoor AC unit

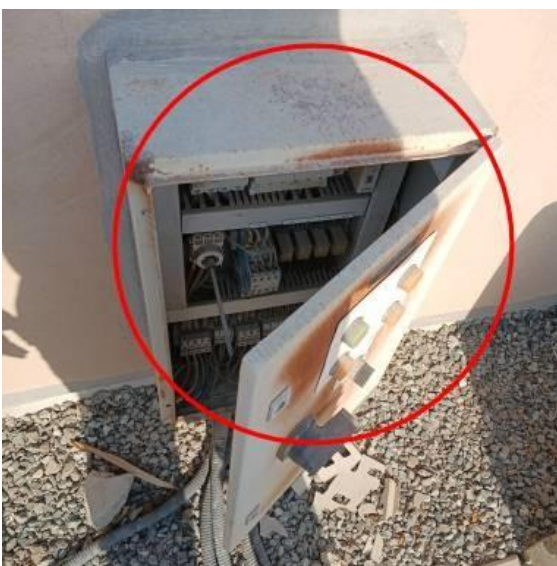
Rusted and door is not closing for control panel box

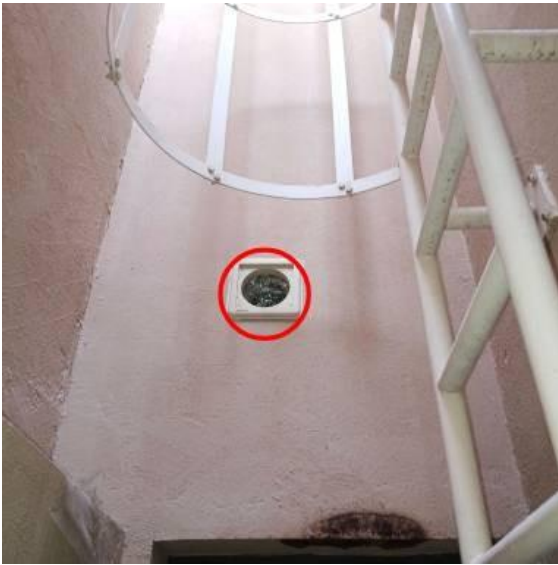
Exhaust cover not installed

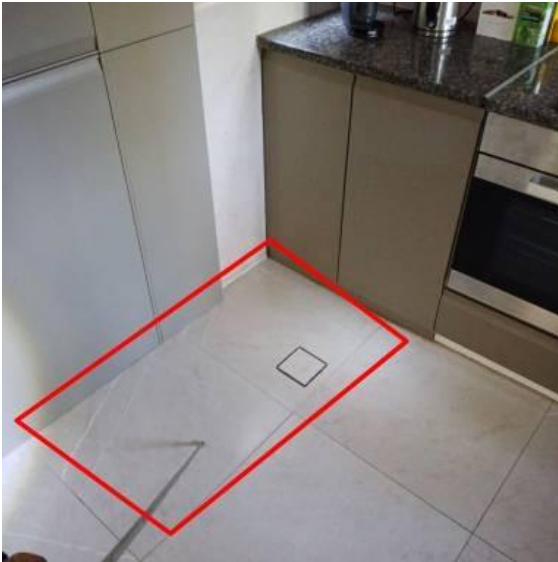
Floor tiles grout color damaged

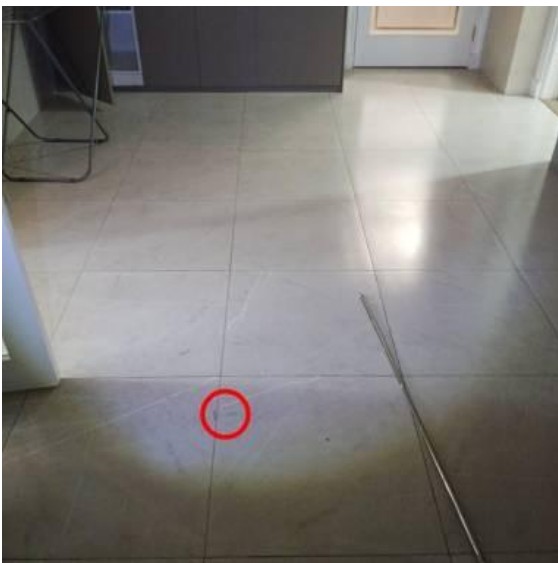
Hollow tiles were found

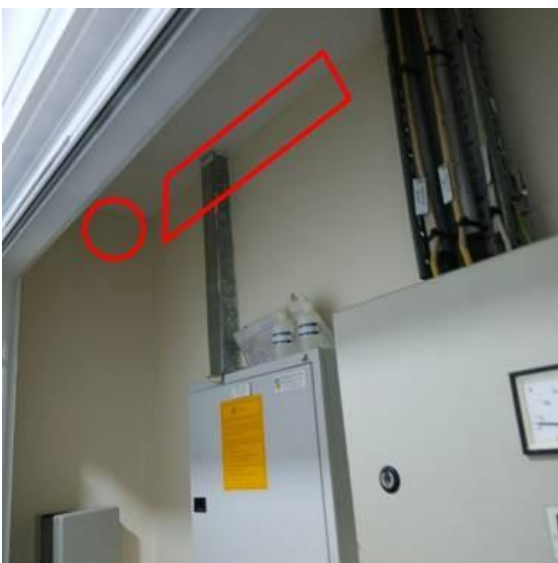
Paints were damages on wall

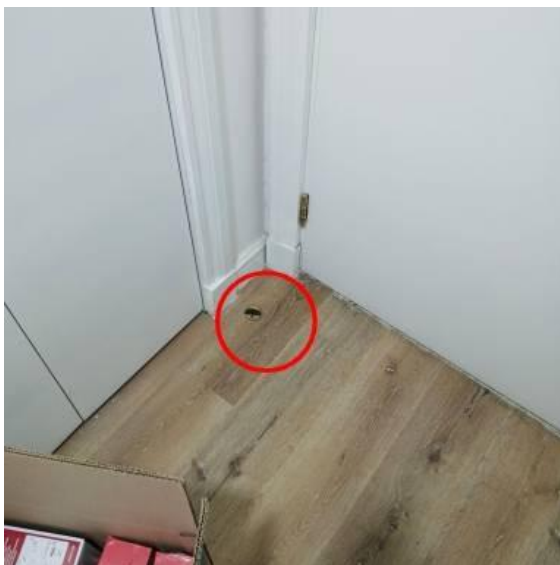
Created: Sat 22 Nov 14:00 2025
Location:Maid room
Status:open
Comments:
Loose door stopper found

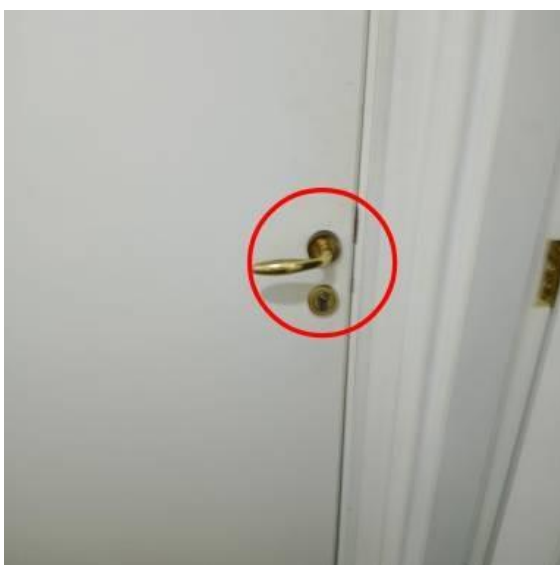
Created: Sat 22 Nov 14:01 2025
Location:Maid room
Status:open
Comments:
Loose door handle found

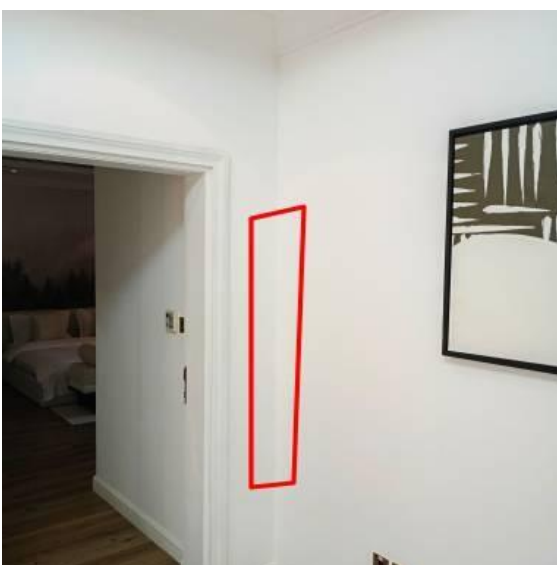
Created: Sat 22 Nov 14:13 2025
Location: Bedroom 2
Status: open
Comments:
Paints damages at skirting

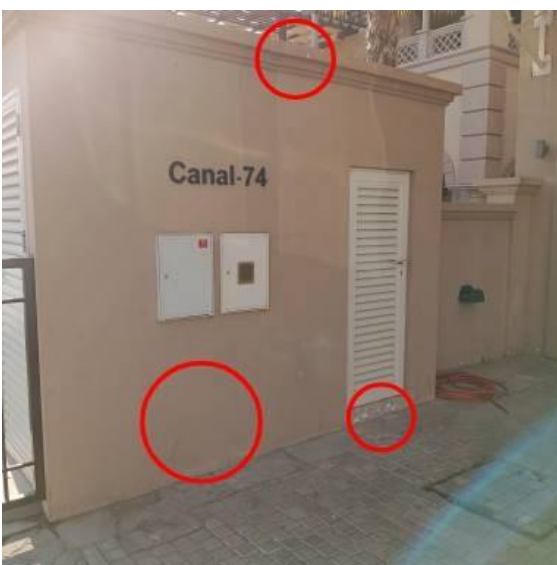
Cracks on wall

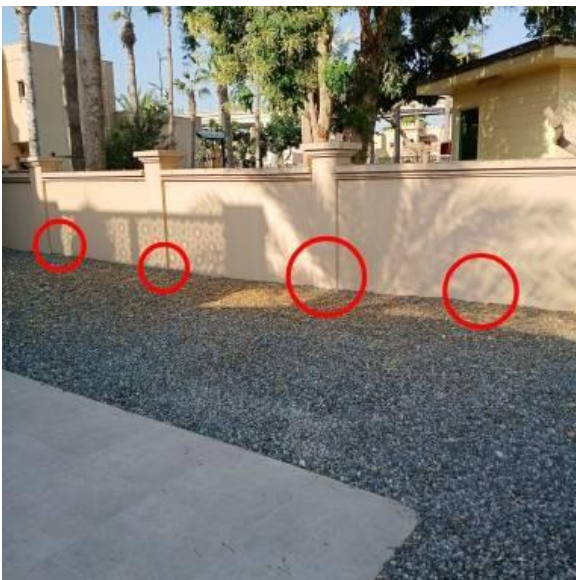
Improper Paint finishes on wall were noted
