PROPERTY INSPECTION REPORT

VILLA # N74 CANAL COVE FROND PALM JUMAIRA

Client Name: Hemalataa Vinayak Shrivastav

Inspection Date: November 22, 2025

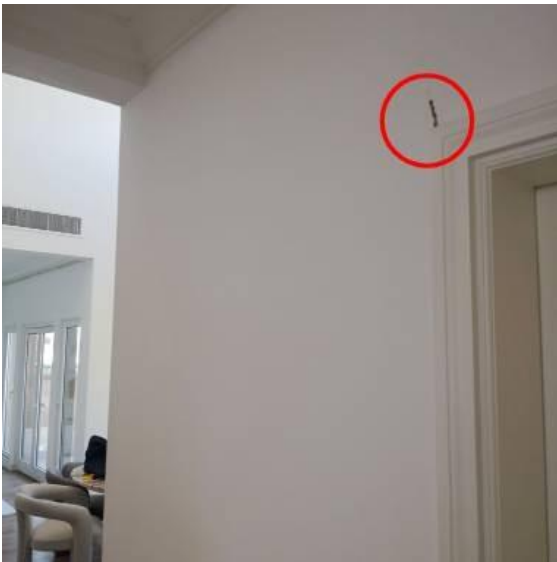
location: Living Room
Status: Open
Comments:

Opening found at ceiling

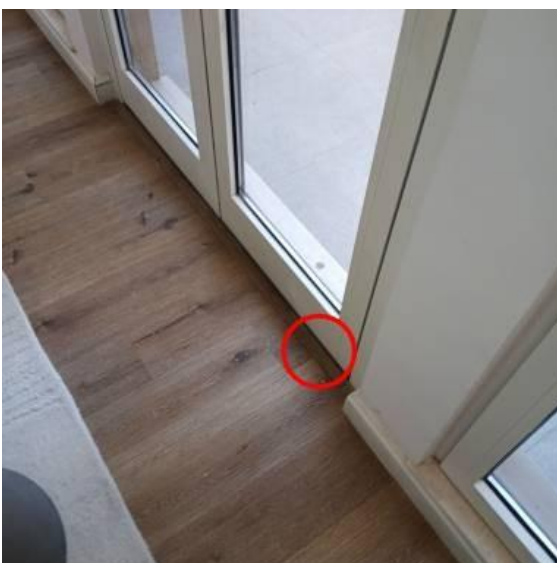
location: Dinning Room
Status: Open
Comments:

Infestation is wide spread across several areas,A pest control inspection is needed,using specialises tools and method to accurately determine the type and severity of the problem.

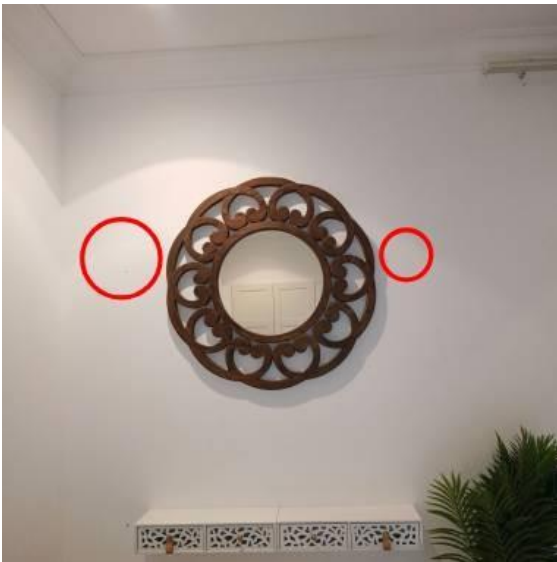
location: G.F Bedroom 1
Status: Open
Comments:

Multiple screw holes on wall

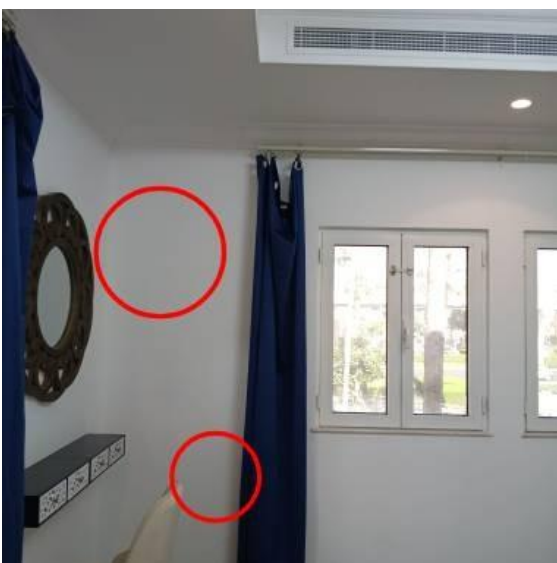
location: 1st floor Bedroom 3
Status: Open
Comments:

Cracks on wall were found

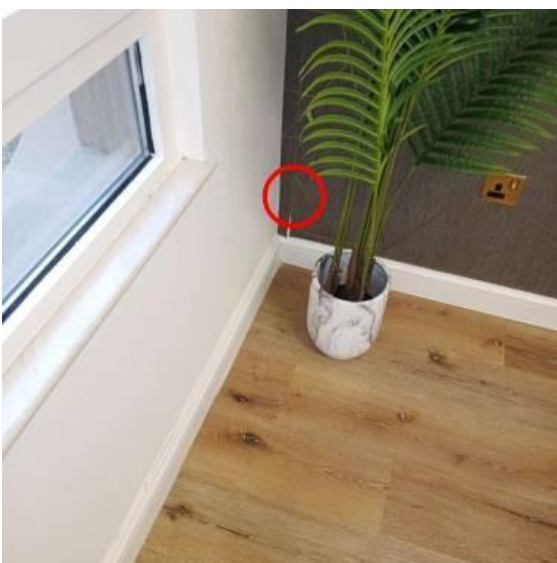
location: 1st floor Bedroom 4
Status: Open
Comments:

Found Cracks on wall

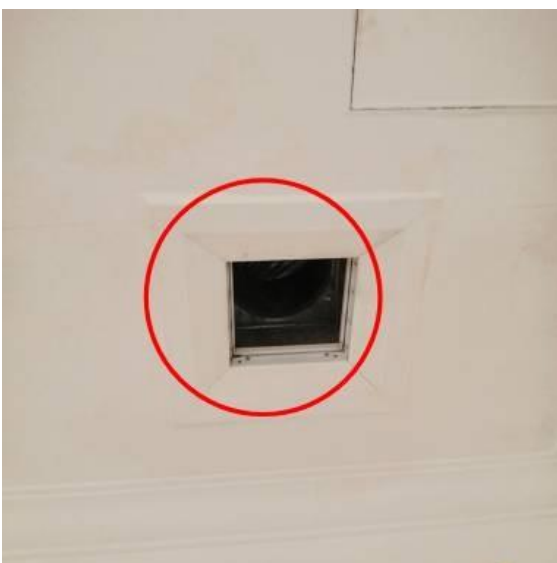
location: 1st floor Bedroom 4 bath
Status: Open
Comments:

Cracks were found on ceiling

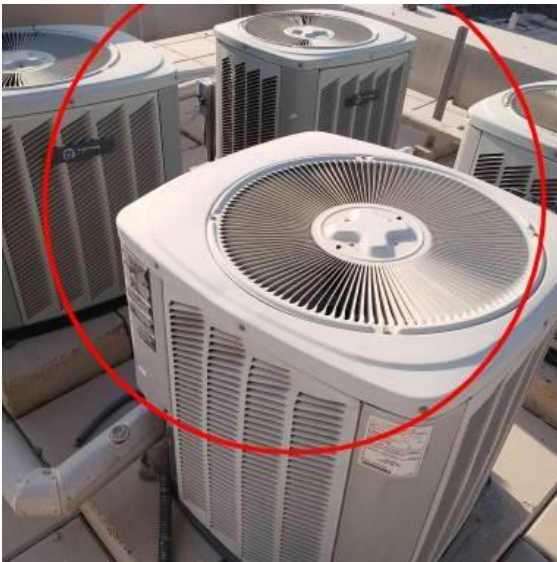
location: Roof top
Status: Open
Comments:
Found Noisy outdoor AC unit

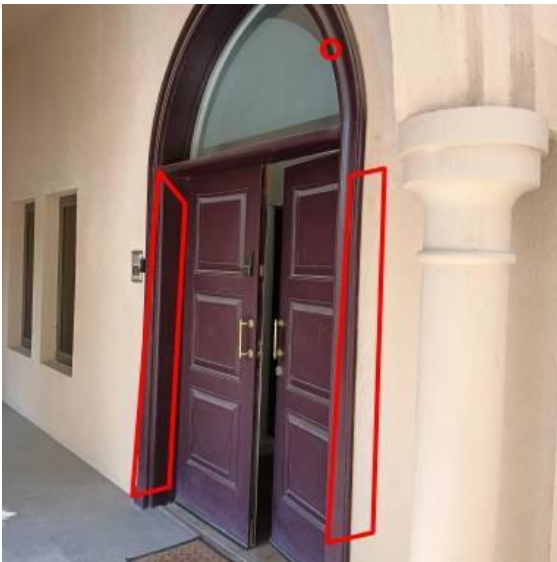
Created: Sat 22 Nov 12:13 2025
Location: Entrance
Status: open
Comments:
Multiple cracks on door and door frame

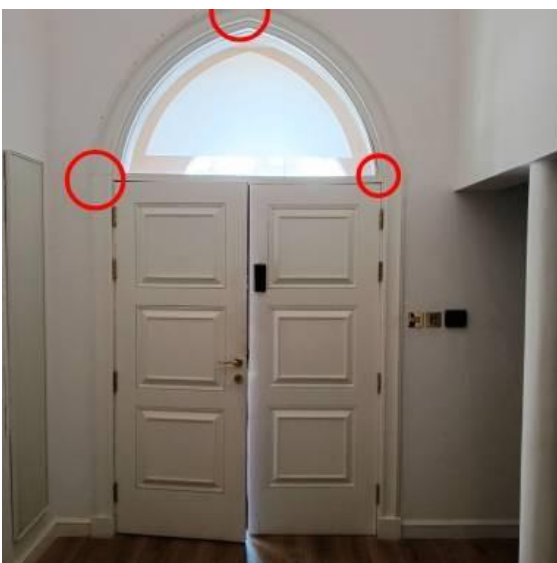
Created: Sat 22 Nov 12:15 2025
Location: Entrance
Status: open
Comments:
Multiple cracks and chipped on door frame
