PROPERTY INSPECTION REPORT

VILLA # N74 CANAL COVE FROND PALM JUMAIRA

Client Name: Hemalataa Vinayak Shrivastav

Inspection Date: November 22, 2025

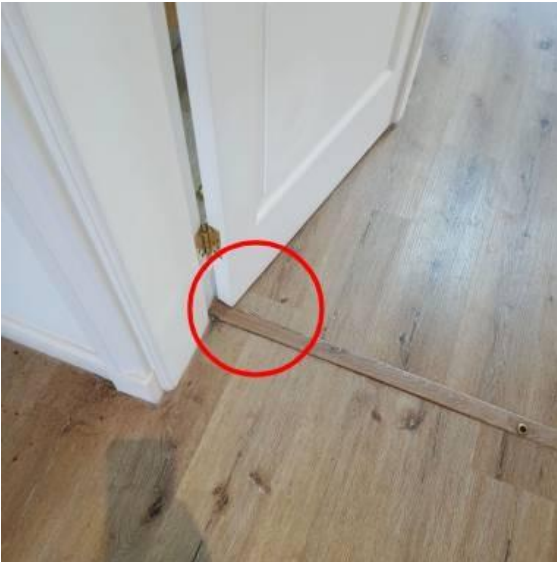
location: Living Room
Status: Open
Comments:

Found Broken door frame

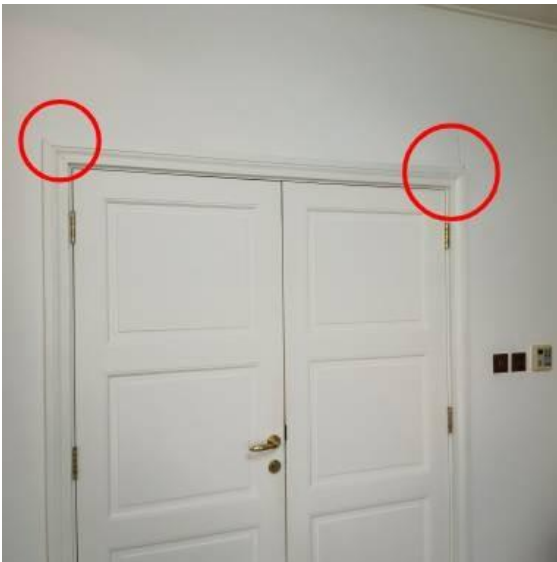
location: Living Room
Status: Open
Comments:

Rust on door lock

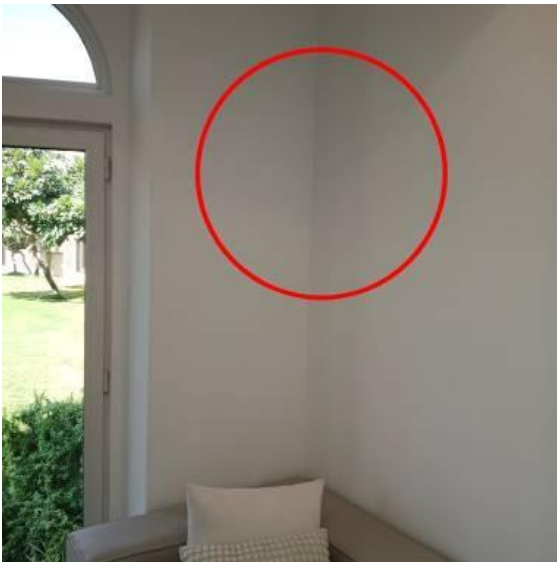
location: Living Room
Status: Open
Comments:

Found Loose door stopper

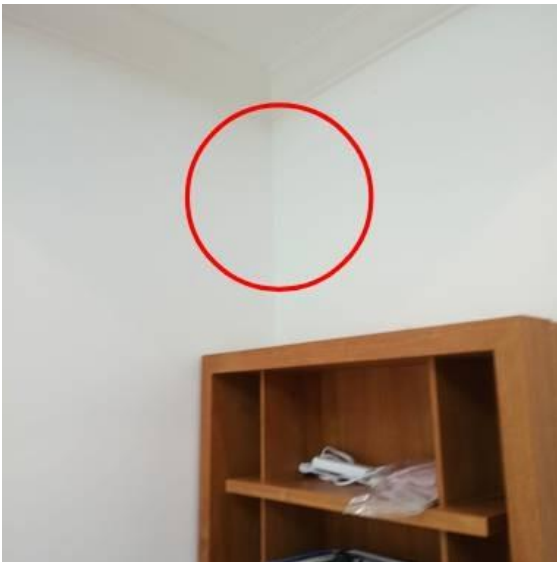
location: Living Room
Status: Open
Comments:

Skirting is detached from the wall

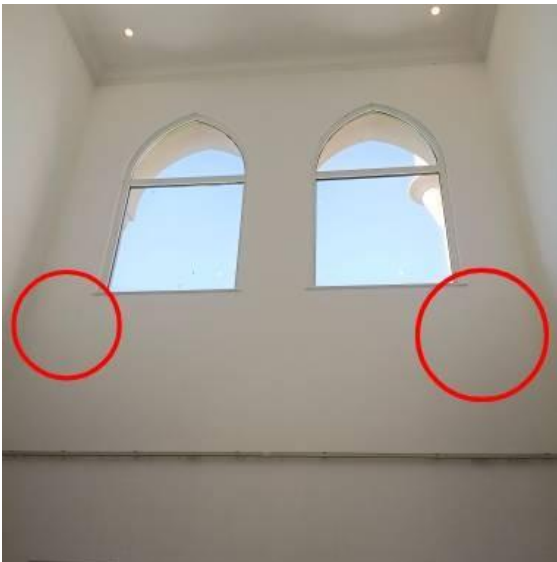
location: Dinning area
Status: Open
Comments:

Cracks on ceiling and paint damaged were noted

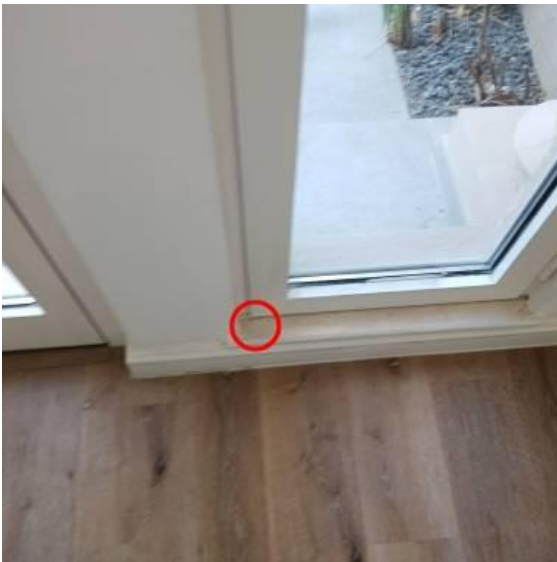
location: Dinning area
Status: Open
Comments:

Broken marble on window sill were found

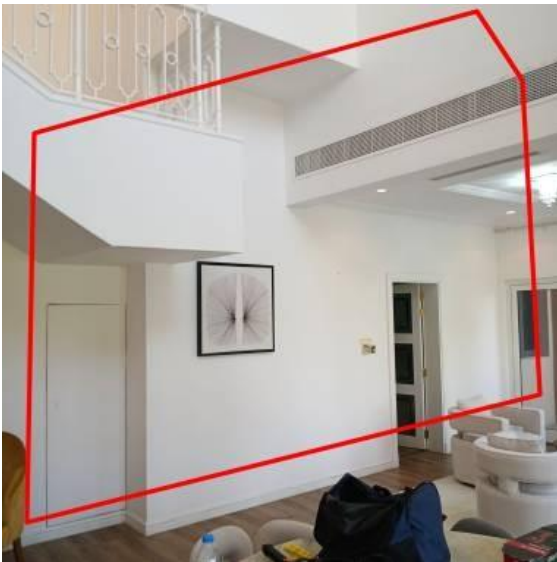
location: Dining area
Status: Open
Comments:

Found Cracks on wall

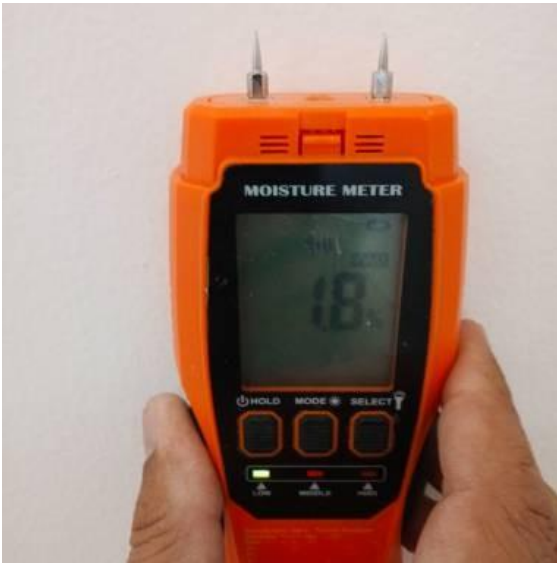
location: Dining area
Status: Pass
Comments:

Moisture test result is as per standard

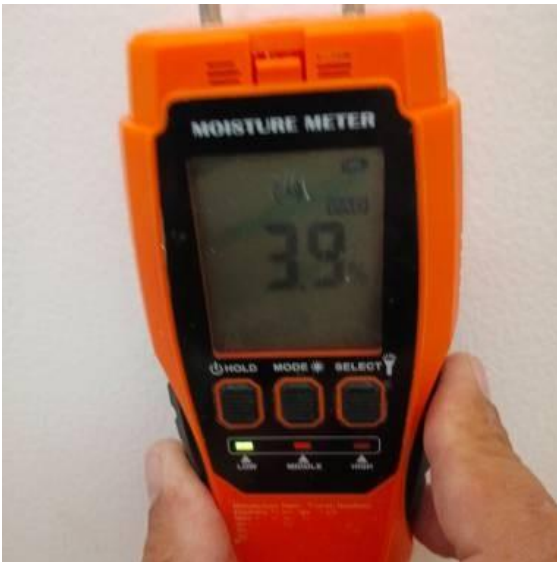
location: Living Room
Status: Pass
Comments:

Moisture test result is as per standard

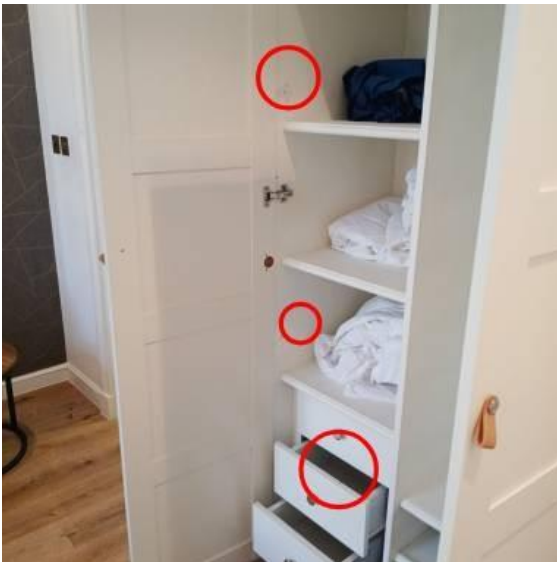
location: G.F Bedroom 1
Status: Open
Comments:

Damaged found on wardrobe cabinets

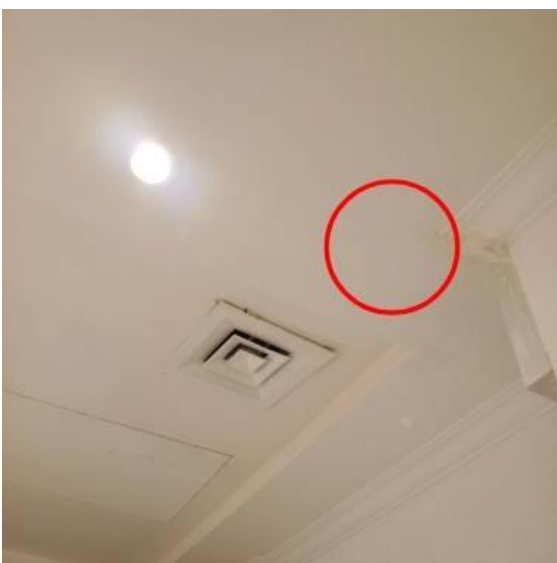
location: G.F Bedroom 1 Bath
Status: Open
Comments:

Cracks on wall were noted

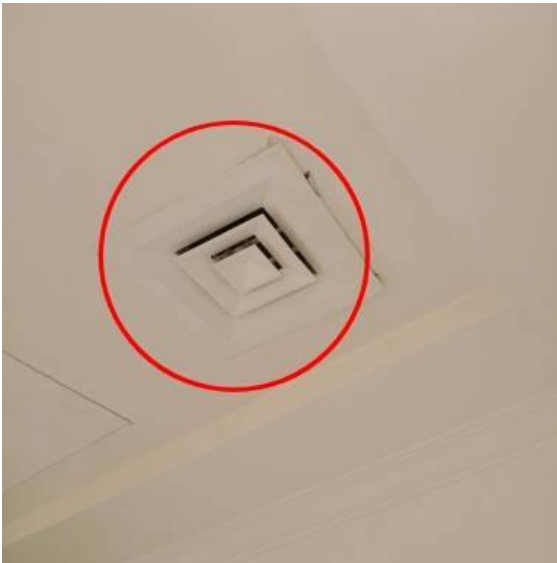
location: G.F Bedroom 1 Bath
Status: Open
Comments:

Cracks were found on ceiling

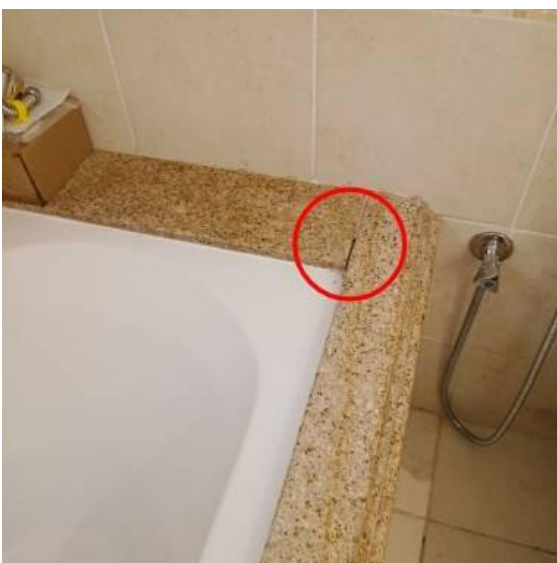
location: G.F Bedroom 1 Bath
Status: Open
Comments:

Bathtub sealant were damaged

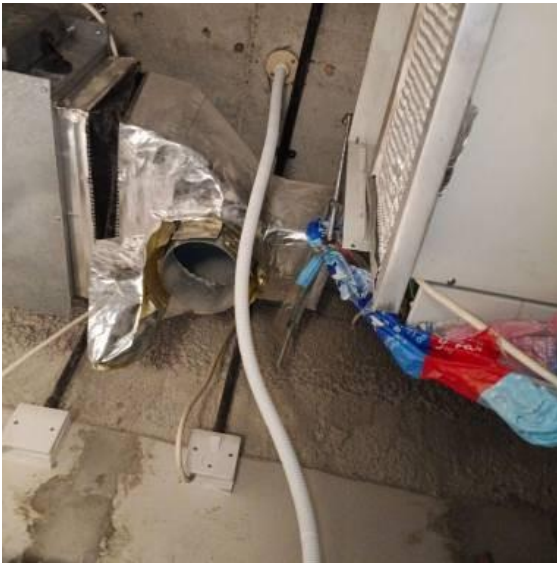
location: G.F Bedroom 1 Bath
Status: Open
Comments:

Debris inside drain and drain guard cover is missing

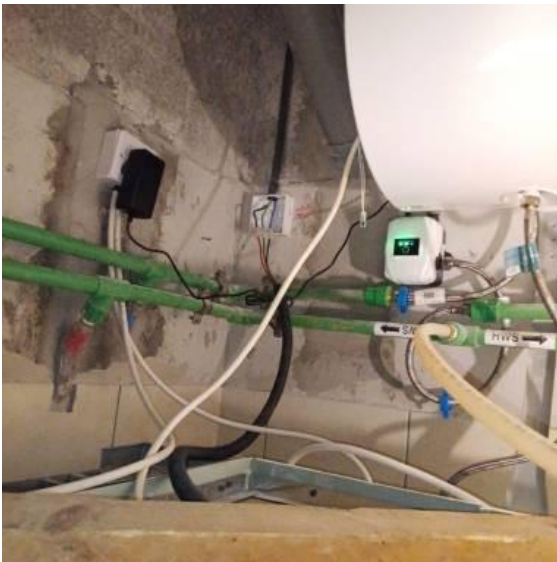
location: G.F Bedroom 1 Bath
Status: Open
Comments:

Insulation damaged at access panel

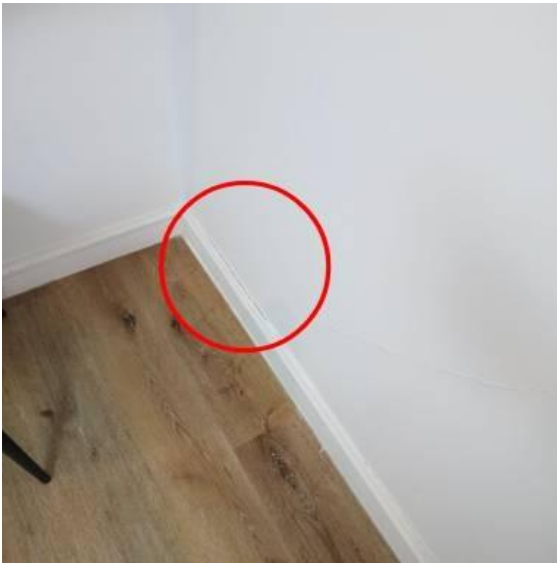
location: 1st floor Bedroom 3
Status: Open
Comments:

Multiple cracks were found on wall

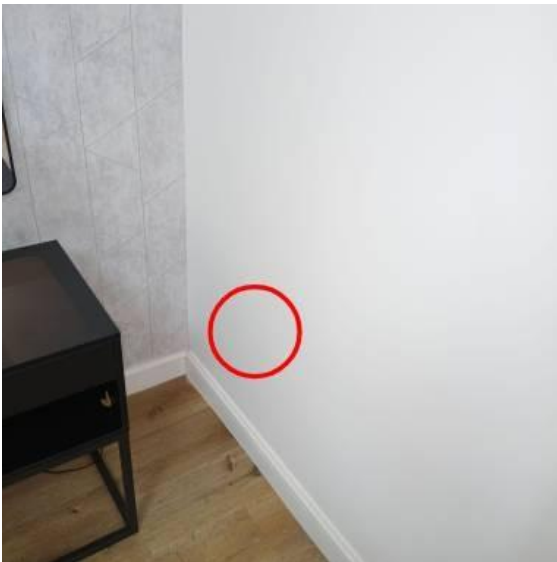
location: 1st floor Bedroom 3

Skirting tiles detached from wall

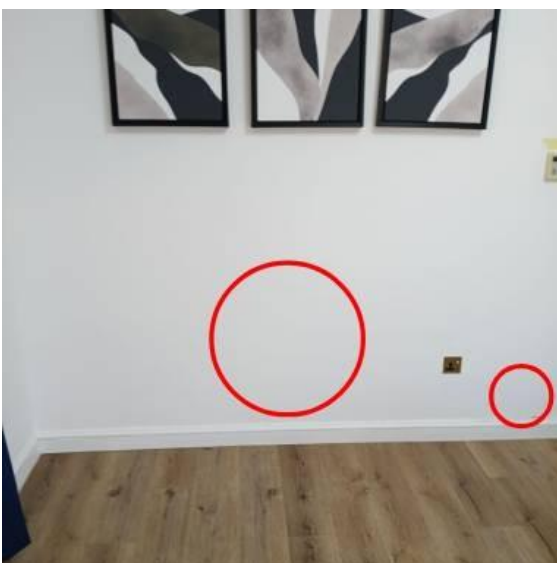
location: 1st floor Bedroom 3

Cracks on wall were found

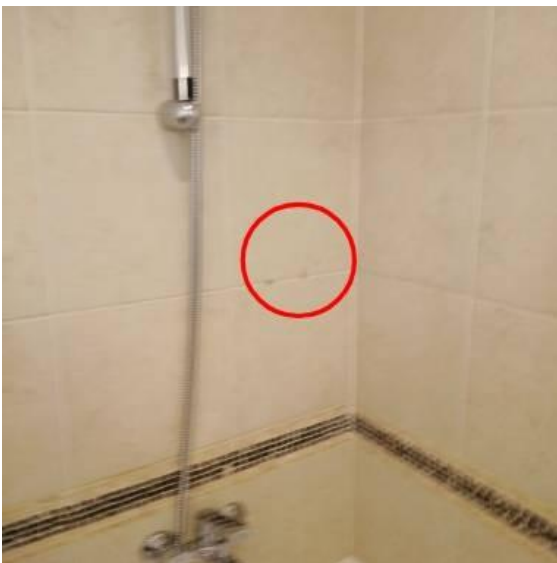
location: 1st floor Bedroom 3 Bath
Status: Open
Comments:

Chipped on wall tiles

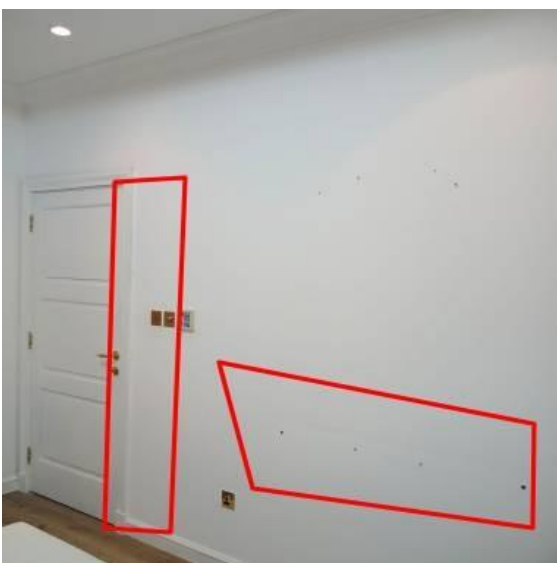
location: 1st floor Bedroom 4

Multiple Broken edges and gap between door frame were noted

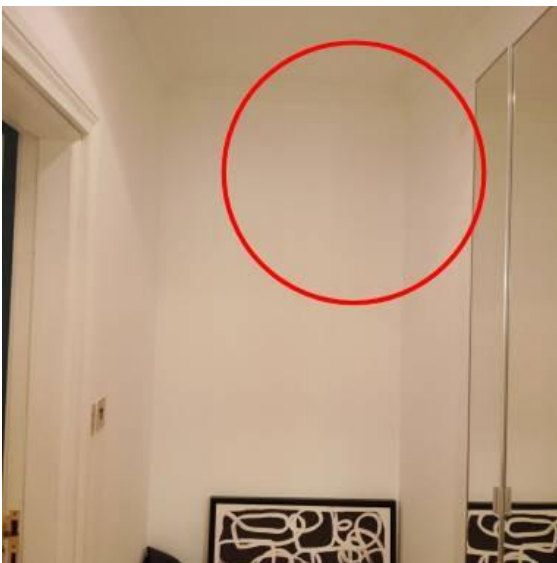
location: 1st floor Bedroom 4
Status: Open
Comments:

Cracks were found on ceiling

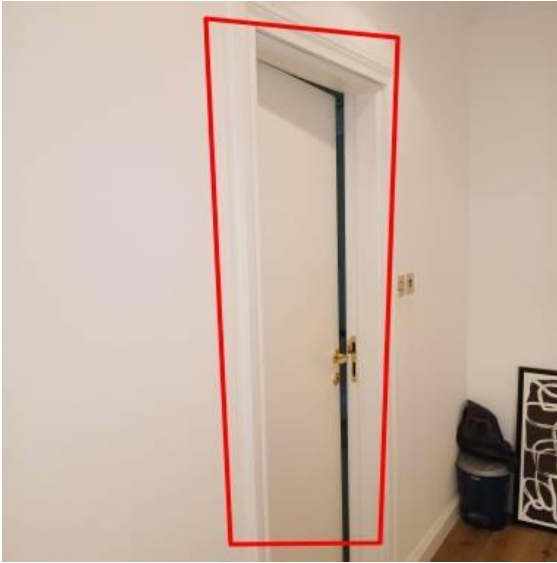
location: 1st floor Bedroom 4
Status: Open
Comments:

Cracks found on wall

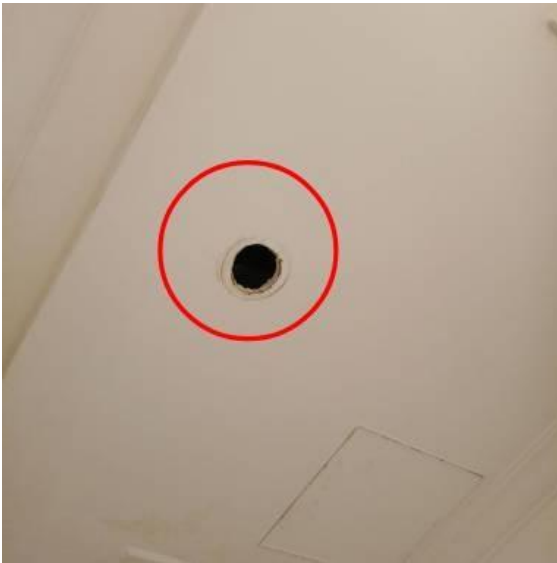
location: 1st floor Bedroom 4 bath
Status: Open
Comments:

Exhaust fan were not installed

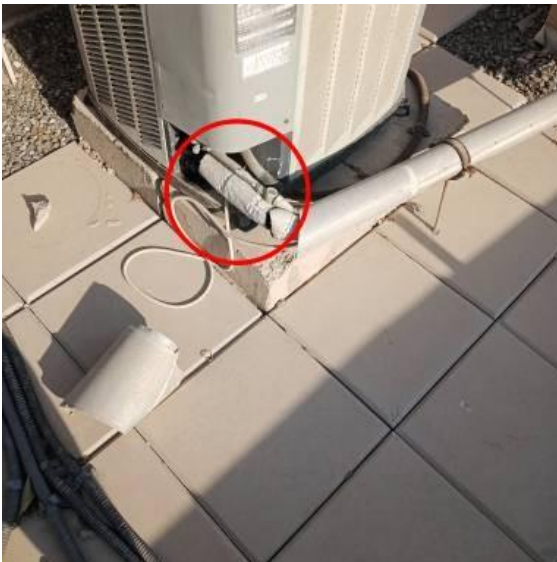
location: Roof top
Status: Open
Comments:

Rusted and dusty outdoor AC unit

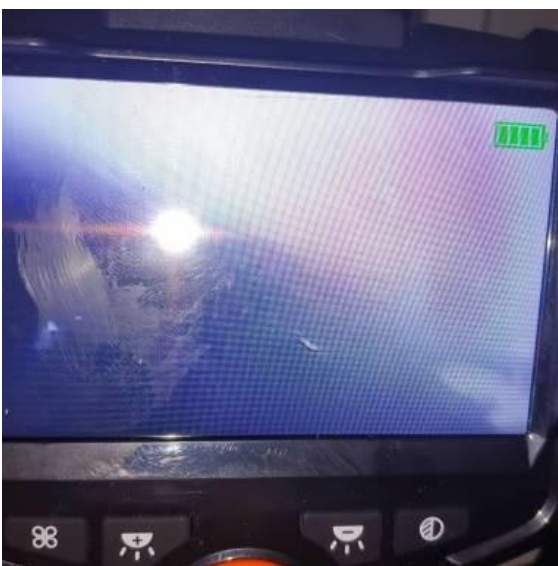
location: All AC ducts
Status: Open
Comments:

All AC duct need to be clean from debris and dust

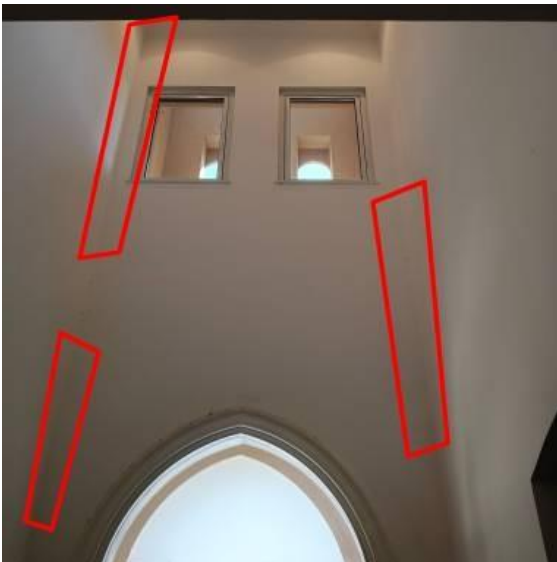
Created: Sat 22 Nov 12:18 2025

Cracks on wall were noted

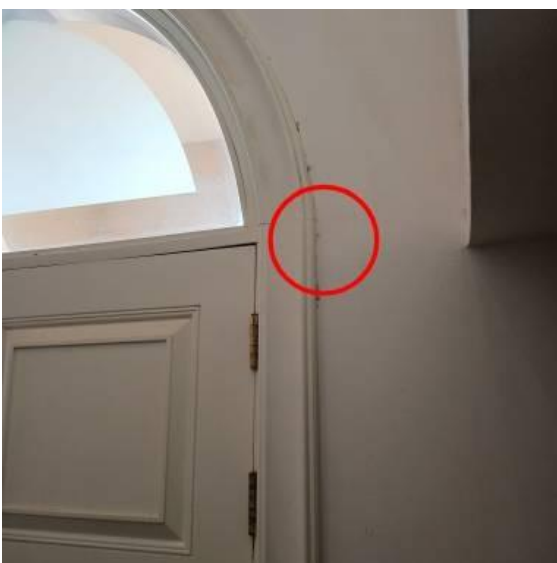
Created: Sat 22 Nov 12:19 2025

Multiple cracks on wall

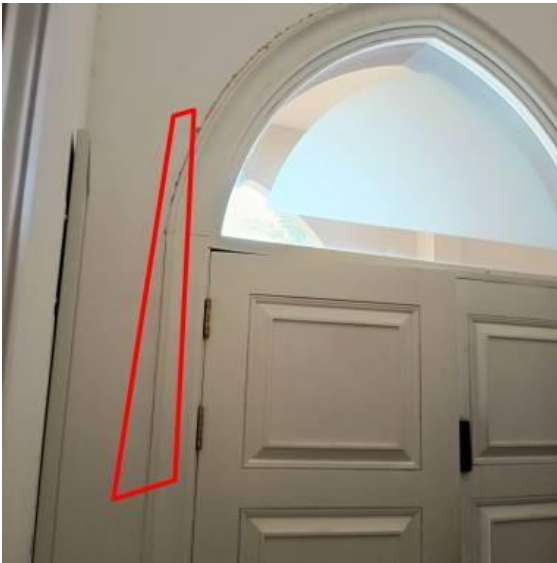
Created: Sat 22 Nov 12:20 2025

Cracks on wall were noted

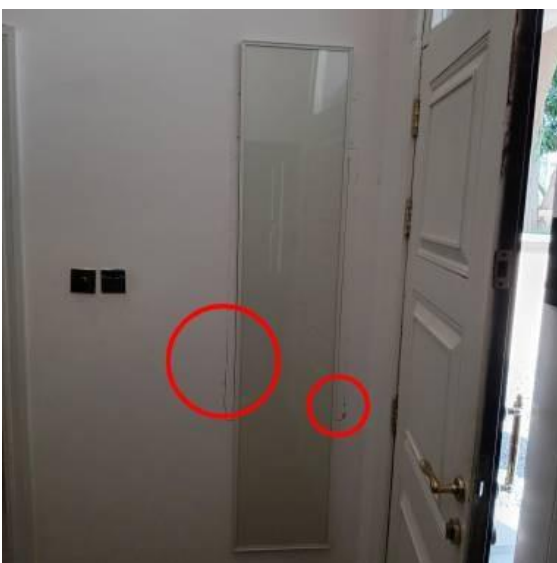
Created: Sat 22 Nov 12:21 2025

Entire wall paint deteriorated

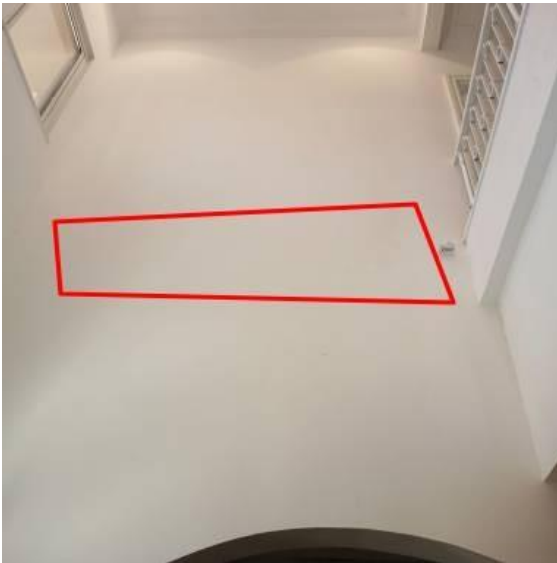
Created: Sat 22 Nov 12:21 2025

Plaster damage were noted

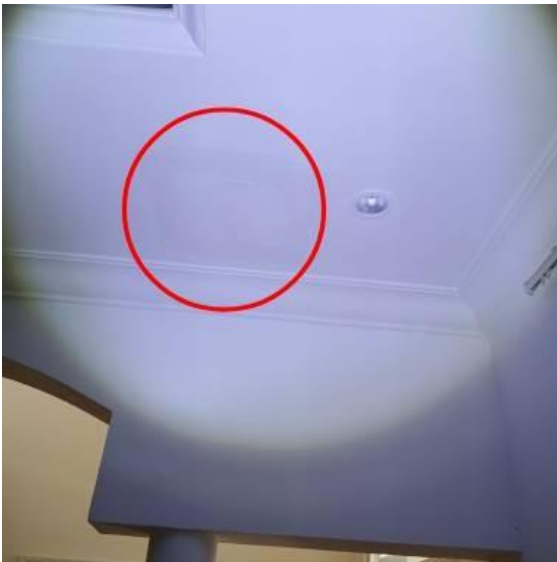
Created: Sat 22 Nov 12:22 2025

Cracks on wall

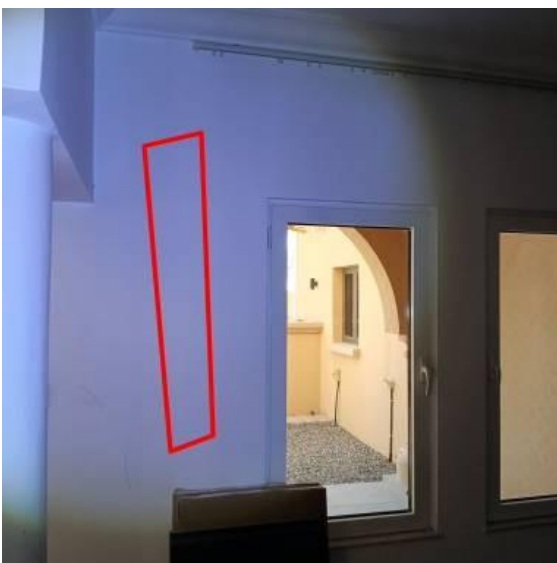
Location: Entrance lobby

Poor Paint finishing on ceiling

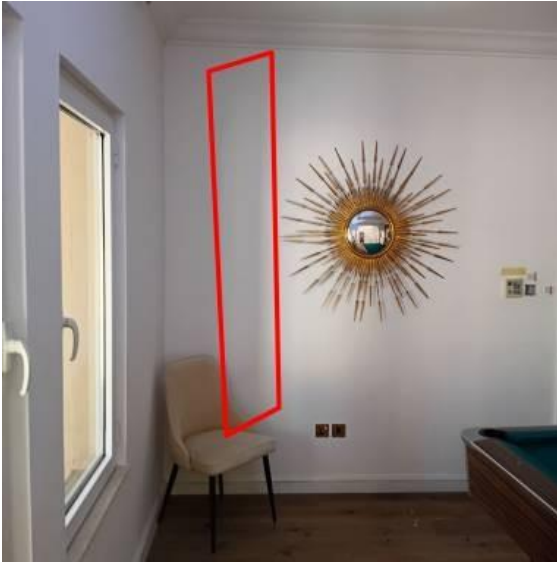
Location: Entrance lobby
Status: open
Comments:

Cracks on wall

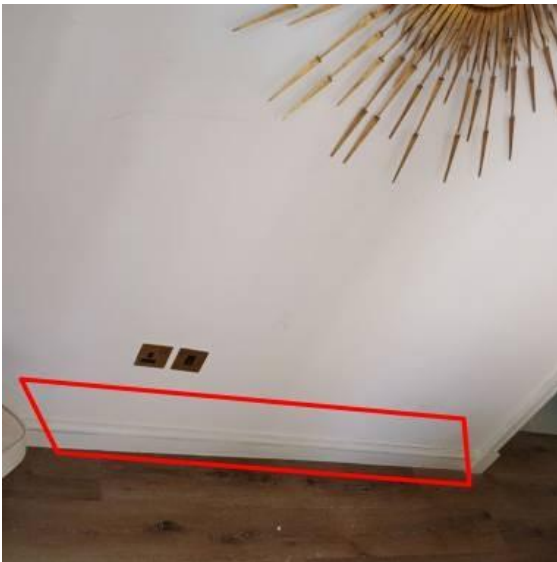
Location: Entrance lobby
Status: open
Comments:

Crack noted at skirting

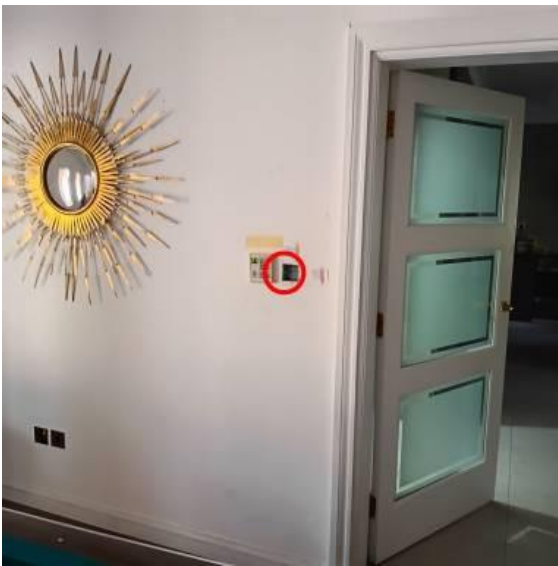
Location: Entrance lobby

Socket missing and wire are exposed

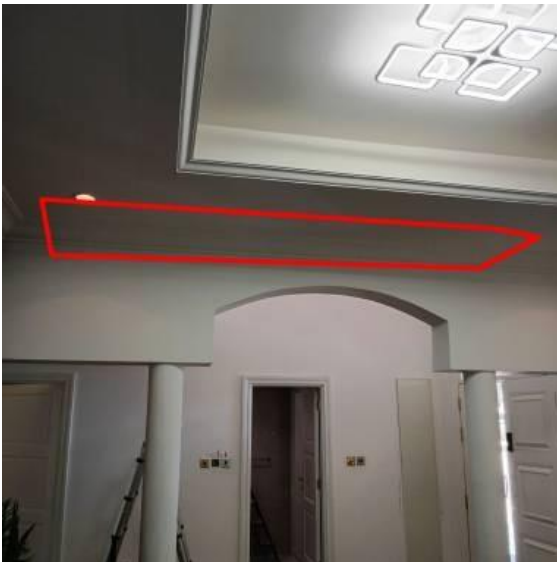
Location:Entrance lobby
Status:open
Comments:

Crack noted at ceiling

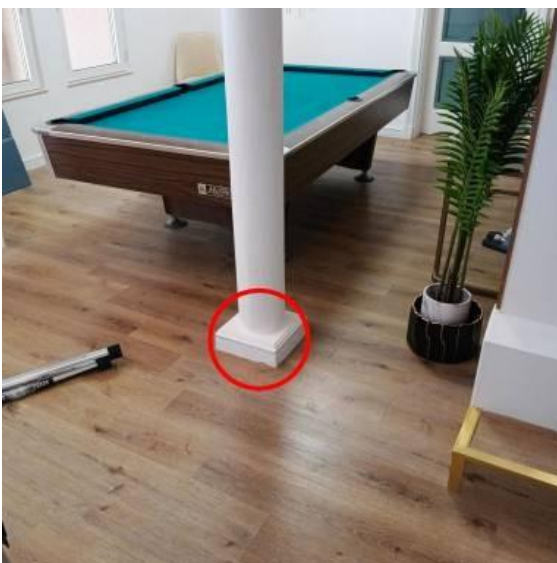
Location:Entrance lobby
Status:open
Comments:

Paint damage at column bottom

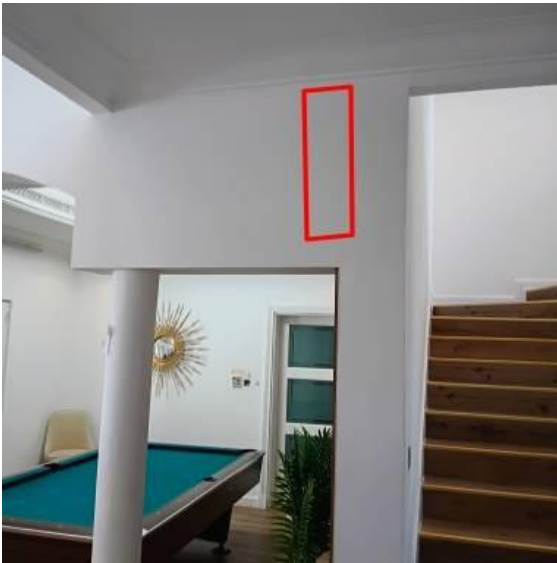
Location: Entrance lobby
Status: open
Comments:

Cracks on wall were noted

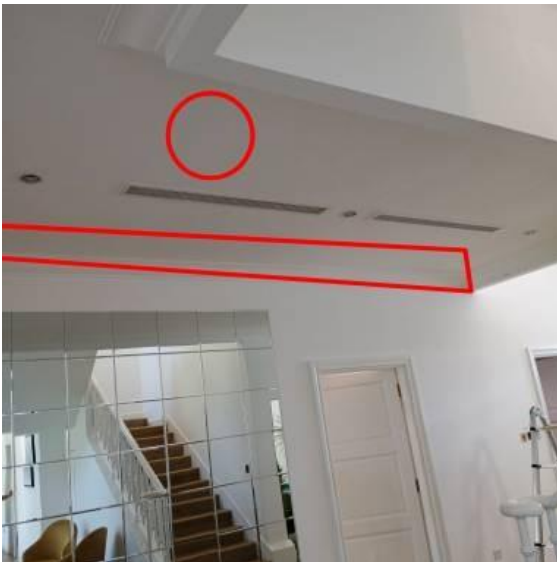
Location: Entrance lobby
Status: open
Comments:

Multiple cracks on ceiling

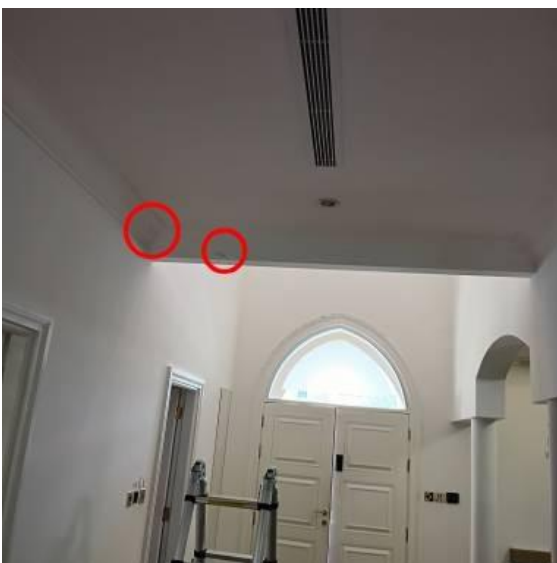
Location: Entrance lobby
Status: open
Comments:

Cracks and Sealant marks were noted

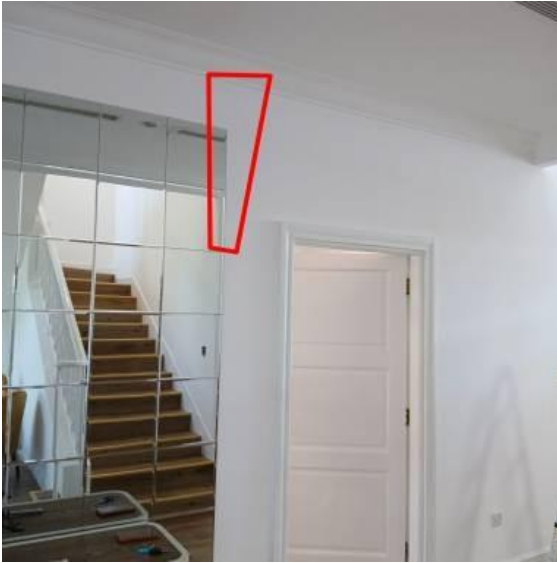
Location: Entrance lobby

Cracks on wall

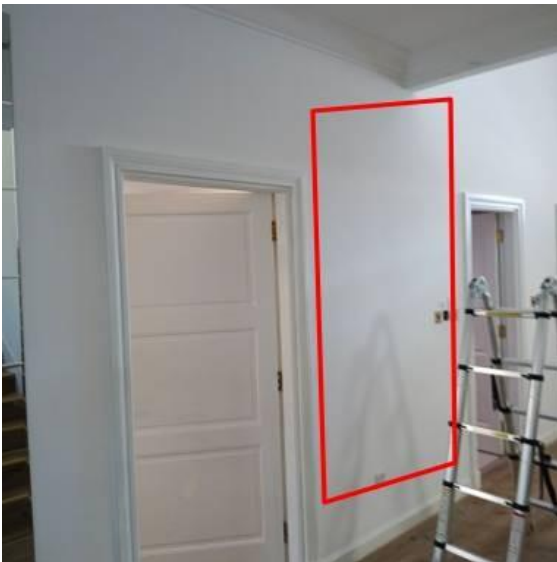
Location: Entrance lobby

Wall paint deteriorated

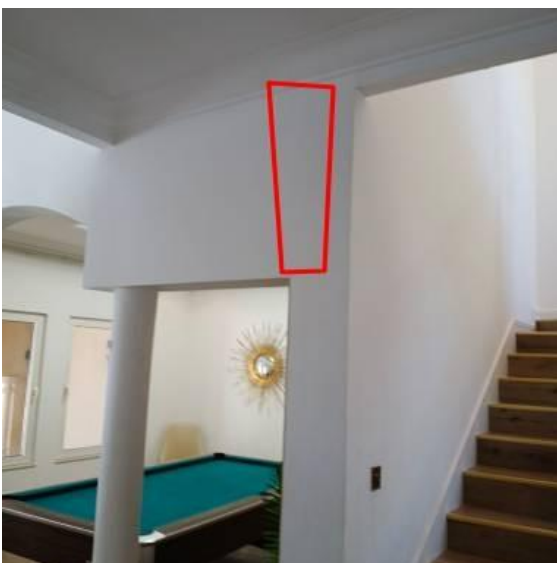
Location: Entrance lobby

Cracks on wall

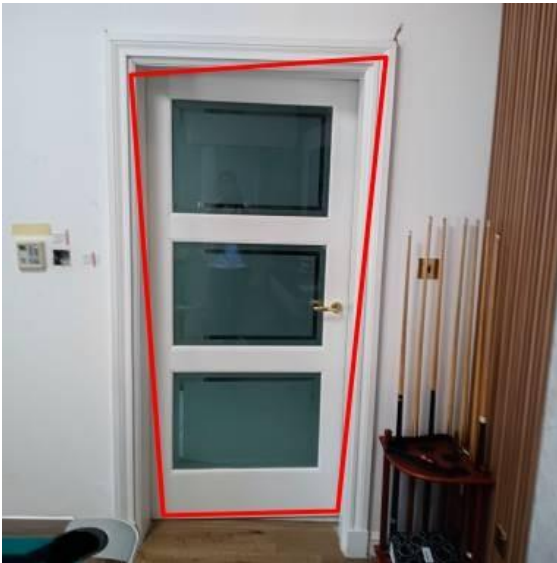
Location:Kitchen

Door hard to open/ close

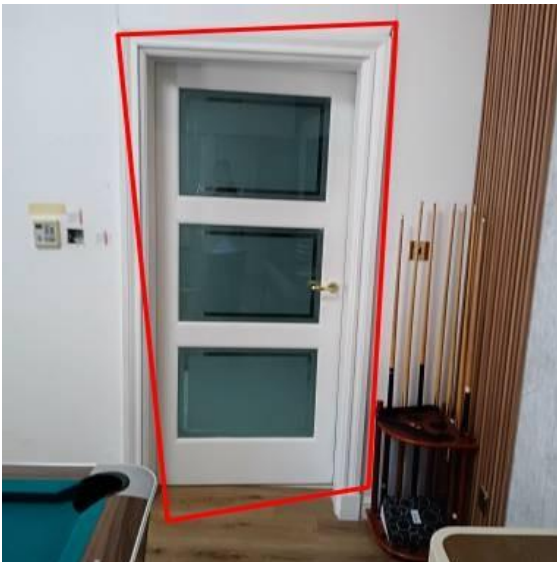
Location:Kitchen

Multiple chipped and cracks on door and door frame

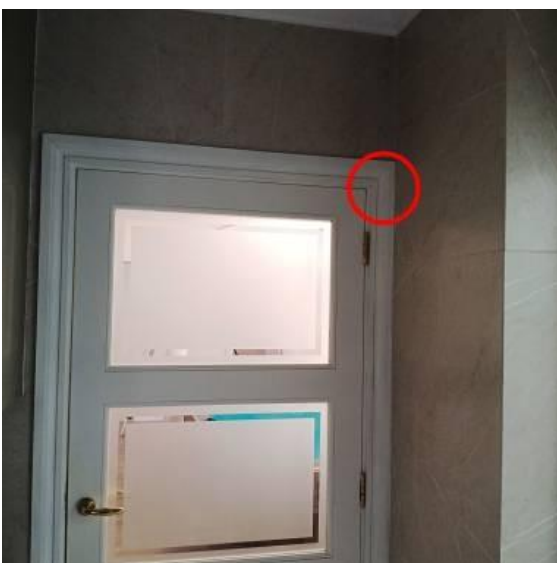
Location:Kitchen

Sealant damage at door frame

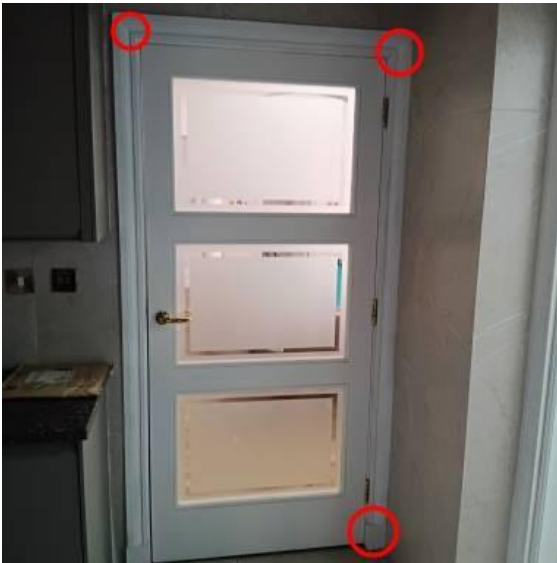
Location:Kitchen

Sealant missing and Sealant damage at door frame

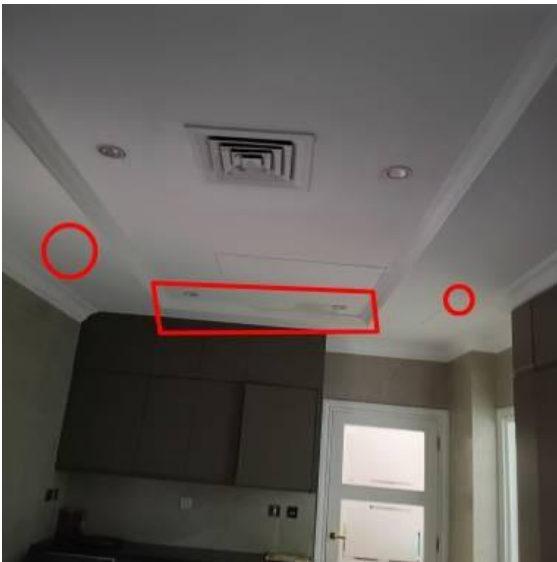
Location:Kitchen

Multiple cracks on ceiling were noted

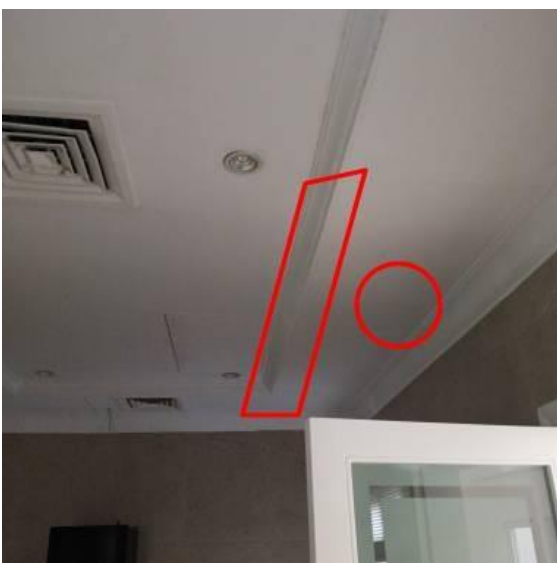
Location:Kitchen

Multiple Cracks on ceiling

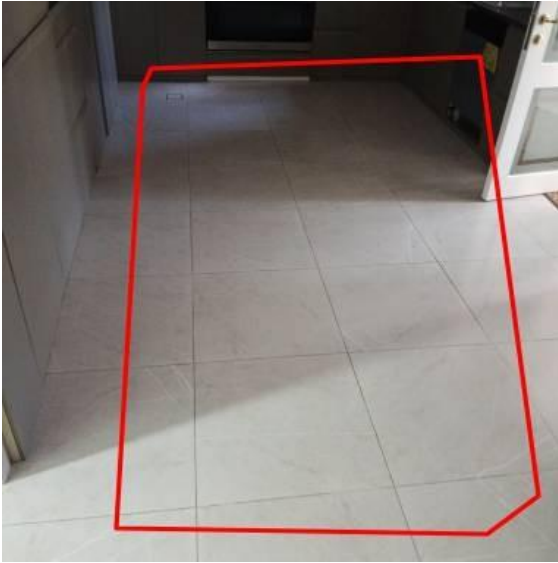
Location:Kitchen

Floor tiles grout color damaged

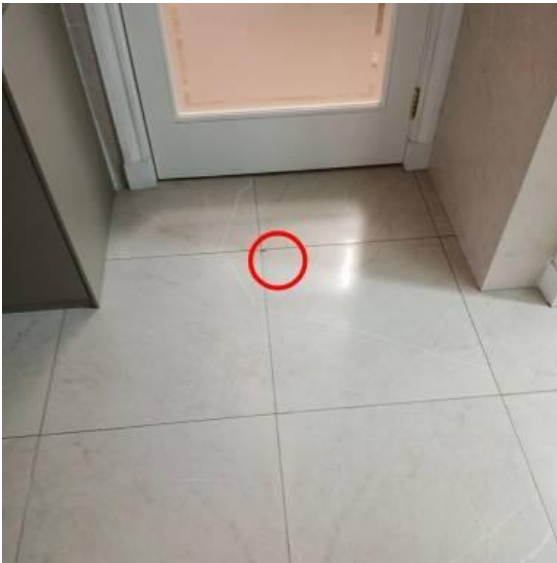
Location:Kitchen

Improper grout finishing

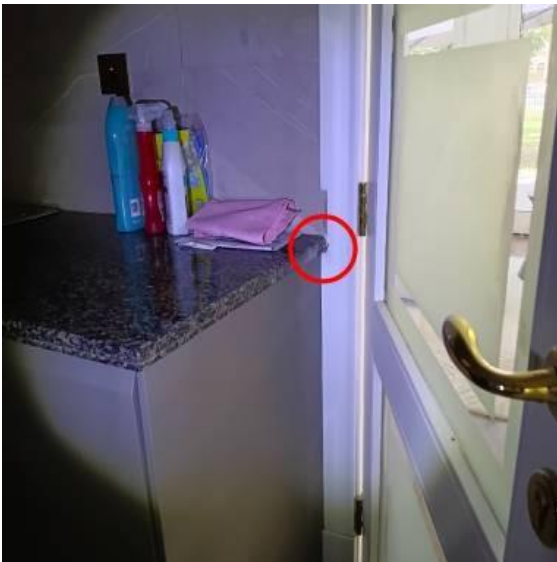
Location:Kitchen

Sealant mark on door frame

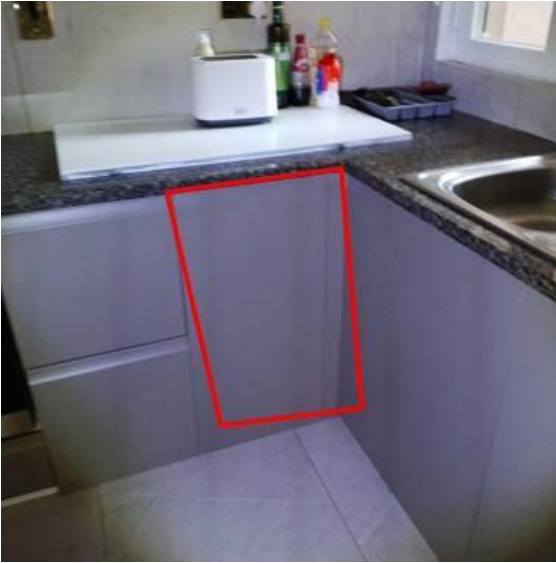
Location:Kitchen
Status:open
Comments:

Door not aligned properly

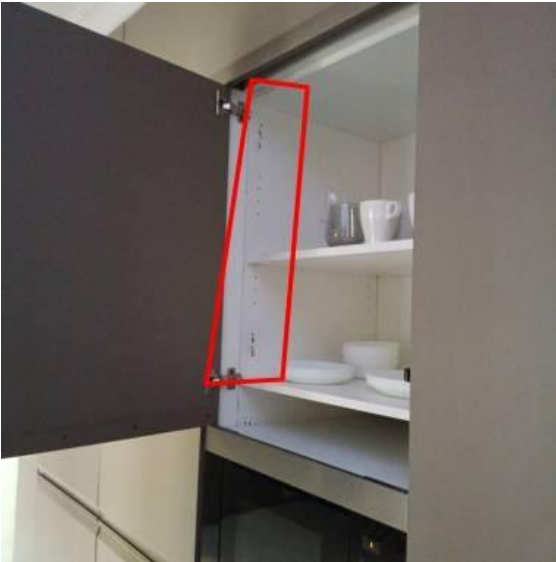
Location:Kitchen
Status:open
Comments:

Multiple screw holes were found

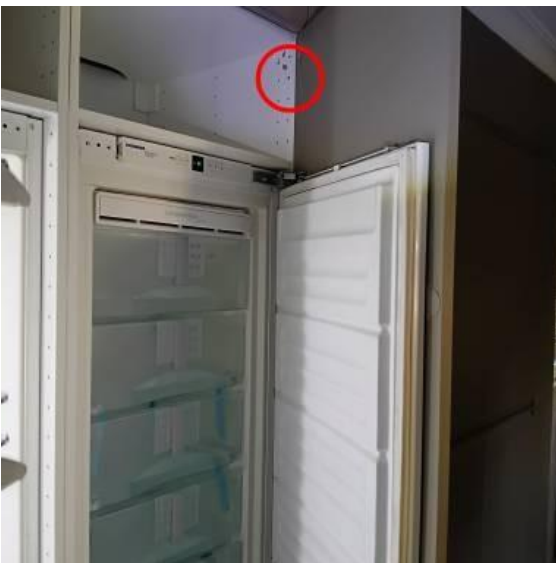
Location:Kitchen
Status:open
Comments:

Multiple screw holes were found

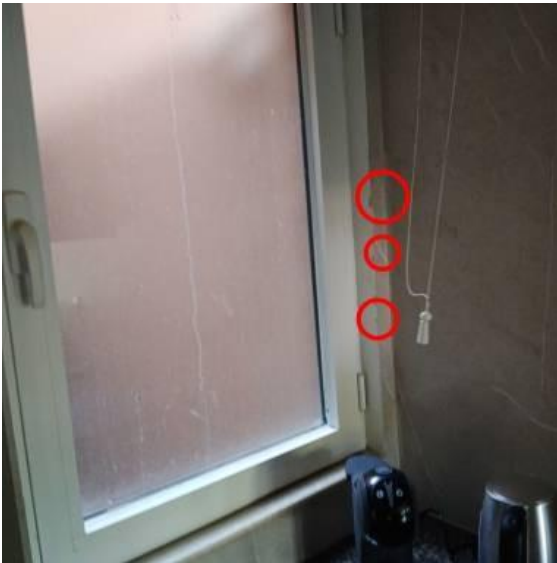
Location:Kitchen

Multiple chipped on wall were noted

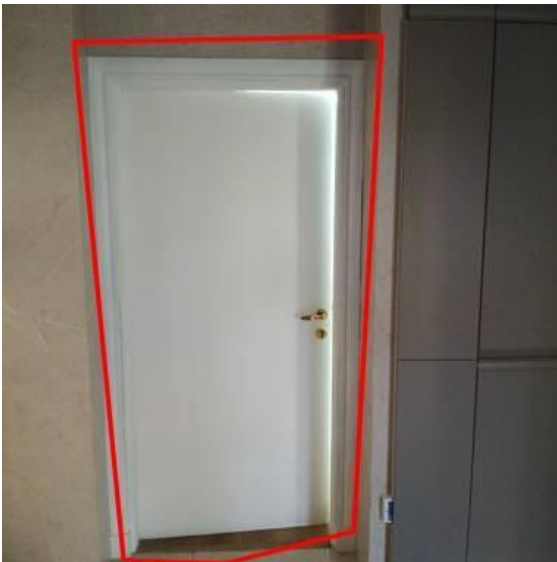
Location:Kitchen

Multiple chipped, Sealant missing, Stains marks,Poor joint termination

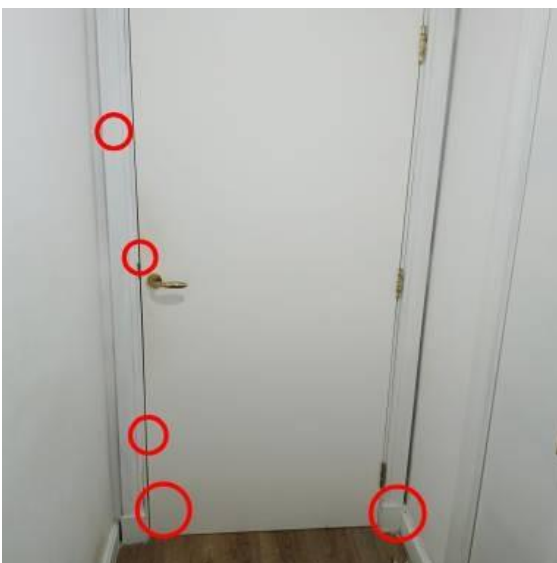
Location:Kitchen

Sealant missing, Multiple chipped on door and door frame

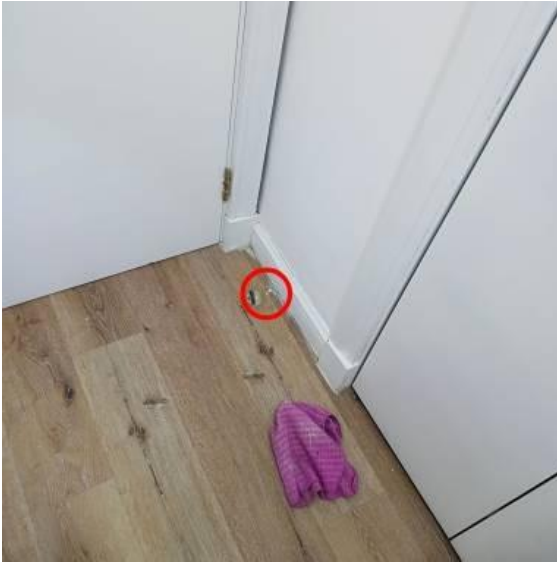
Location:Kitchen

Loose door stopper

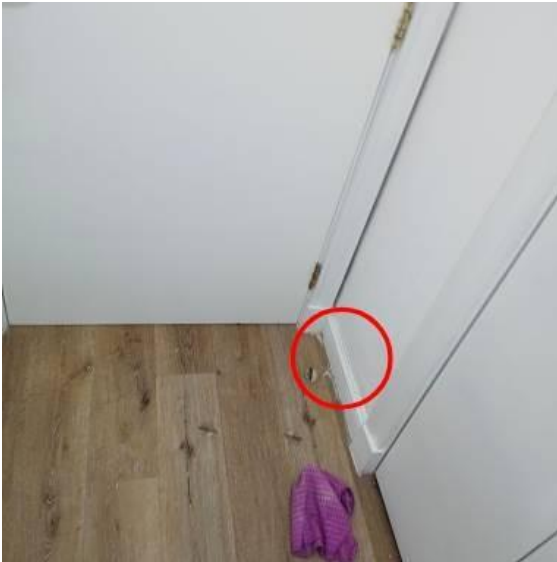
Location:Kitchen

Cracks on skirting

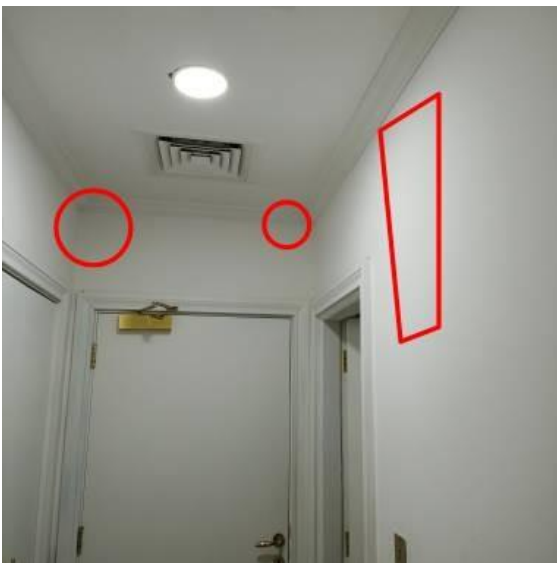
Location:Kitchen

Multiple cracks on ceiling and wall

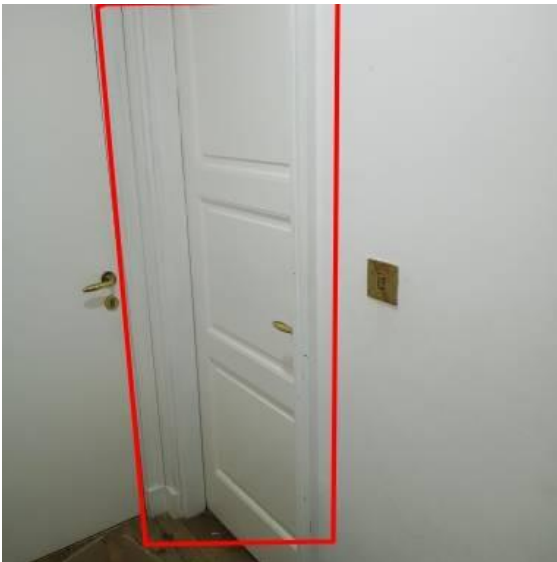
Location:Maid room
Status:open
Comments:

Multiple chipped and stains marks on door and door frame

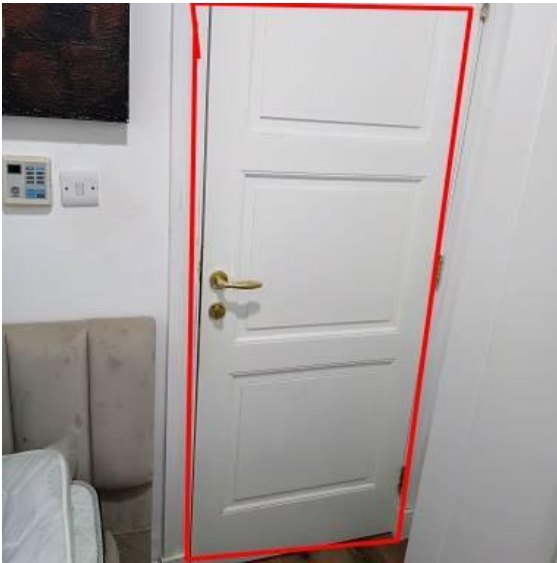
Location: Maid room

Multiple chipped on door were noted

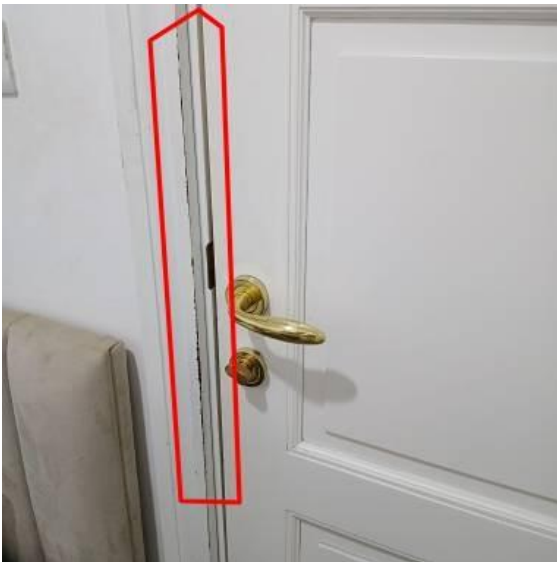
Location: Maid room

Paints damage at door frame

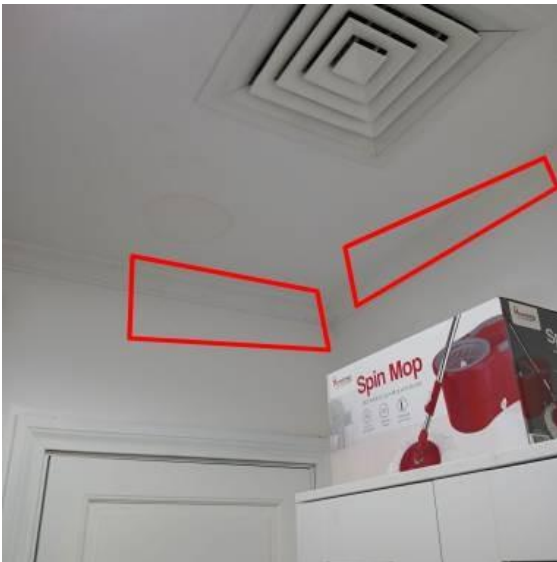
Multiple cracks on ceiling and wall

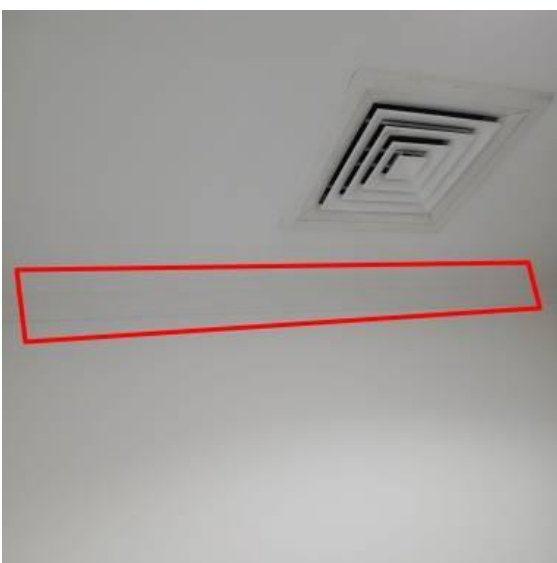
Cracks on ceiling panel

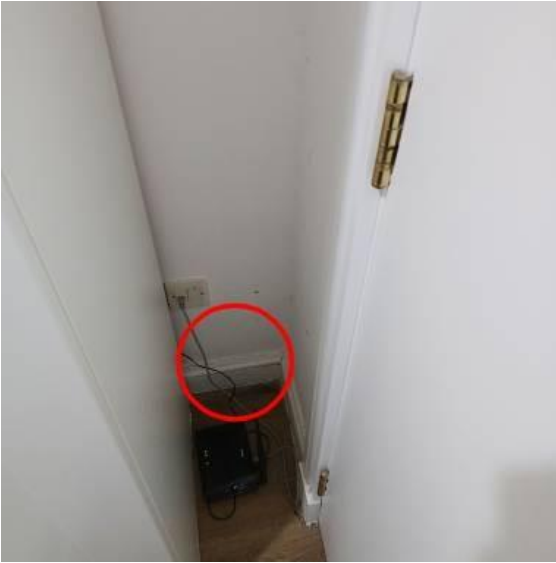
Cracks on skirting were noted

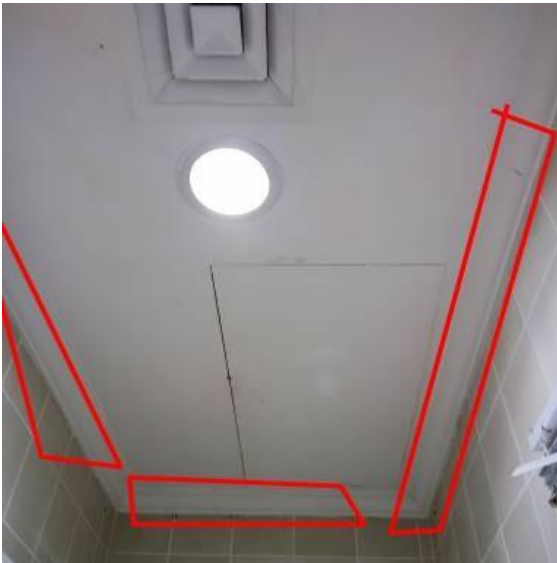
Multiple cracks on ceiling panel

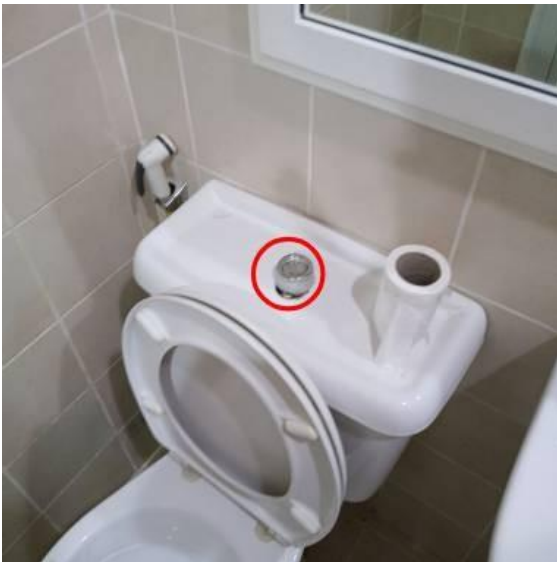
Loose flush button were noted

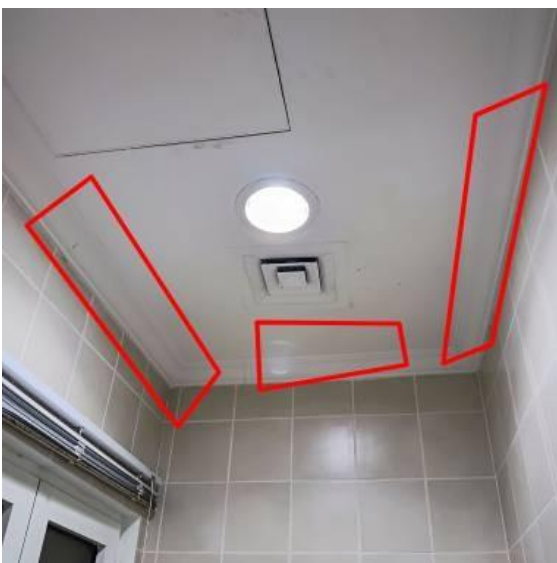
Multiple cracks on ceiling panel
