PROPERTY INSPECTION REPORT

VILLA # N74 CANAL COVE FROND PALM JUMAIRA

Client Name: Hemalataa Vinayak Shrivastav

Inspection Date: November 22, 2025

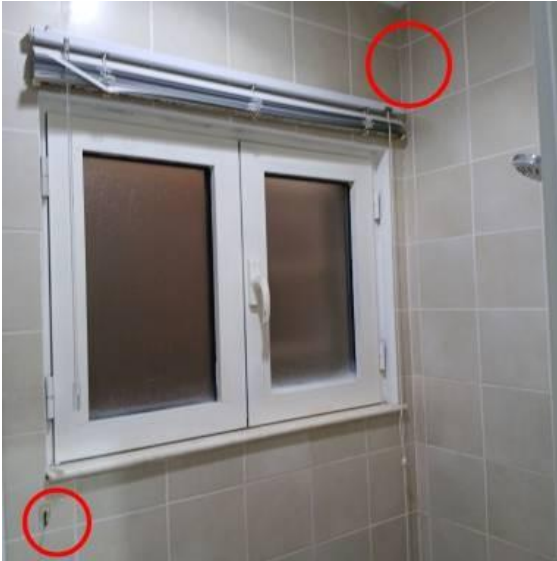
Wall tile damage and cracks on wall

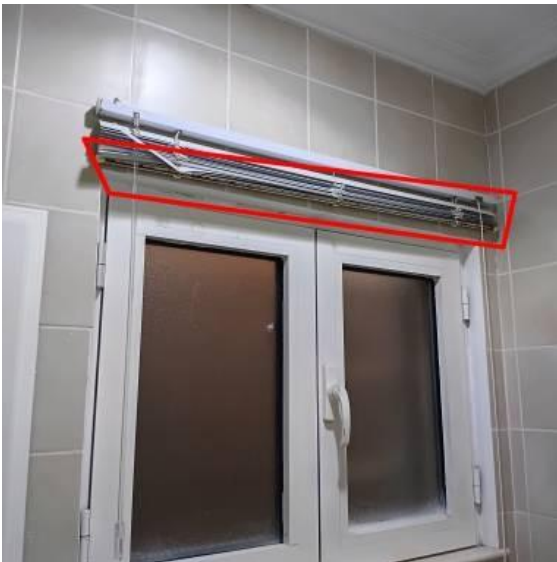
Curtain track rusted

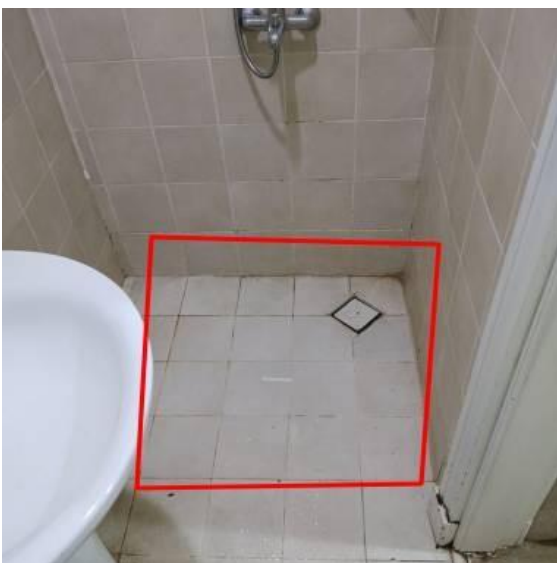
Floor tile grout color damaged

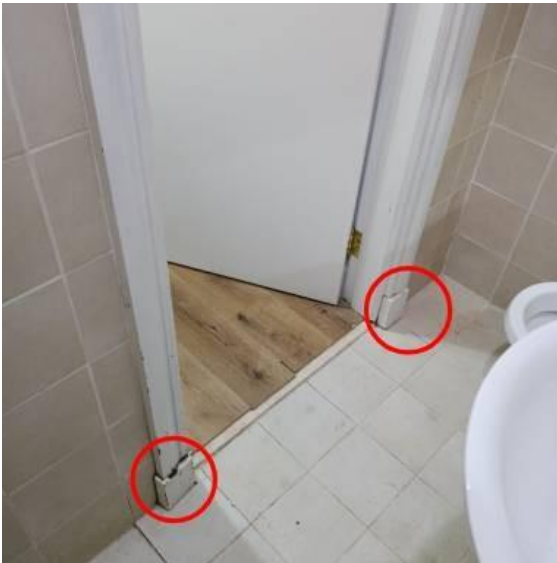
Paints damage at door frame

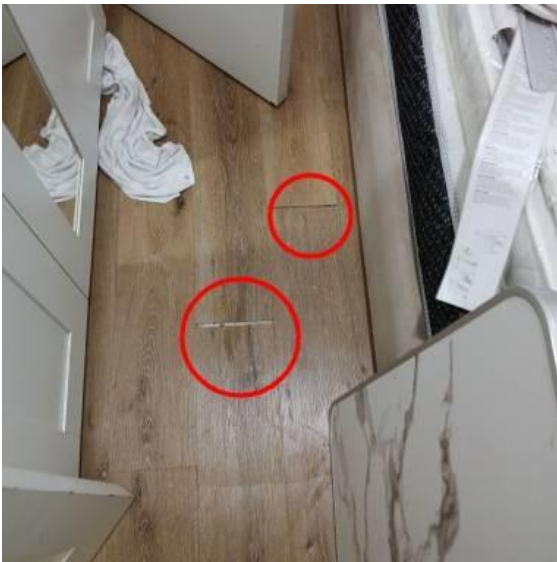
Floor wooden tile damage

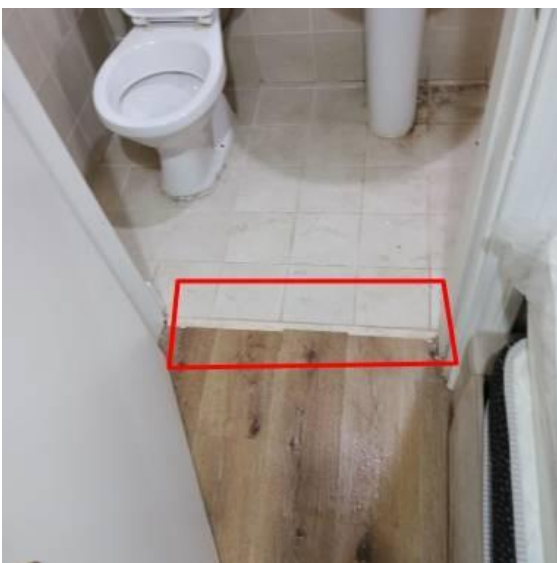
Improper/ incomplete floor tile finishing were noted

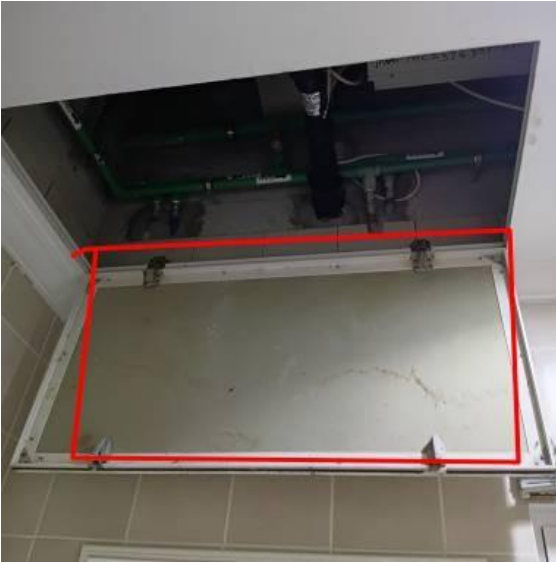
Created: Sat 22 Nov 13:39 2025
Location: Maid bath
Status: open
Comments:
Access panel not closing properly

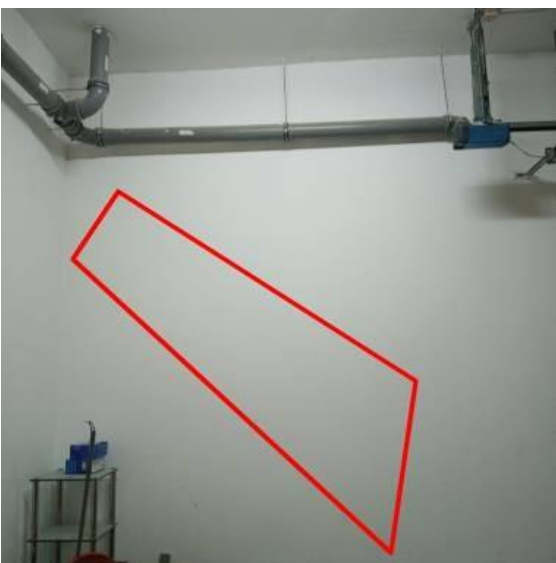
Created: Sat 22 Nov 13:41 2025
Location: Garage
Status: open
Comments:
Cracks on wall

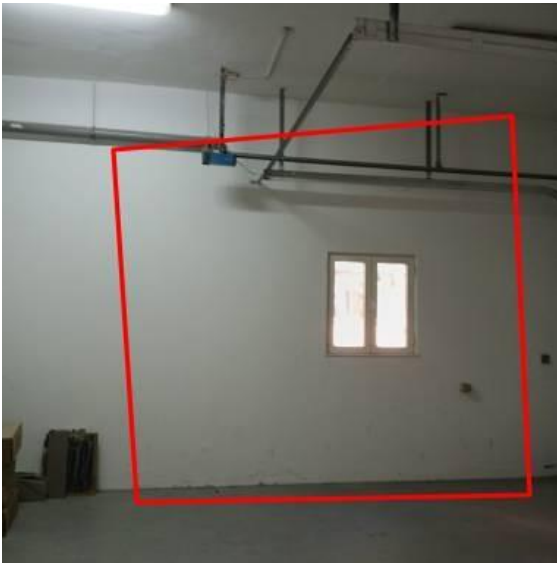
Entire wall color deteriorated

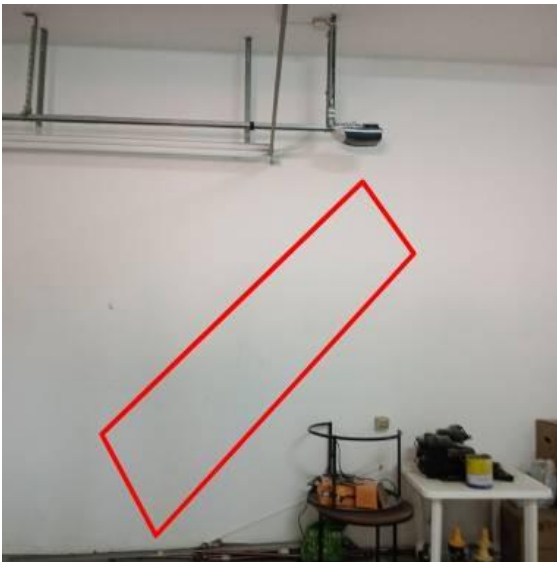
Cracks on wall

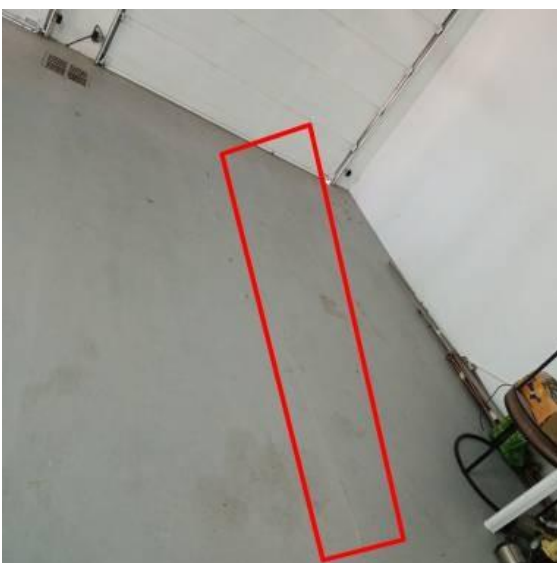
Cracks on floor were noted

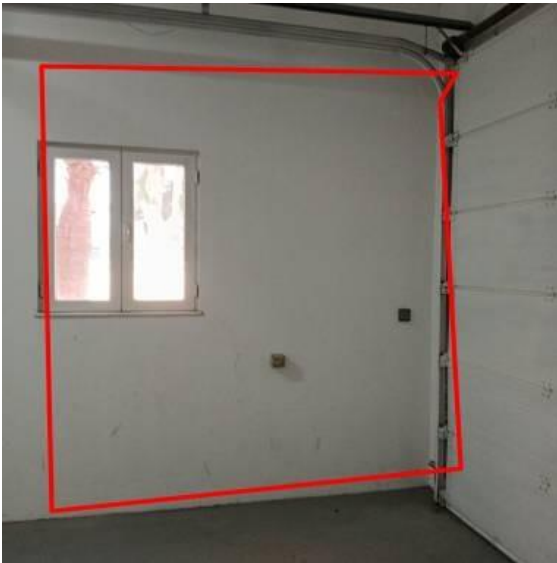
Entire wall paint deteriorated

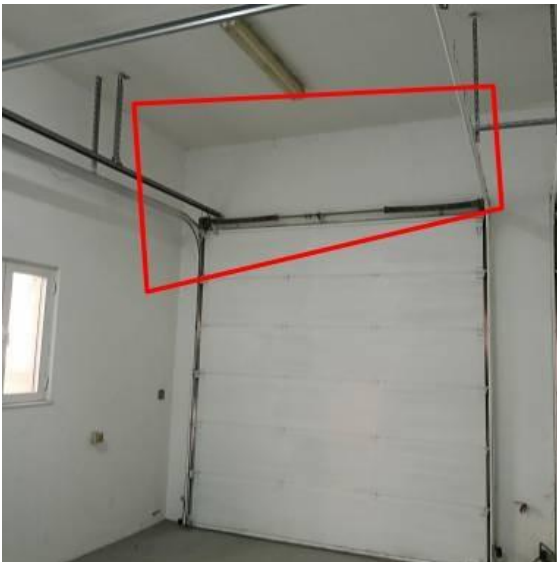
Wall Paint deteriorated

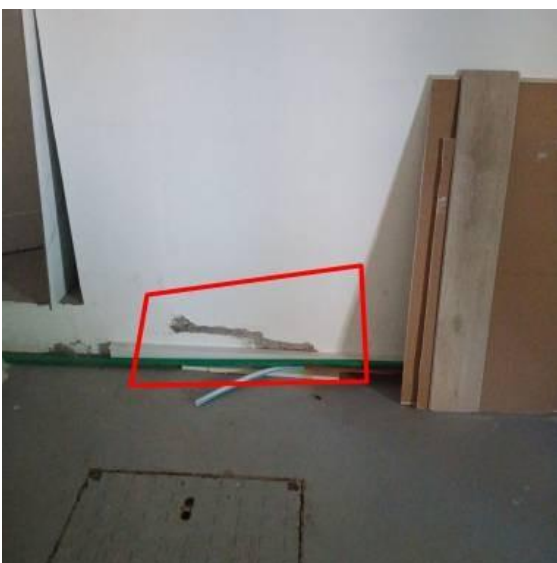
Wall plaster were found damaged

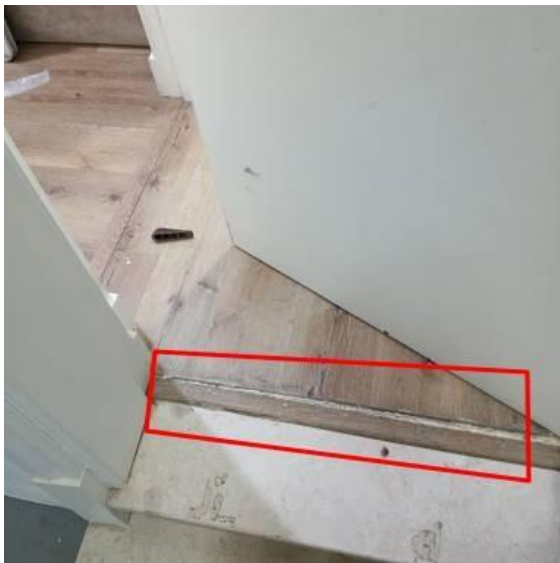
Created: Sat 22 Nov 13:45 2025
Location:Garage
Status:open
Comments:
Wooden threshold detached from floo

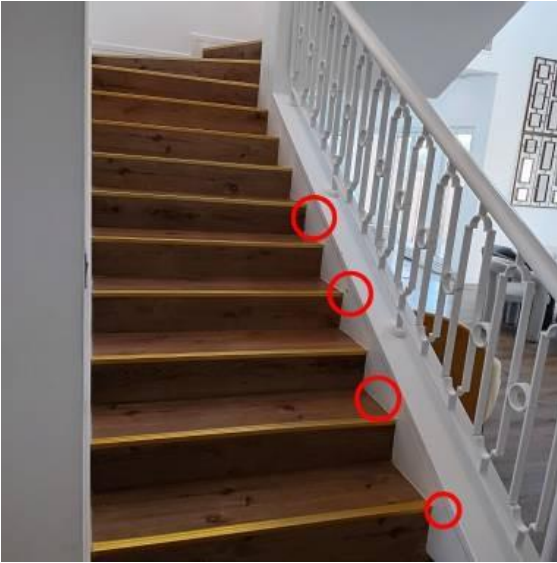
Created: Sat 22 Nov 14:04 2025
Location: Stairs
Status: open
Comments:
Paints damaged at stairs grill

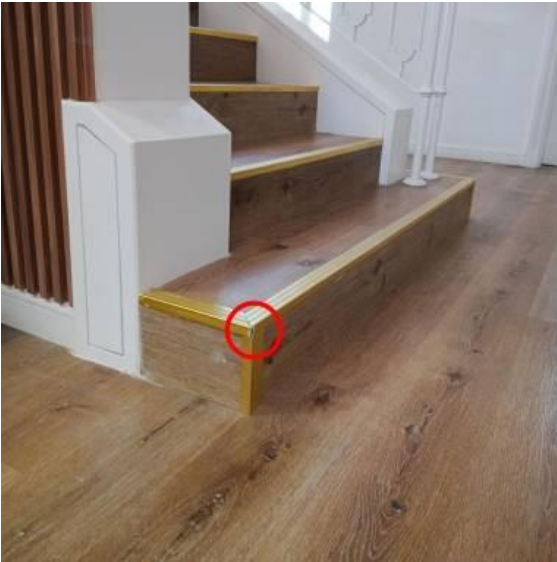
Created: Sat 22 Nov 14:06 2025
Location: Stairs
Status: open
Comments:
Tile trim at stairs were damaged

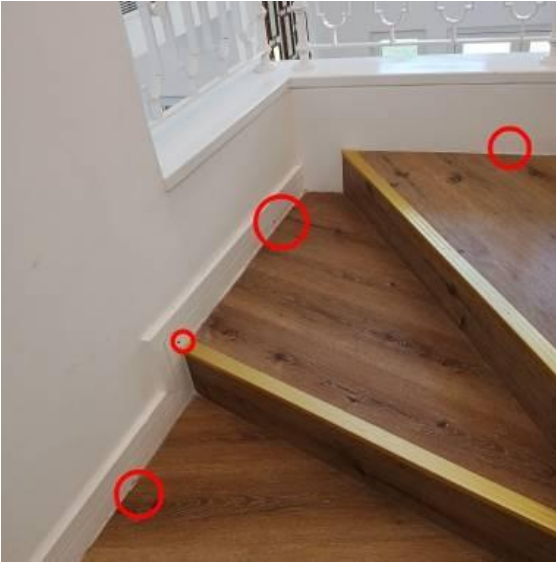
Created: Sat 22 Nov 14:07 2025
Location: Stairs
Status: open
Comments:
Paint damages at skirting

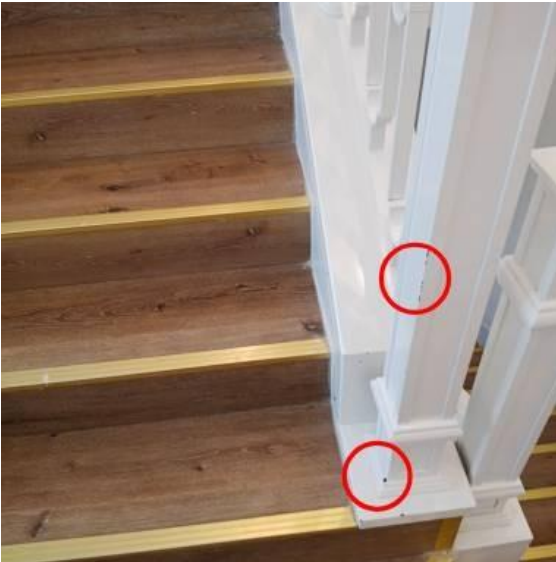
Created: Sat 22 Nov 14:07 2025
Location: Stairs
Status: open
Comments:
Paints damage at stairs rails

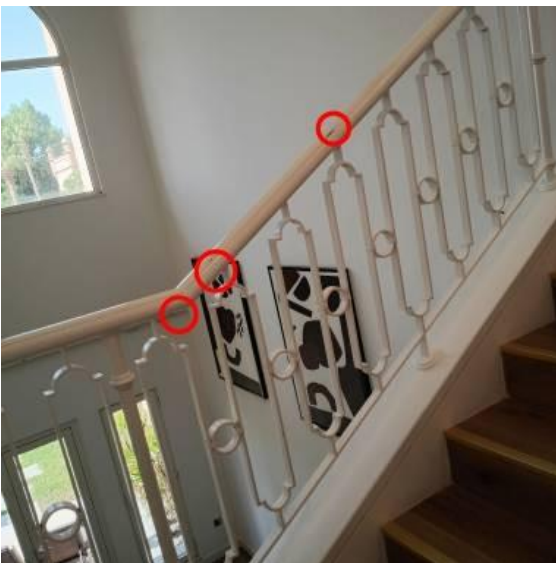
Created: Sat 22 Nov 14:08 2025
Location: Stairs
Status: open
Comments:
Multiple chipped on Stairs rails were noted

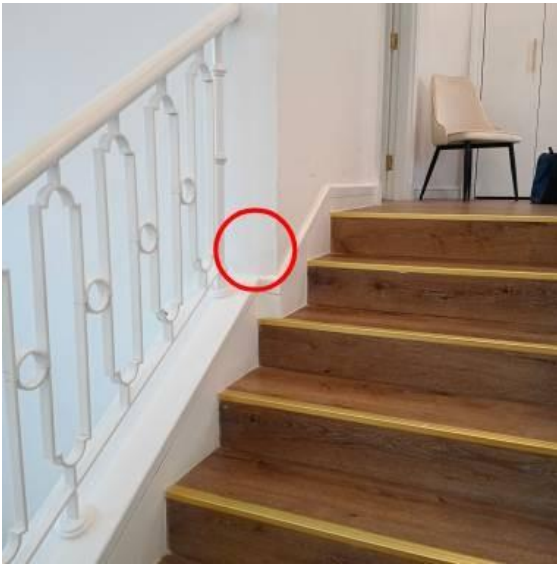
Cracks on wall

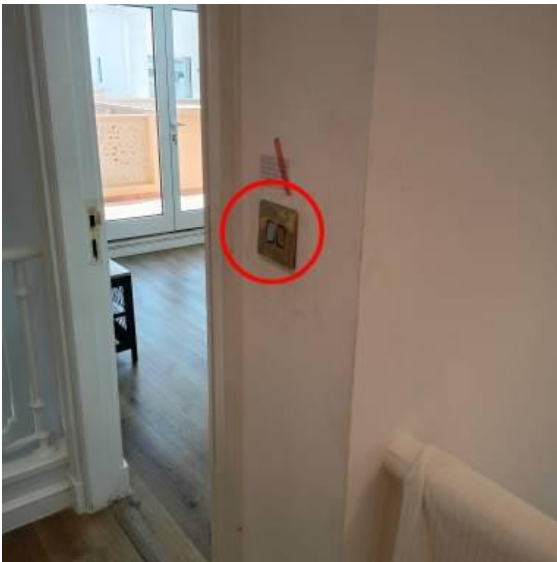
Loose switches were found

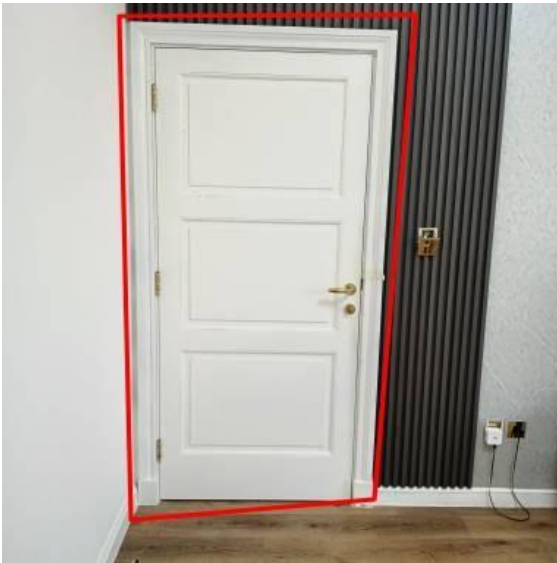
Multiple chipped and cracks on door and door frame

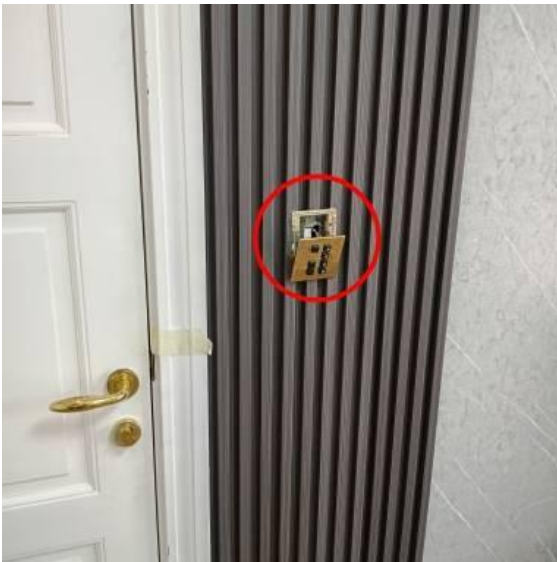
Switches were not fixed properly

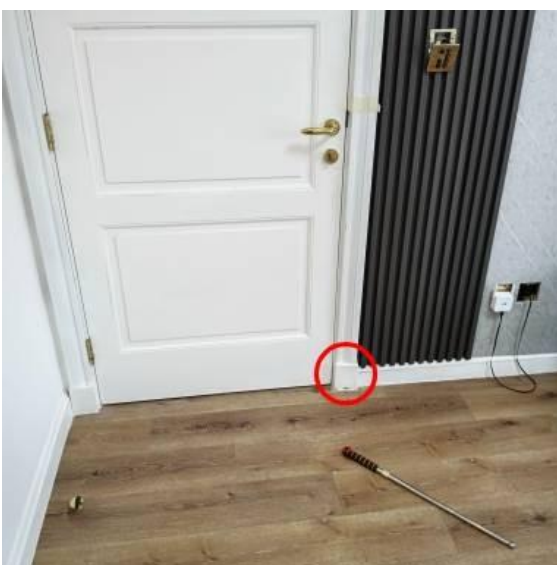
Paints damages at door frame were noted

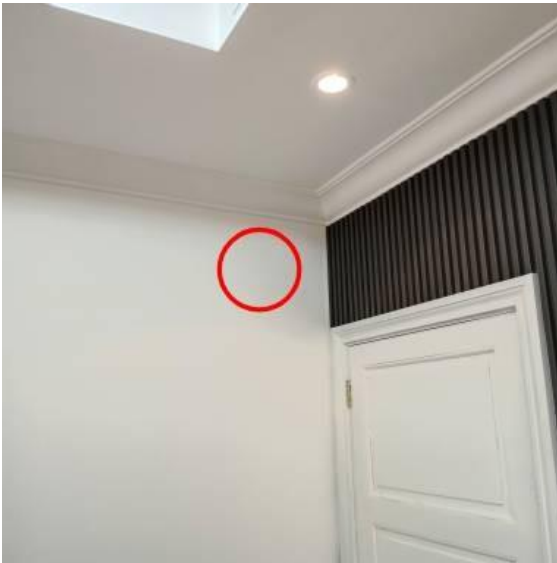
Created: Sat 22 Nov 14:13 2025
Location: Bedroom 2
Status: open
Comments:
Paint peeling off

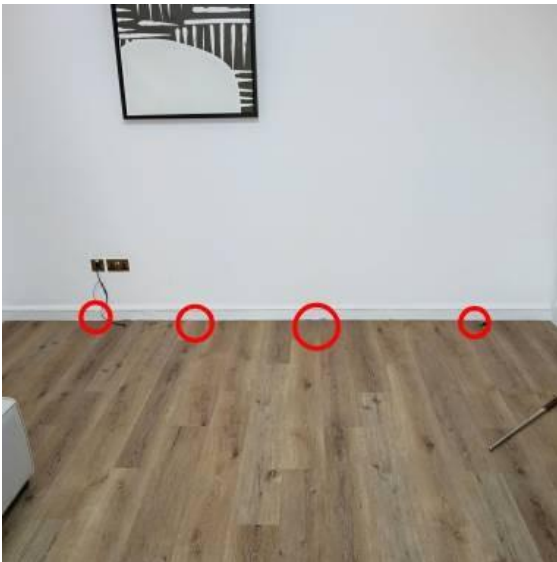
Created: Sat 22 Nov 14:13 2025
Location: Bedroom 2
Status: open
Comments:
Paints damages at skirting

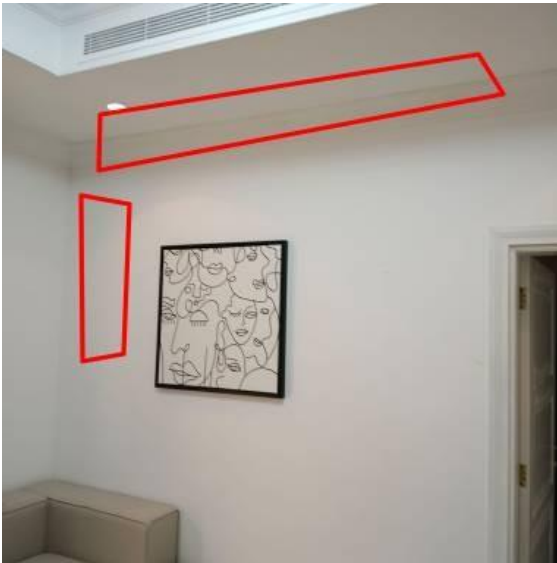
Cracks on wall and ceiling were found

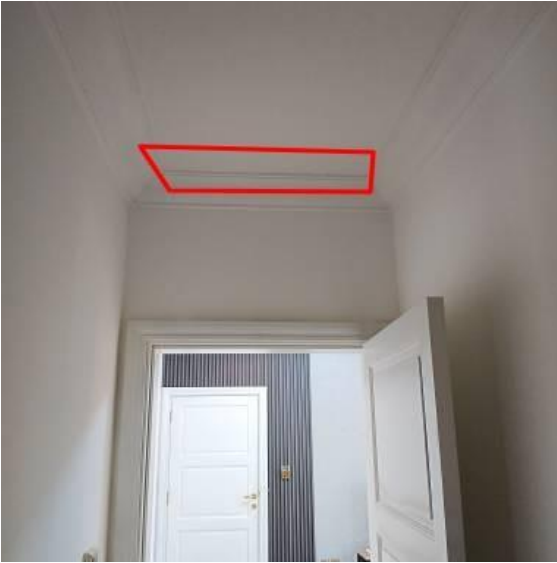
Paints damages at door frame

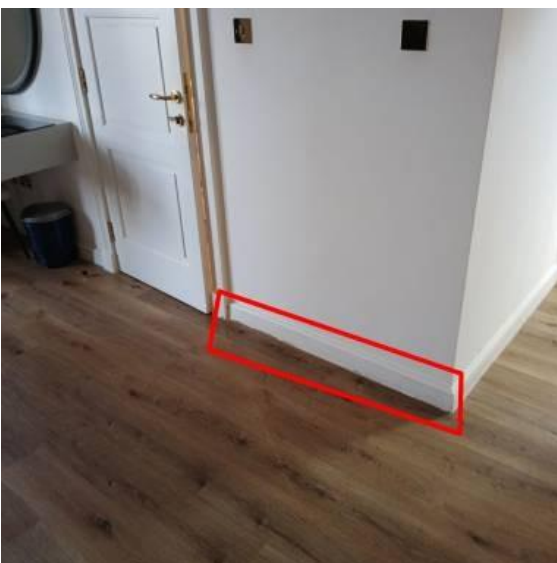
Stains and paints damages

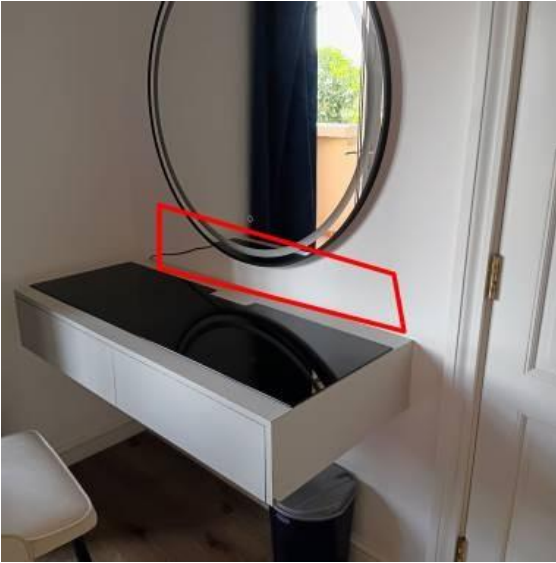
Poor Paint finishing on wall

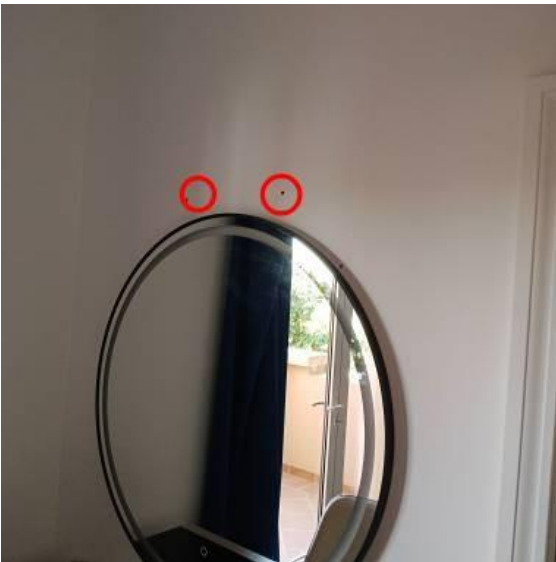
Screw holes on wall were noted

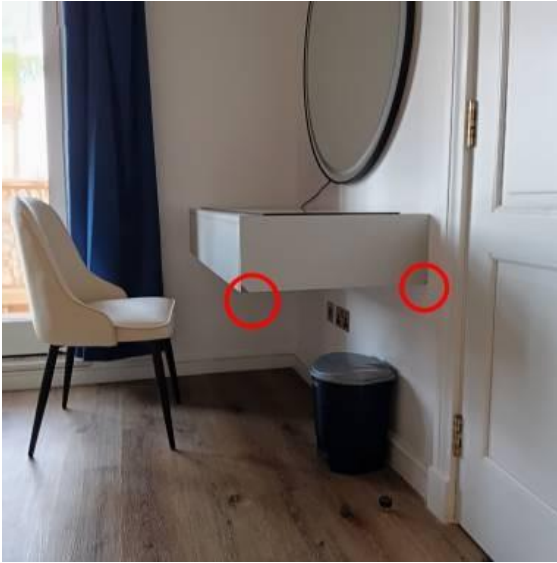
Paint damages at wall

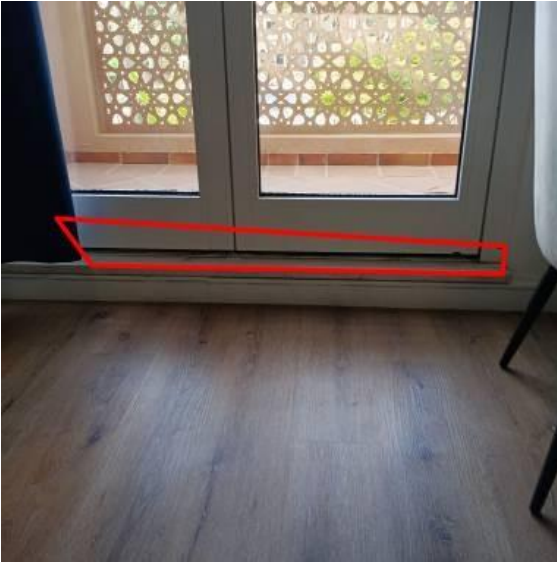
Created: Sat 22 Nov 14:23 2025
Location: Bedroom 2
Status: open
Comments:
Window frame paint were found damaged

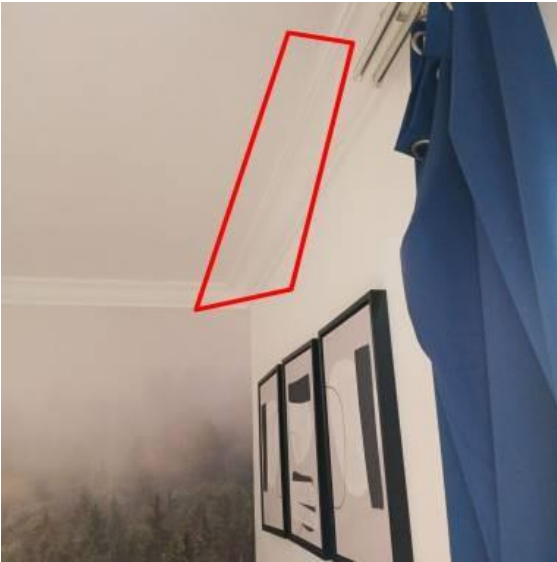
Created: Sat 22 Nov 14:23 2025
Location: Bedroom 2
Status: open
Comments:
Cracks on ceiling were noted

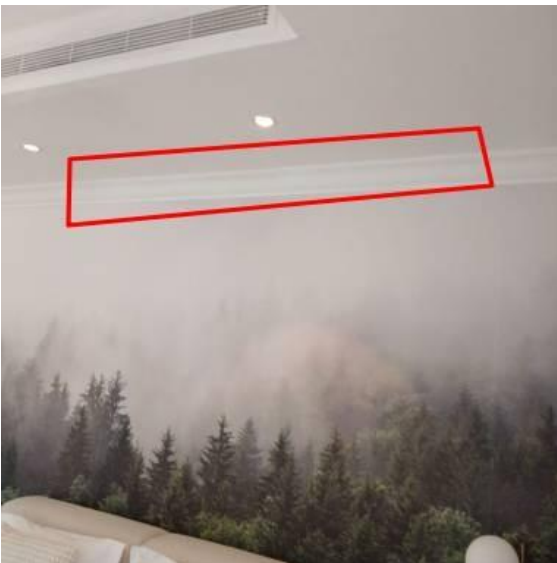
Created: Sat 22 Nov 14:24 2025
Location: Bedroom 2
Status: open
Comments:
Cracks on ceiling

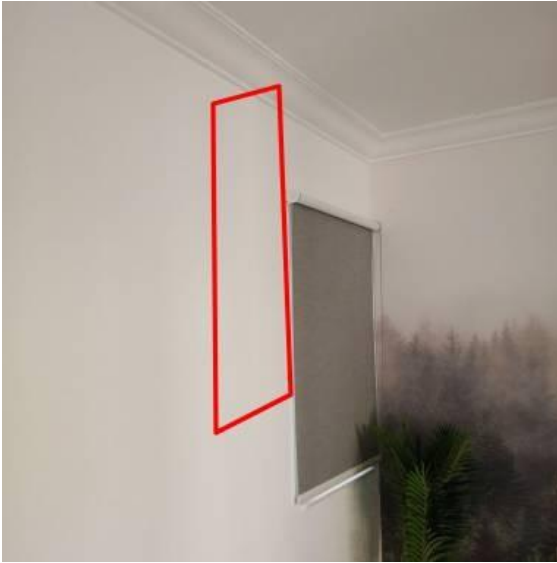
Cracks on wall were noted

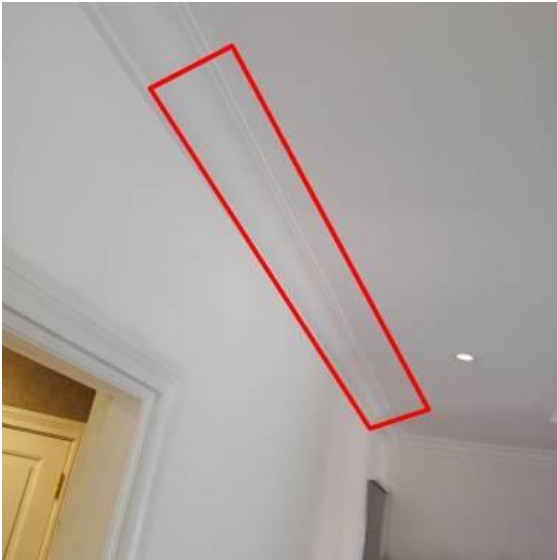
Cracks on ceiling

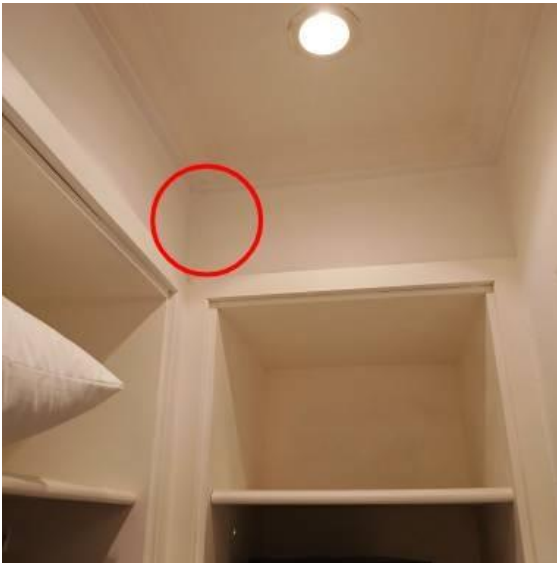
Cracks on wall

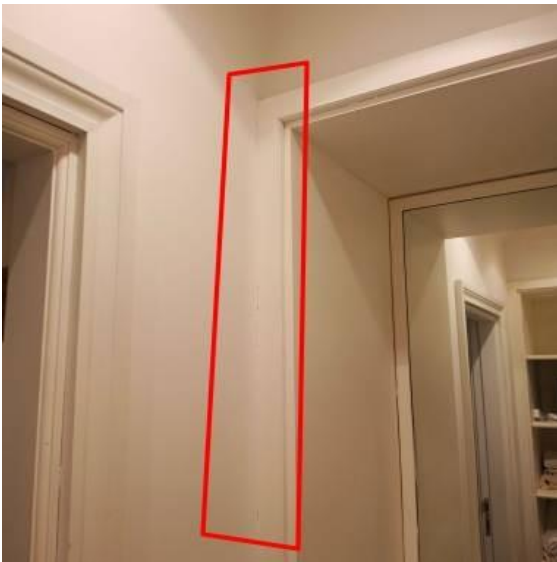
Cracks on wall were noted

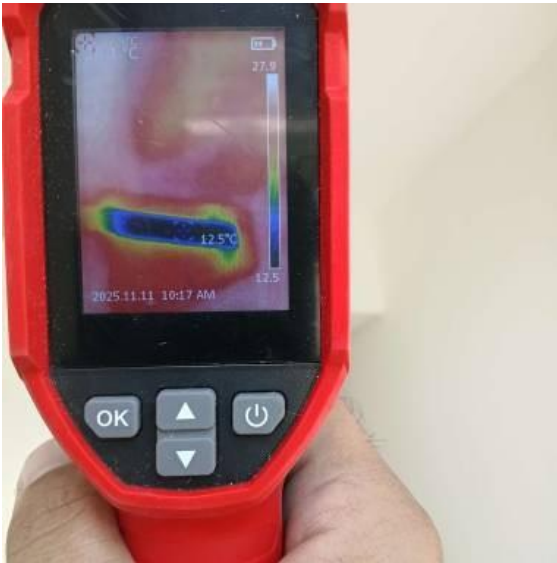
AC cooling is as per standard

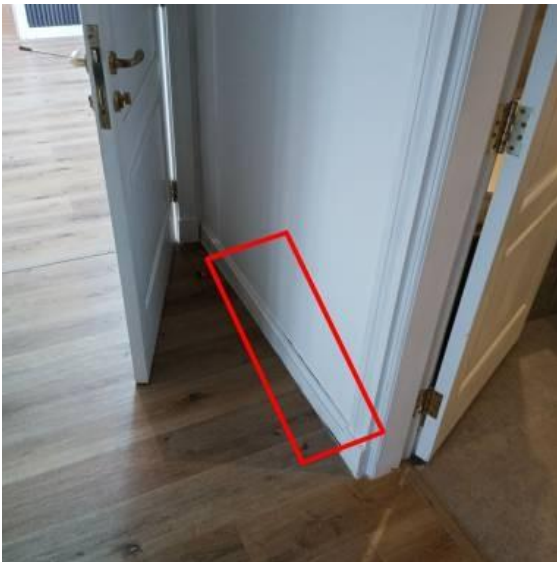
Skirting detached from wall

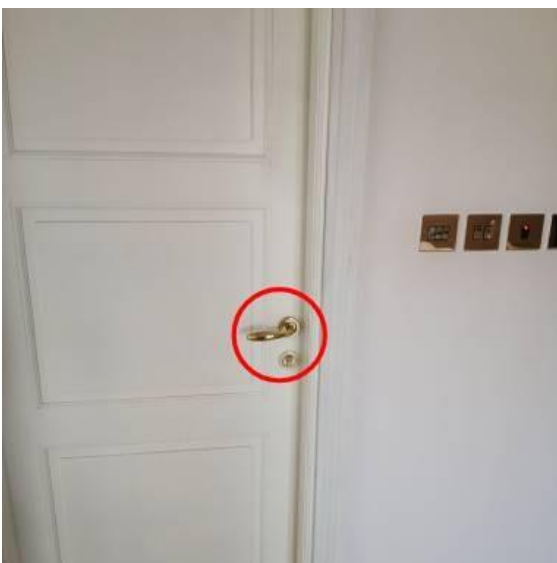
Loose door handle found

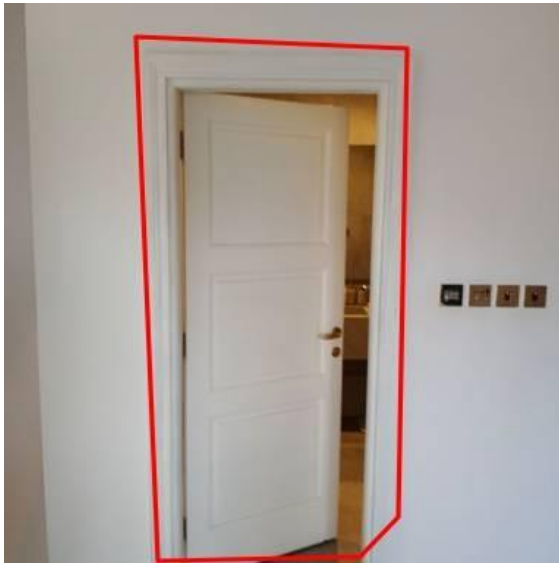
Poor joints termination at door frame

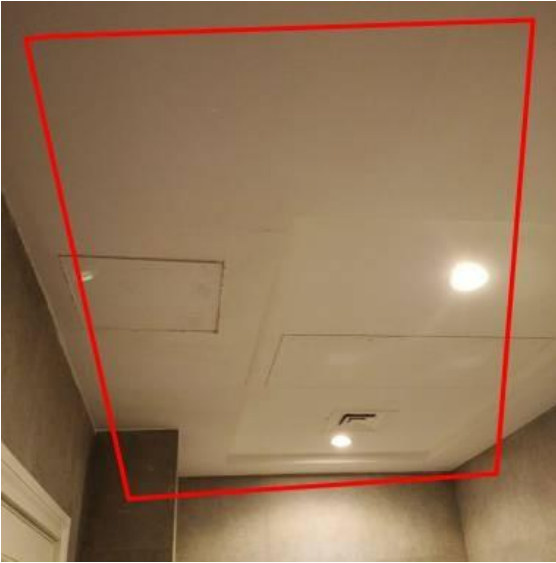
Multiple cracks, Paint determination and water marks

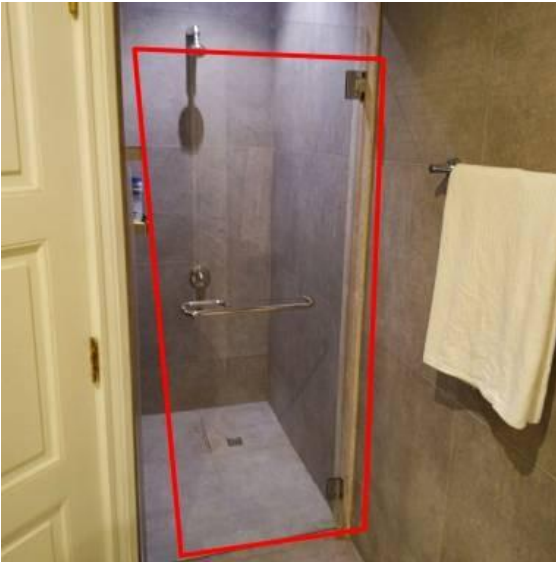
Glass door hard to open/close and noisy

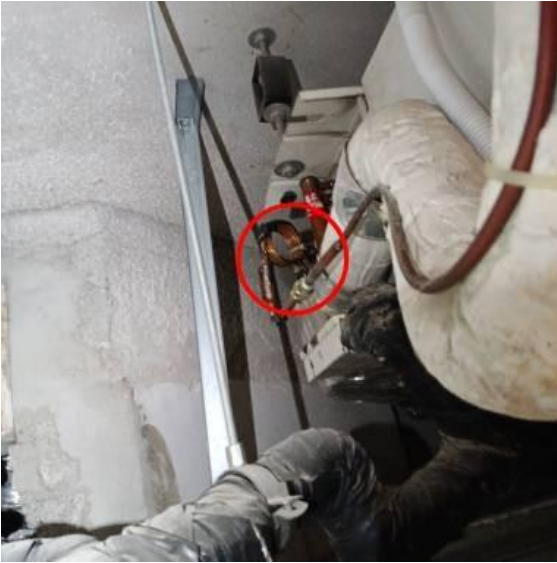
Hot gas copper pipes insulation melted due to over heating

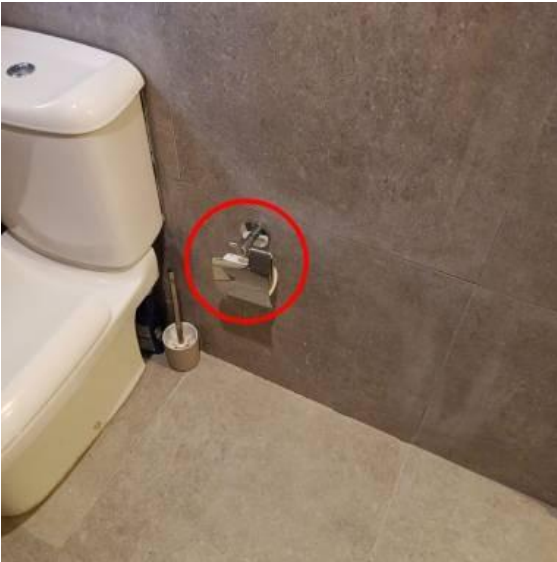
Loose tissue paper holder

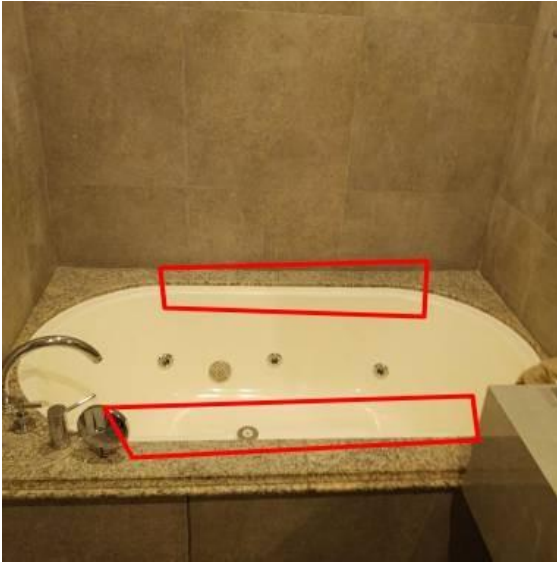
Poor Sealant finishing

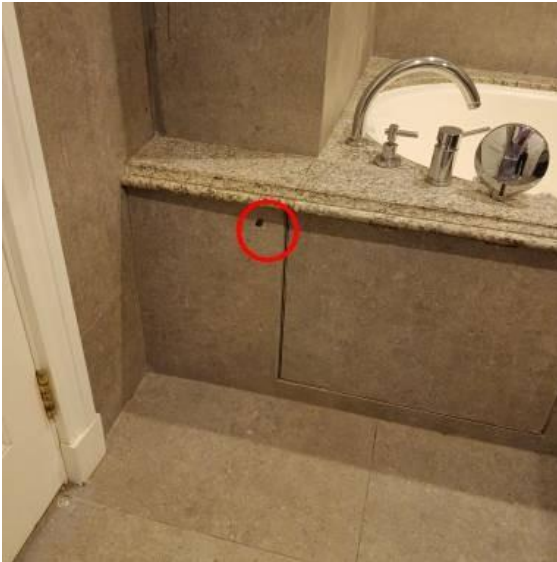
Tile damage were noted

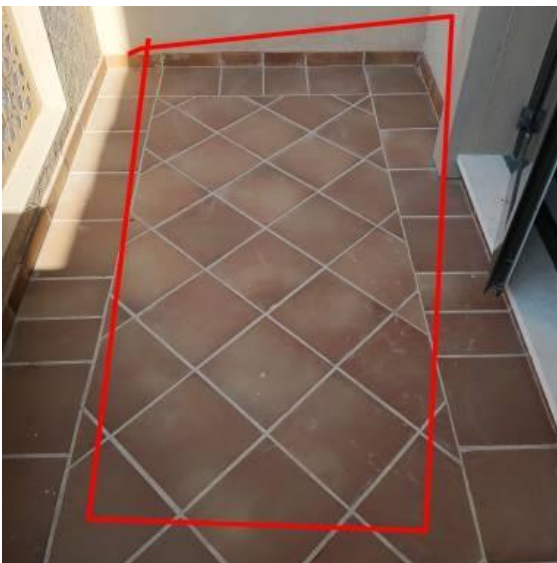
Multiple scratches on floor tile were noted

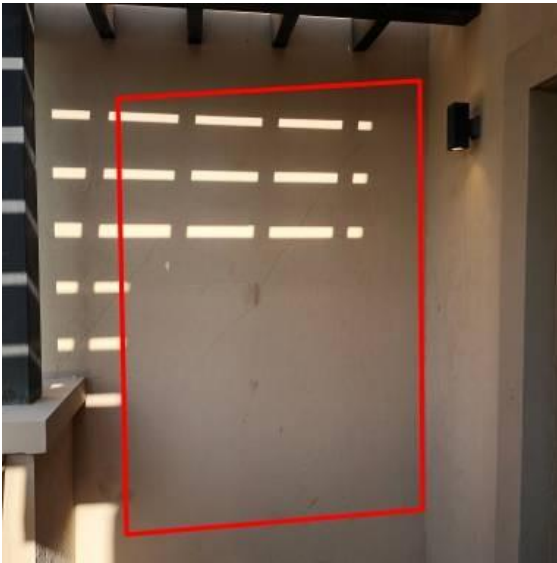
Cracks on wall

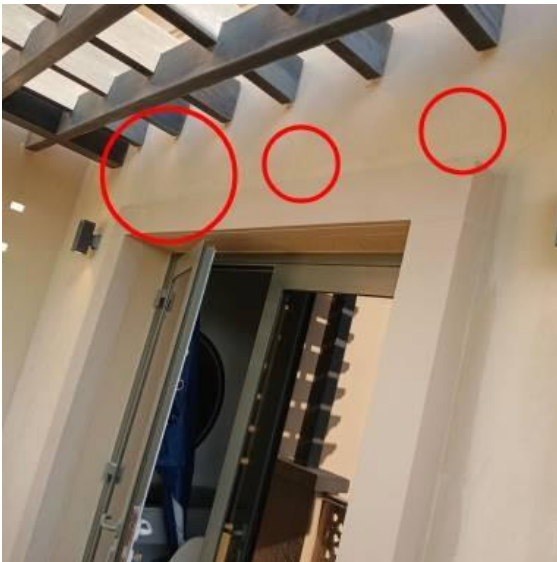
Multiple cracks on wall and Poor Paint finishing

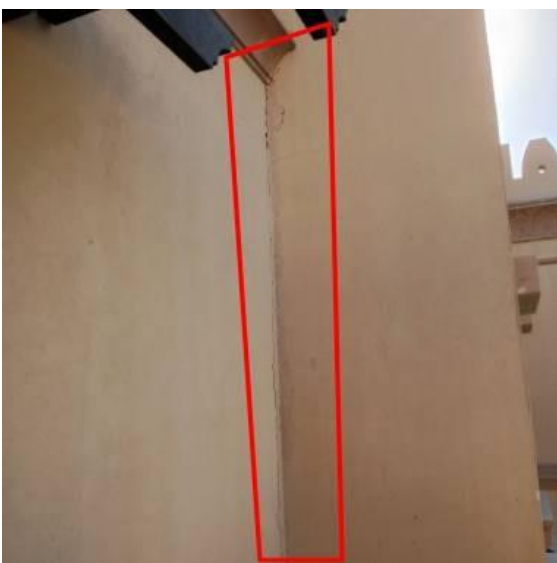
Plaster damaged and cracks on wall

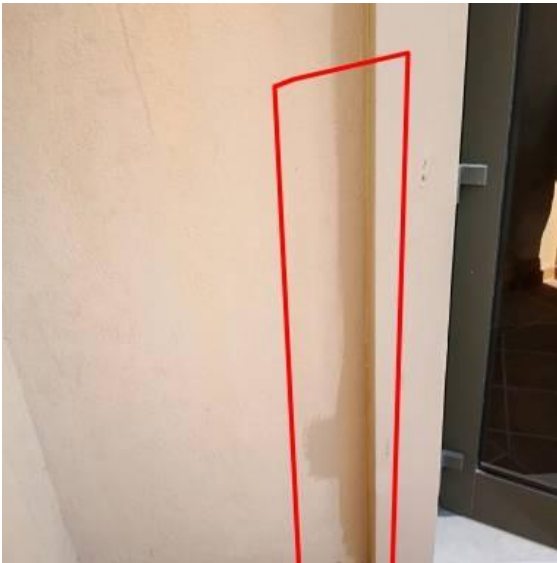
Improper Paint finishing

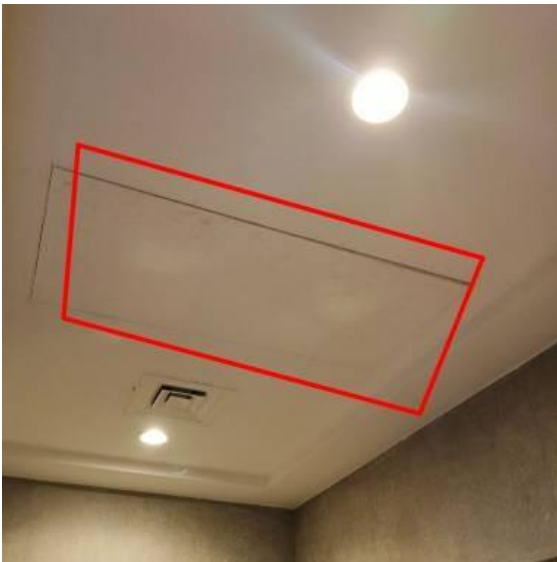
Access panel not closing properly

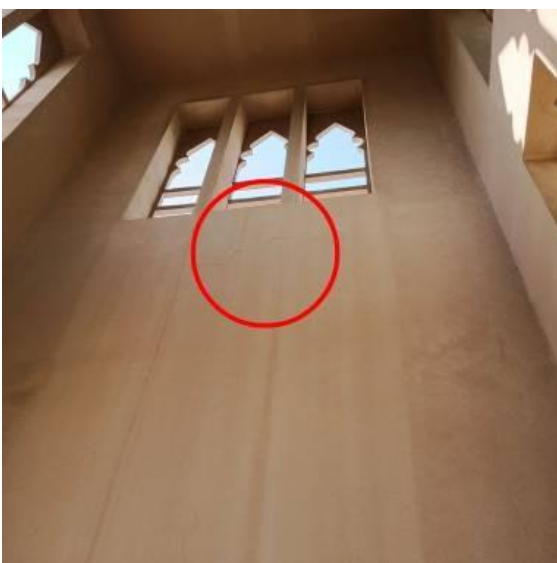
Cracks on wall were noted

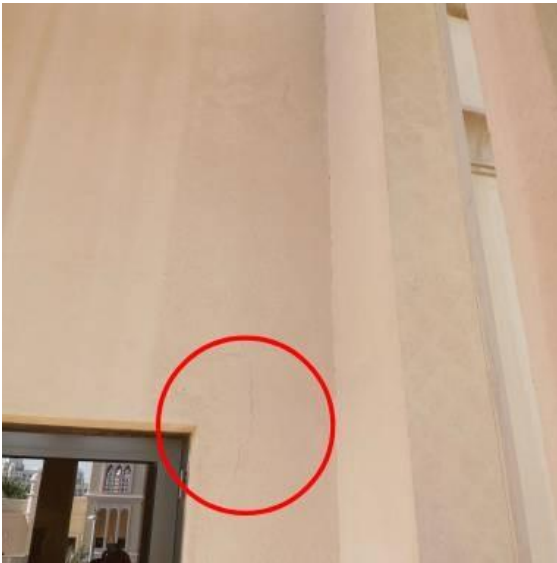
Cracks on wall

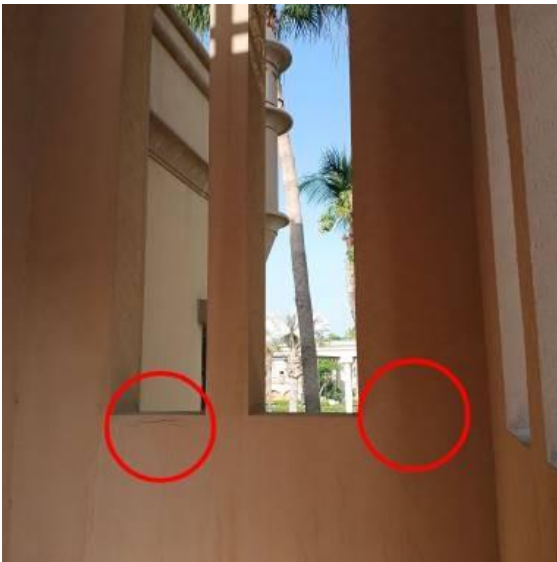
Location: Bedroom 2 balocony
Status: open
Comments:

Multiple cracks on wall were found

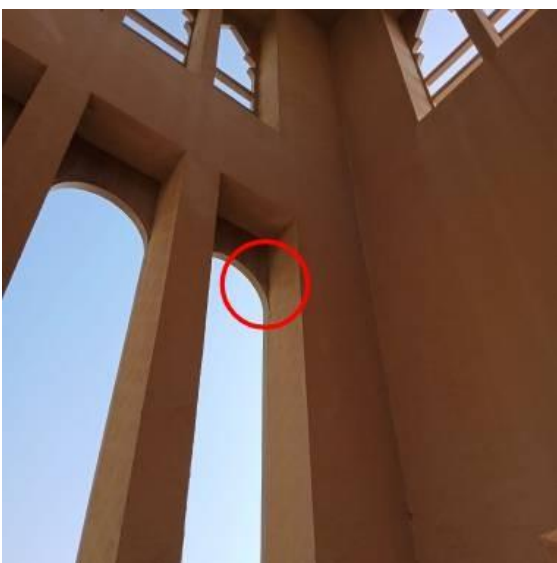
Location: Bedroom 2 balocony
Status: open
Comments:

Cracks on wall

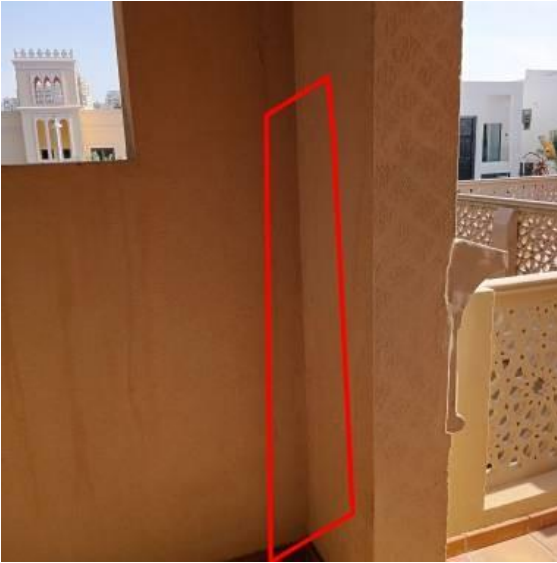
Location: Bedroom 2 balocony
Status: open
Comments:

Cracks on wall were noted

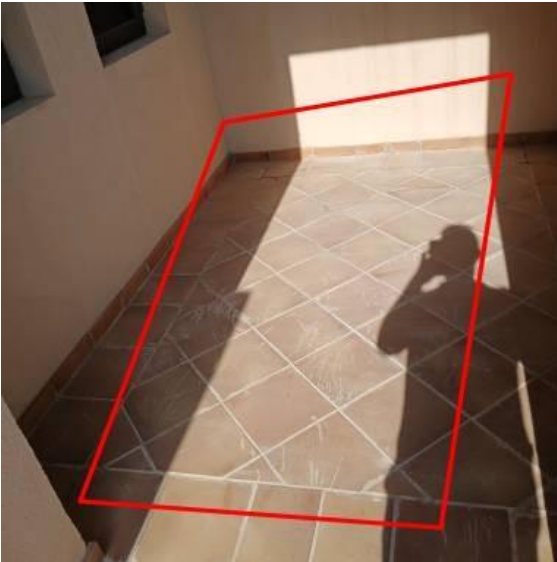
Location: Bedroom 2 balocony
Status: open
Comments:

Improper grout finishing

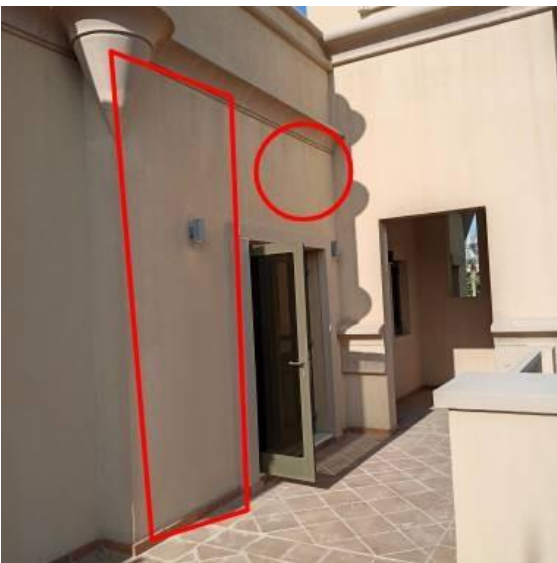
Location: Bedroom 2 balocony
Status: open
Comments:

Multiple cracks on wall

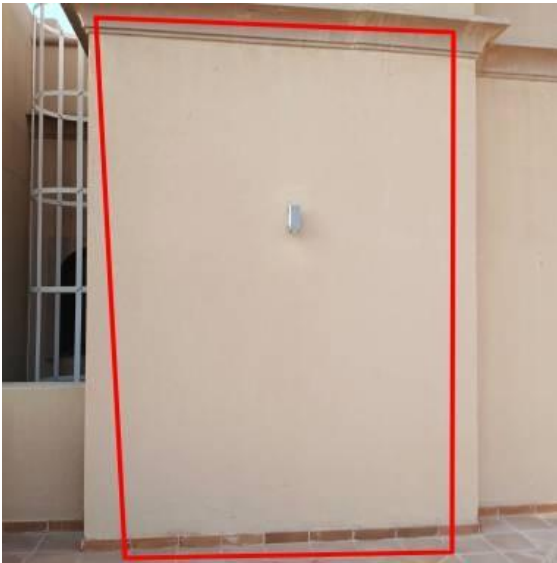
Location: Bedroom 2 balocony

Multiple cracks and paints damages on wall

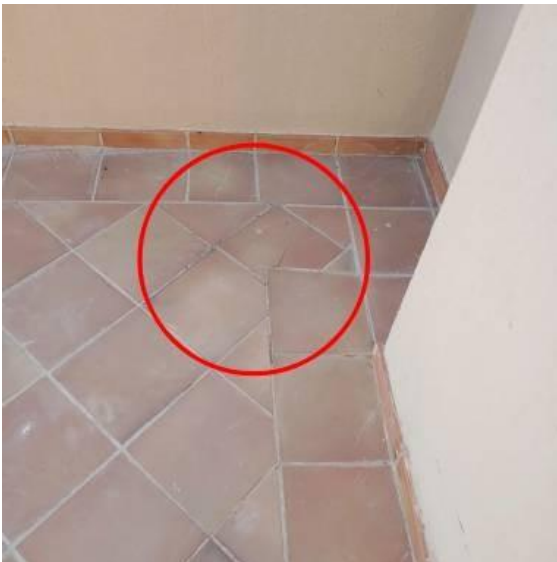
Location: Bedroom 2 balocony

Floor tile damaged were noted

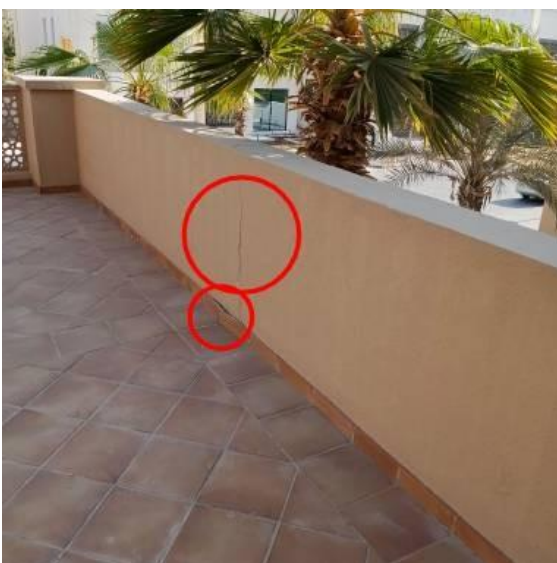
Location: Bedroom 2 balocony

Cracks on wall

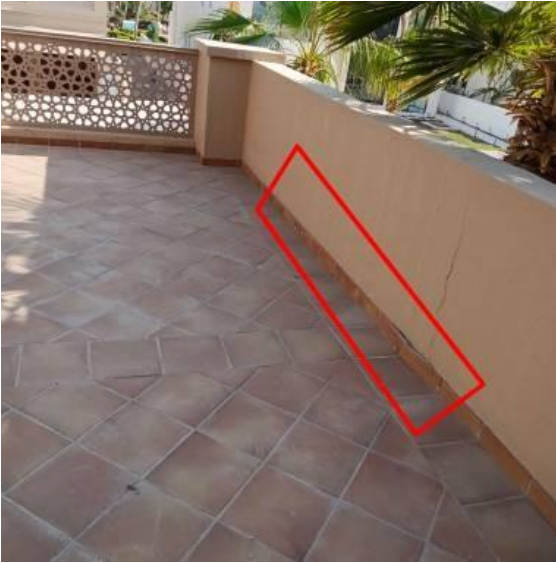
Created: Sat 22 Nov 14:52 2025
Location: Bedroom 2 balocony
Status: open
Comments:
Skirting detached from wall

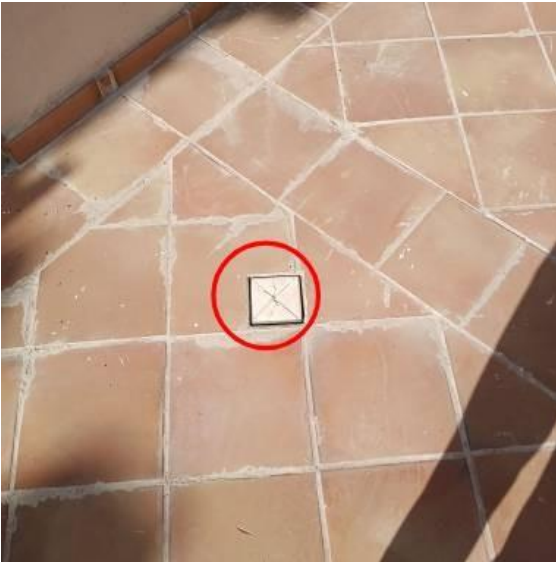
Created: Sat 22 Nov 14:52 2025
Location: Bedroom 2 balocony
Status: open
Comments:
Drain cover not in level

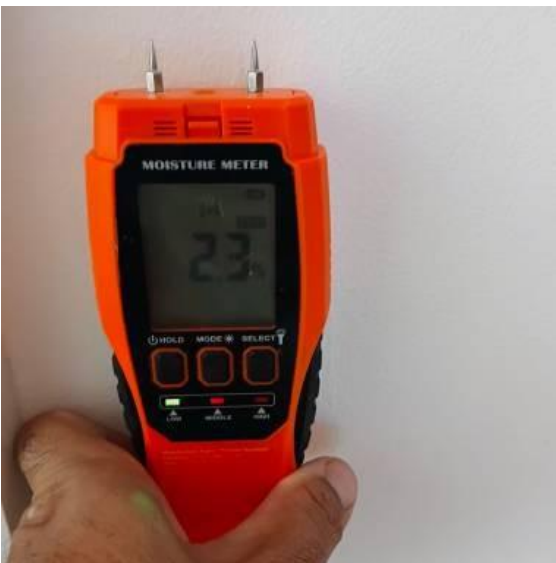
Created: Sat 22 Nov 14:55 2025
Location: Bedroom 2
Status: Pass
Comments:
Moisture test result is as per standard

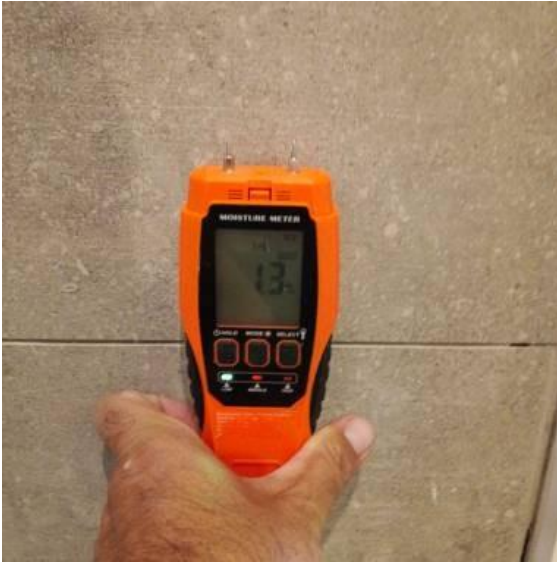
Location: Bedroom 2 bath

Moisture test result is as per standard

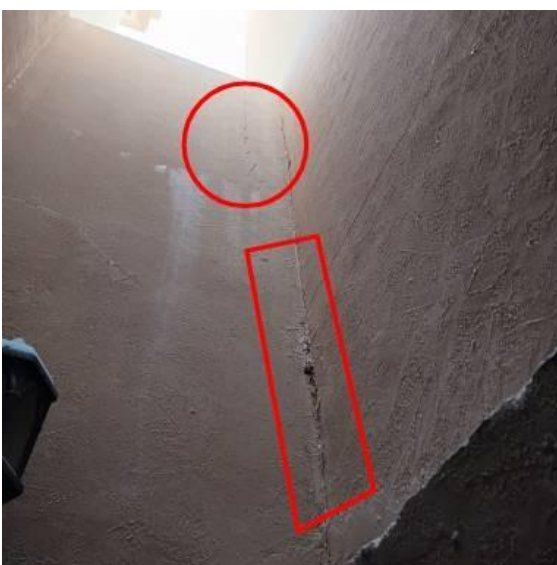
Location: Ladder area

Plaster damaged and cracks on wall were noted
