PROPERTY INSPECTION REPORT

VILLA # N74 CANAL COVE FROND PALM JUMAIRA

Client Name: Hemalataa Vinayak Shrivastav

Inspection Date: November 22, 2025

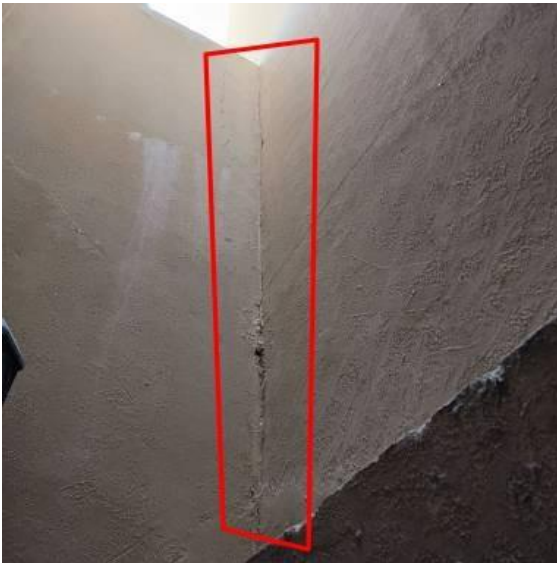
Location:Ladder area
Status:open
Comments:

Cracks on wall were noted

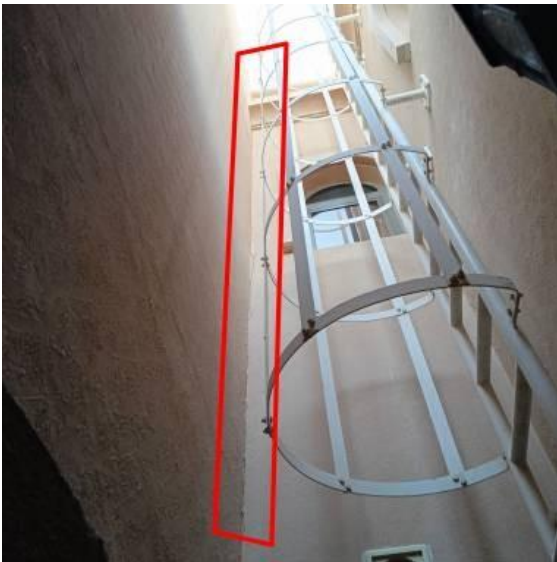
Location:Ladder area
Status:open
Comments:

Cracks on wall

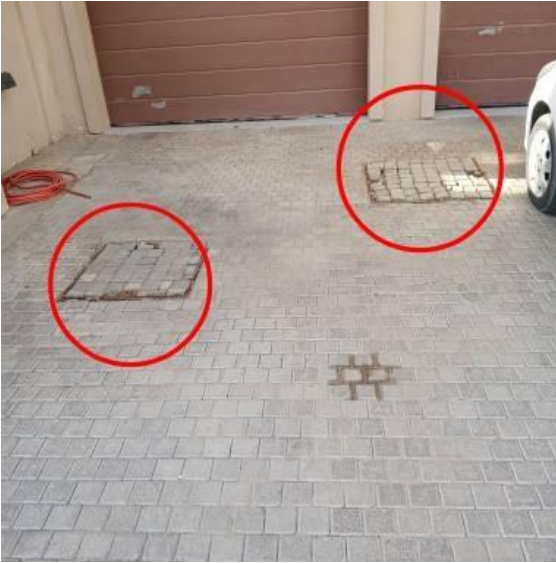
Location:Front area

Interlock not fixed properly

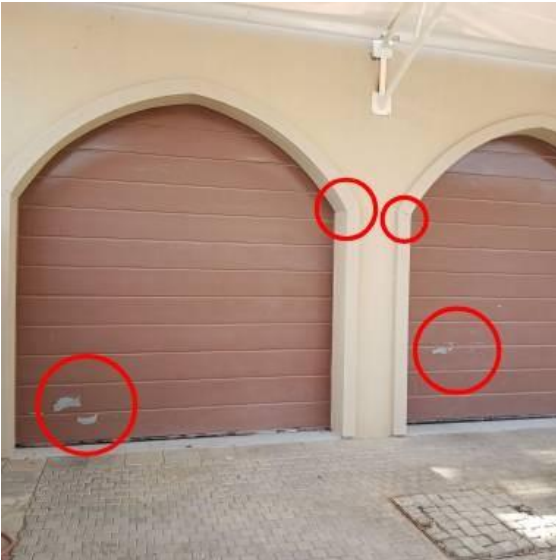
Location:Front area

Paints damage and Multiple cracks

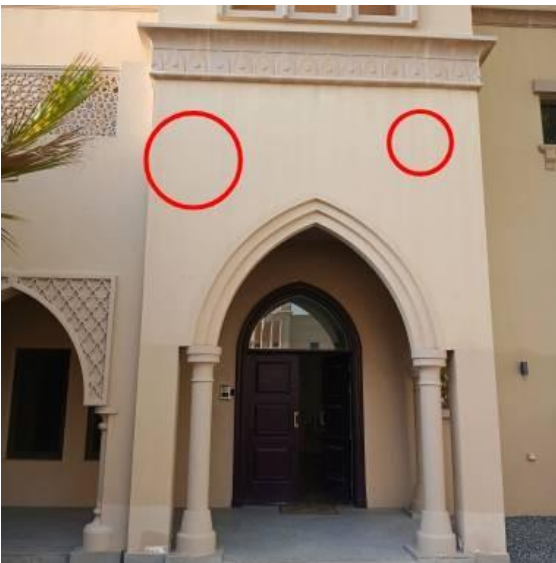
Location:Front area

Cracks on wall were noted

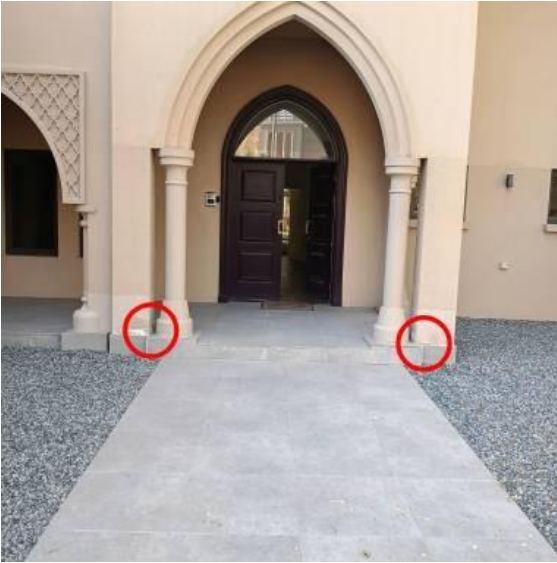
Location:Front area

Paint damages at column bottom

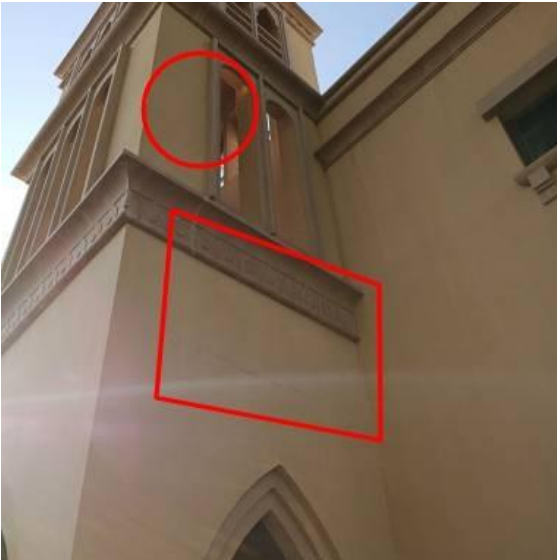
Location:Front area

Multiple cracks on wall

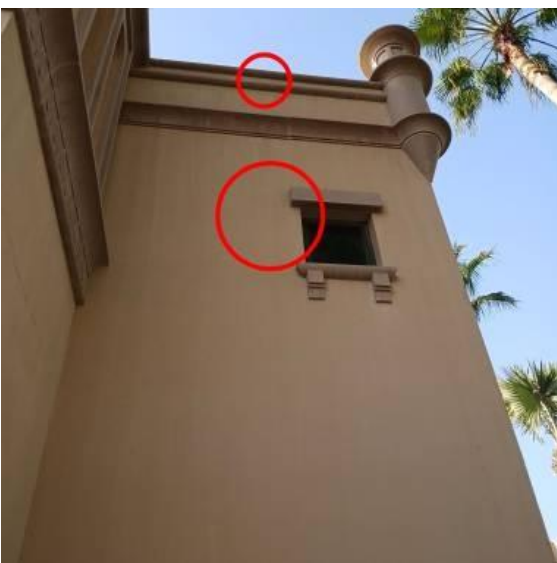
Location:Front area

Multiple cracks on wall were noted

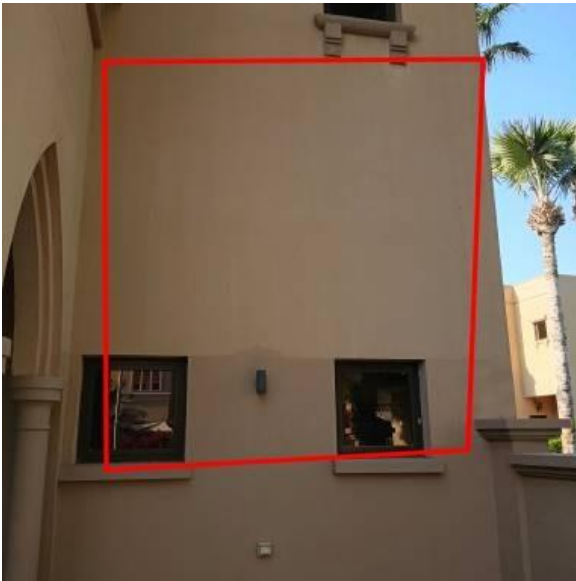
Location:Front area

Improper Paint finishes on wall were noted
